NBSIR 75-688

Performance of Mobile Homes - A Field Inspection Study

June 1975

Interim Report

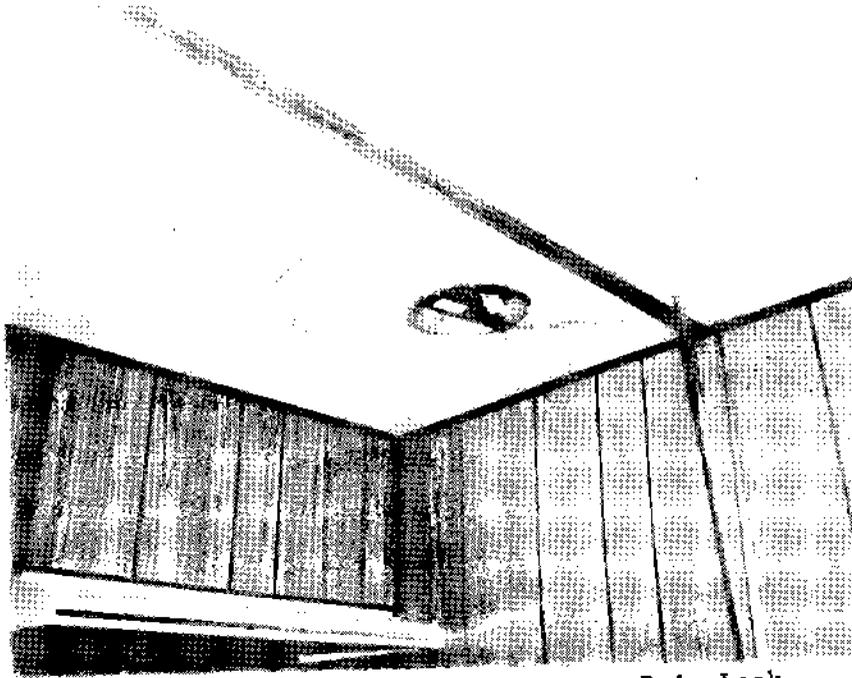
Figure C-12 Water Damage to Ceiling Due to Rain Leak at Vent Stack Penetration Through Roof

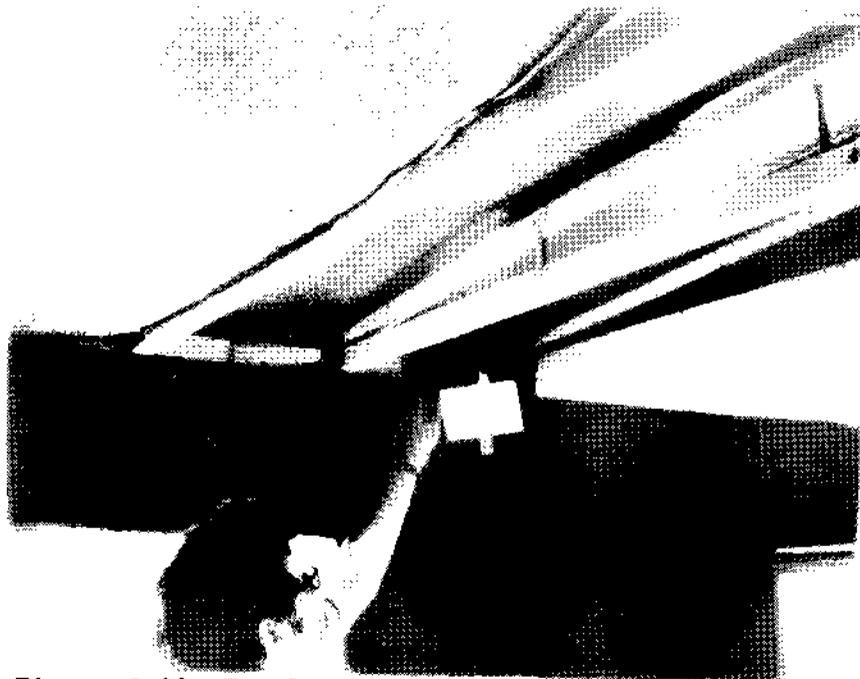
Figure C-22 Insulation Missing in Roof System. Note Metal Roofing Loosely Lying on Roof Truss Which Would Likely Result in "Roof Rumble" in Windy Condition

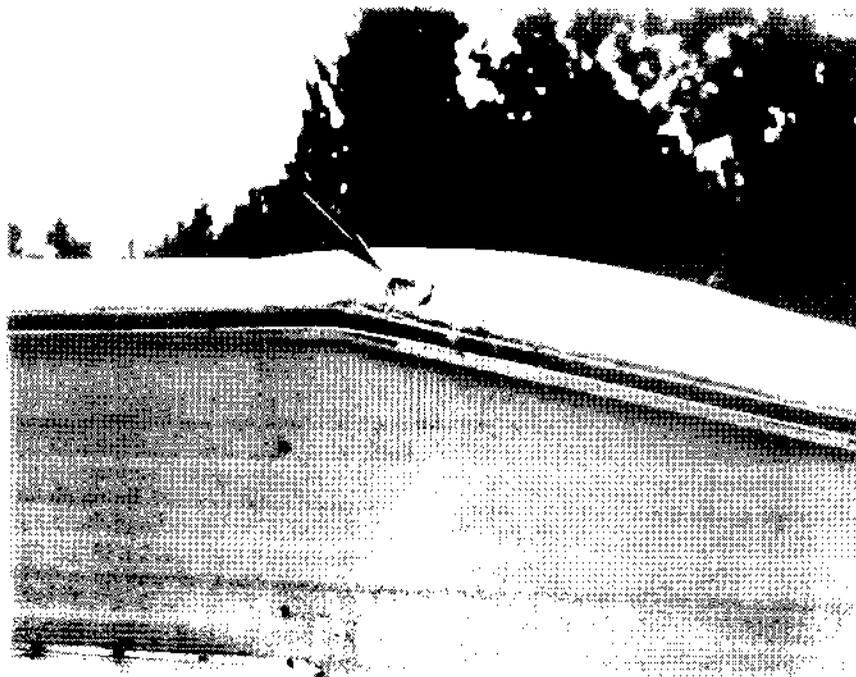
Figure C-26 Crimped Steel Membrane at Change in Slope of Roof

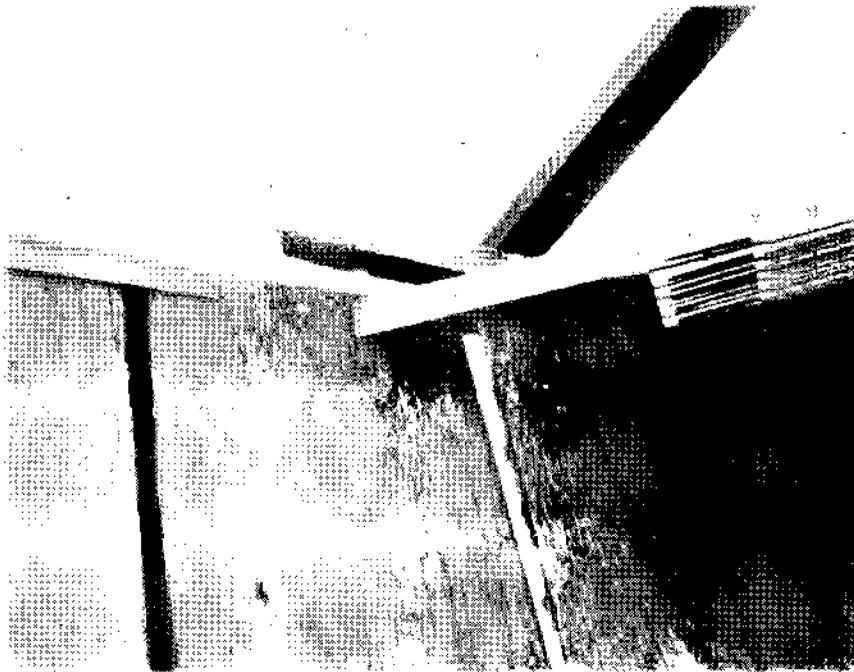
Figure C-29 Loose Interior Paneling to Wall Framing Attachment
At Intersection of Exterior Wall and Ceiling

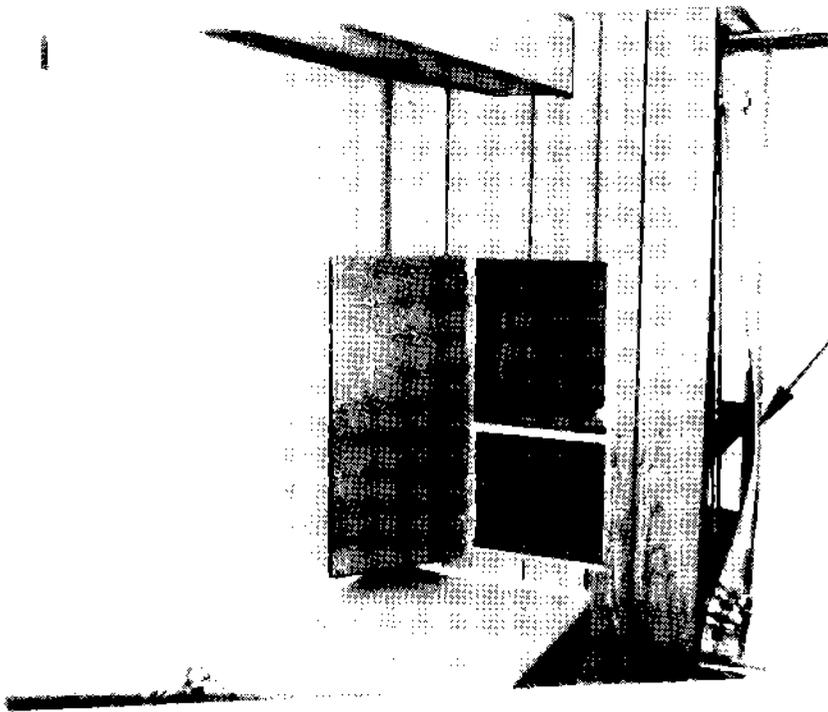
In the "Plumbing Fixtures" section (20.4% of problems), the most frequent violation was the inadequate floor connection of toilets, figure C-79. A submerged ball cock flushing device that could possibly allow flush tank water to back flow into the potable water supply is shown in figure C-78. Other problems were lack of watertightness of shower stall enclosures, figure C-32; and poor access to hot water heaters, figures C-80 and C-81.

Figure C-32 Distortion of Shower Enclosure
Wall Due to Effects of Moisture

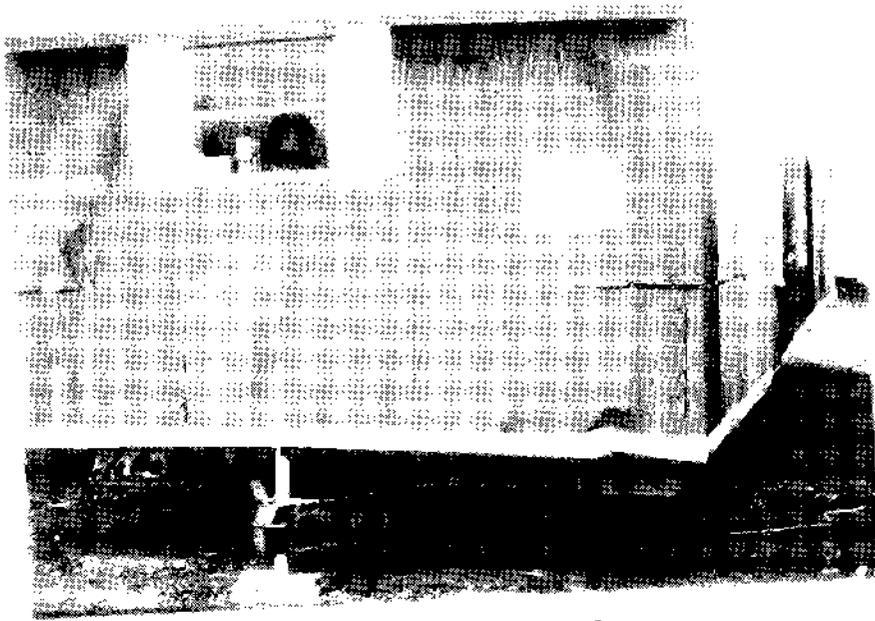
Figure C-36 A-Frame Assembly Failure

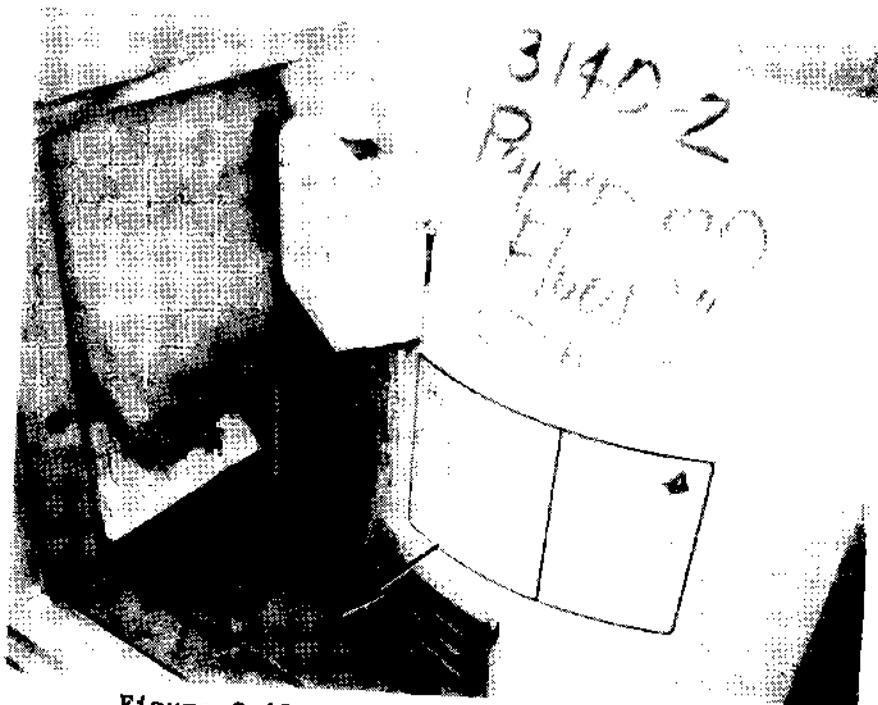
Figure C-45 Combustible Material on Hot Water Heater Compartment Floor

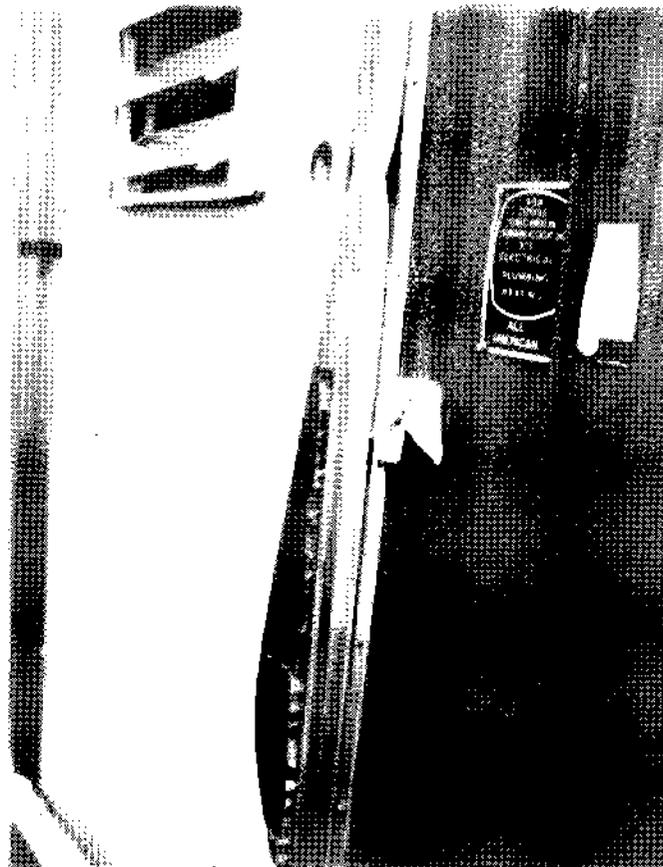
Figure C-54 Exterior Door Construction of Paper Honeycomb Core and Aluminum Skins - Exterior Skin Was Buckled.

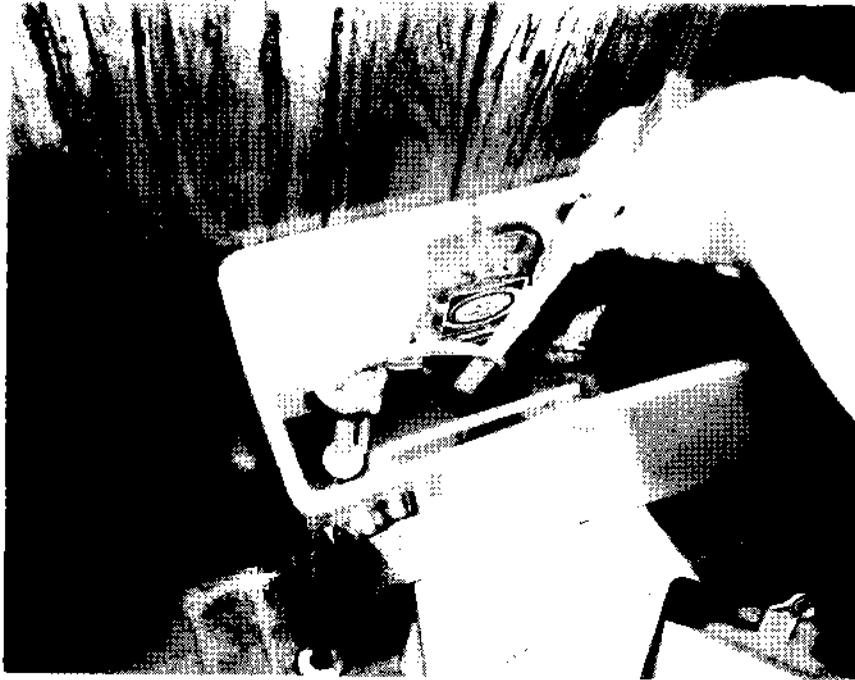
Figure C-78 Submerged Valve Flushing Device Which Could Allow Flush Tank Water to Back Flow Into The Potable Water Supply

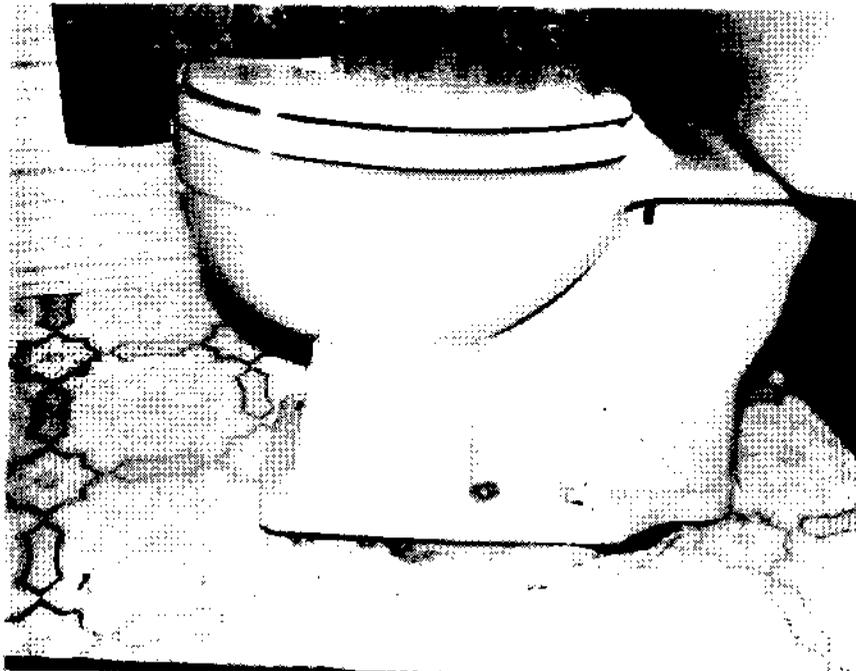
Figure C-79 Loose Toilet at Floor Connection.

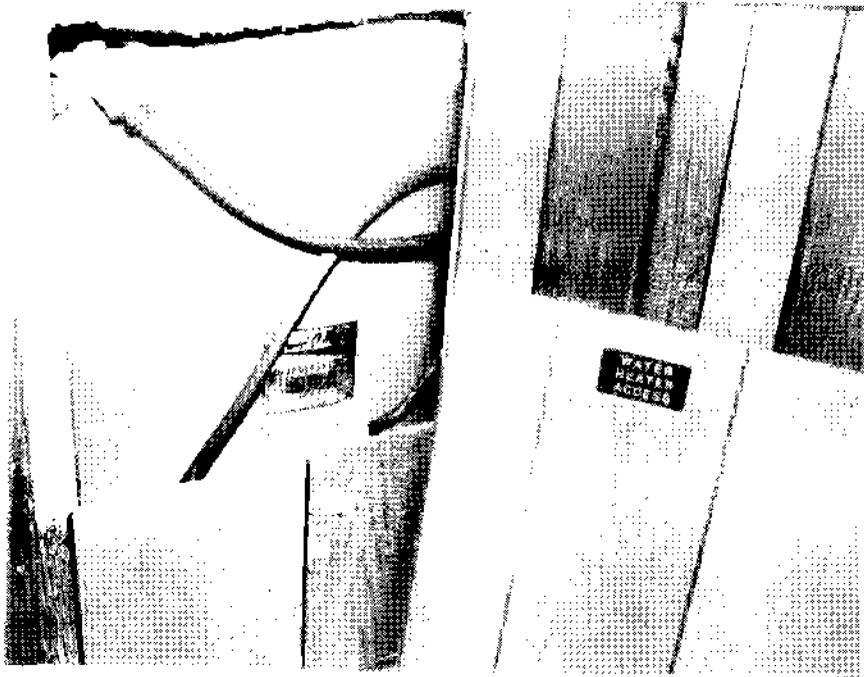
Figure C-80 Inadequate Hot Water Heater Access From Within Closet. Wall Paneling Would Have to be Removed to Replace Hot Water Heater

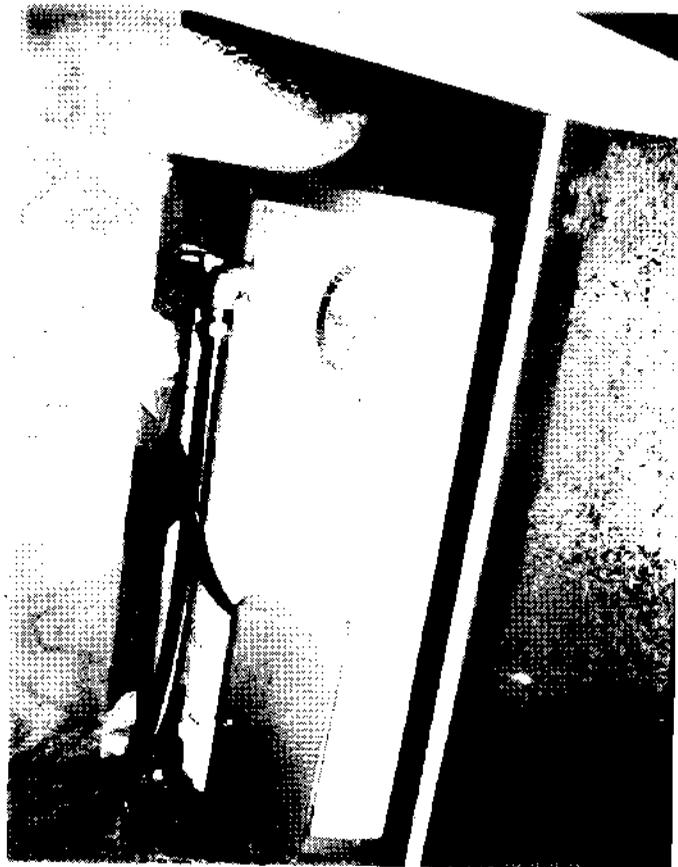
Figure C-81 Hot Water Heater Access Under Kitchen Cabinet. Kitchen Cabinetry would Have to be Removed to Replace Hot Water Heater

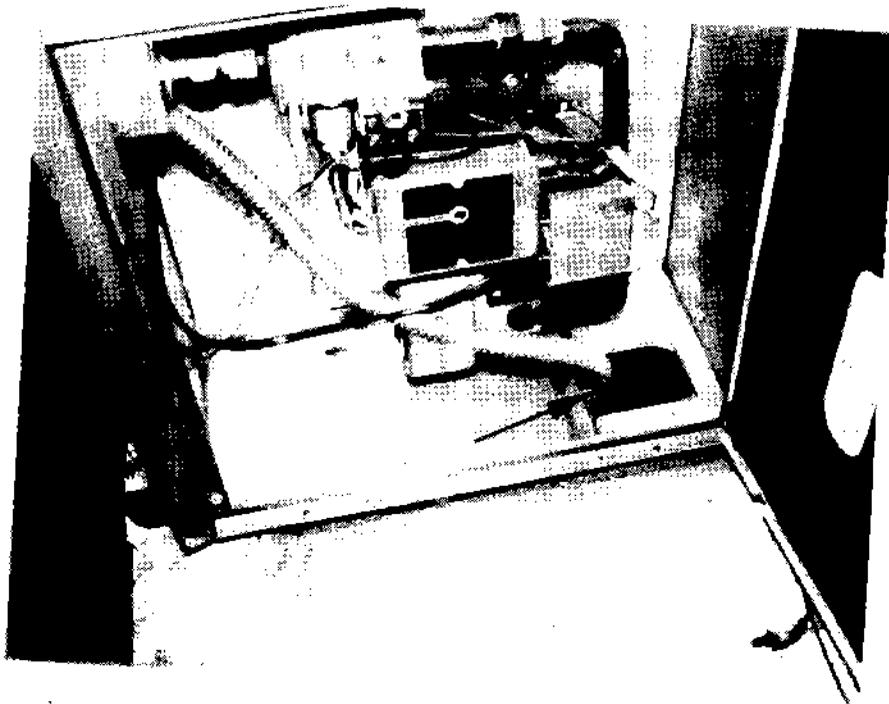
Figure C-82 Flexible Gas Connector on Furnace Through Floor to Gas Supply Piping

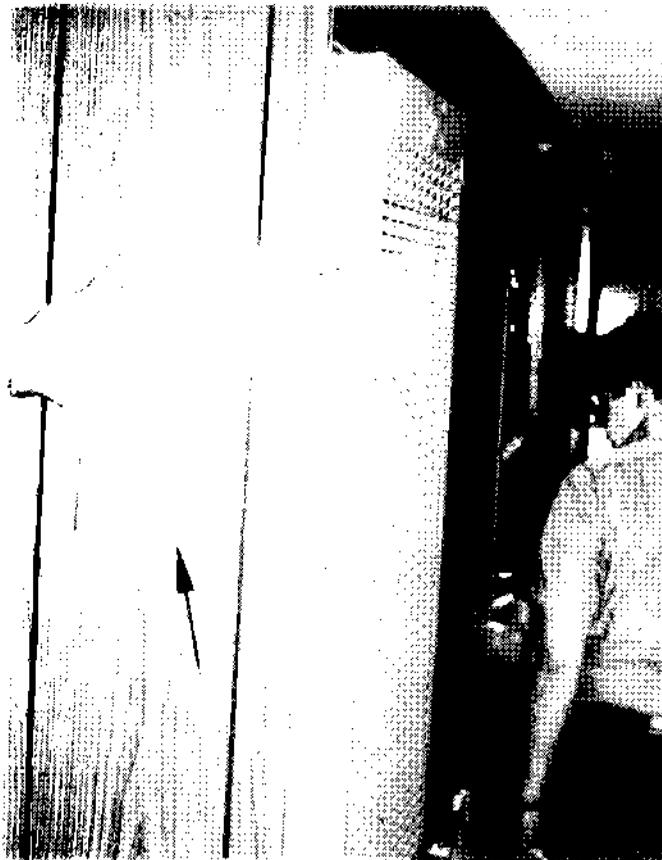
The remaining problems are shown in figures C-90 through C-94. The venting problems are violations of the ANSI A119.1 Standard (figures C-90 and C-91) but the location of the furnace thermostat (figure C-92) and the location of furnace registers (figures C-93 and C-94) are not violations in the strict sense but were prevalent enough to be considered omissions in the Standard or poor construction practice.

Figure C-92 Furnace Thermostat Located Adjacent to Furnace on Wall Common to Furnace Compartment Causes Problems of Temperature Control.

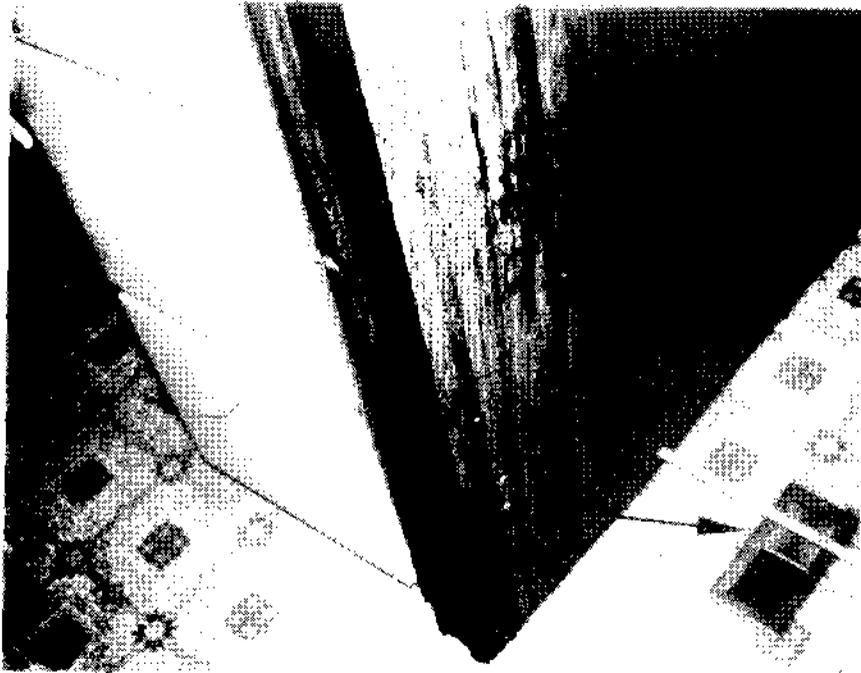
Figure C-93 Floor Register Located Eight Inches From Furnace Compartment Wall in Bedroom Creating Non-Uniform Distribution of Heat.

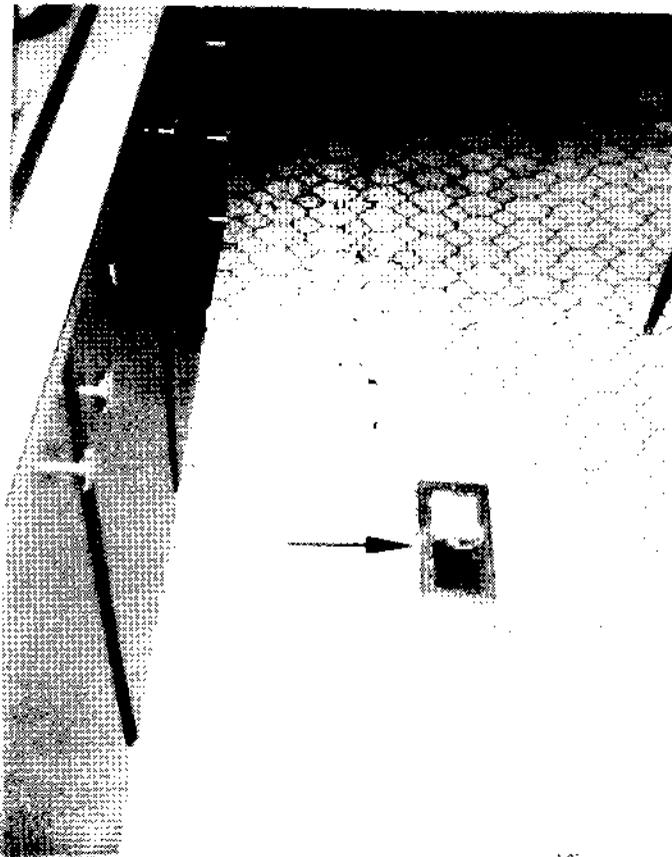
Figure C-94 Floor Register Location Adjacent to Kitchen Cabinets (high traffic area) constituting a Safety Hazard

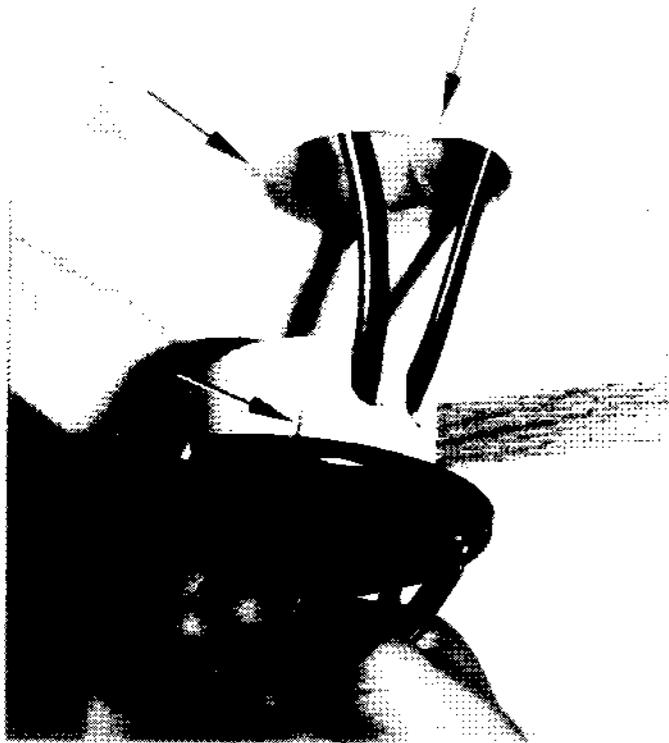
Figure C-96 Ceiling Fixture Inadequately Attached to Vegetable Fiberboard Ceiling Material.

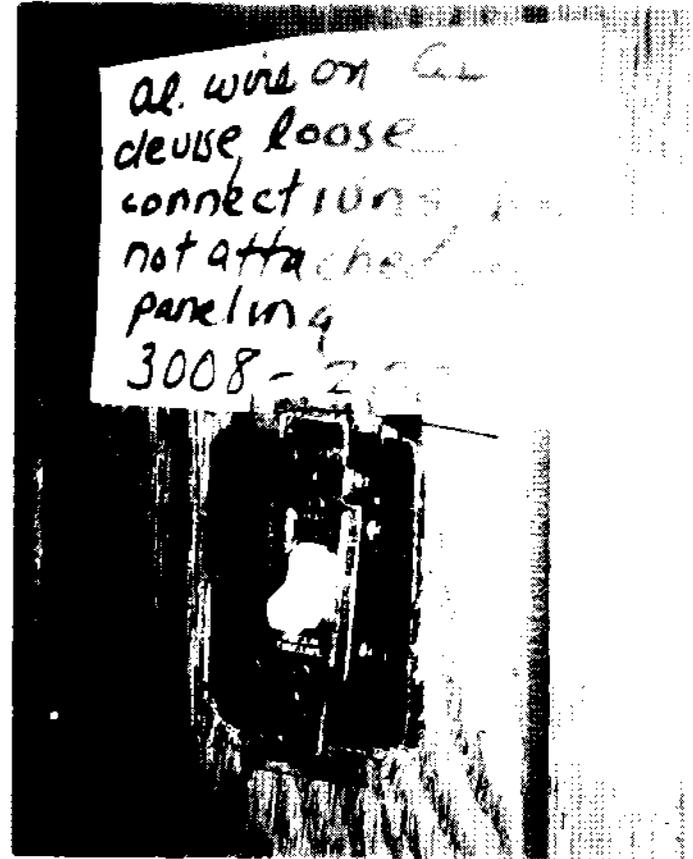
Figure C-95 Aluminum Wire Used With Copper Device

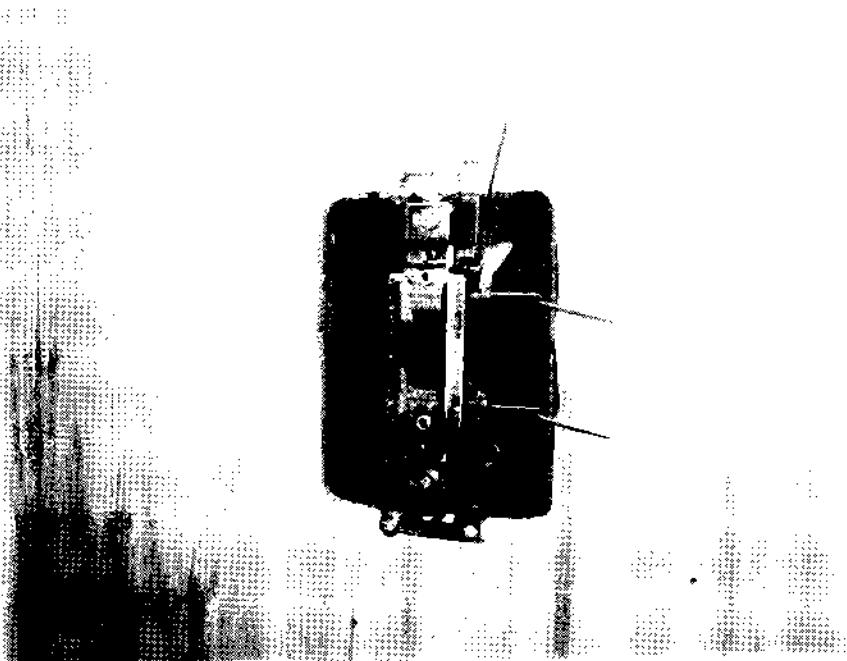
Figure C-100 - Loose Connections
(Copper Wire) in Wall
Switch

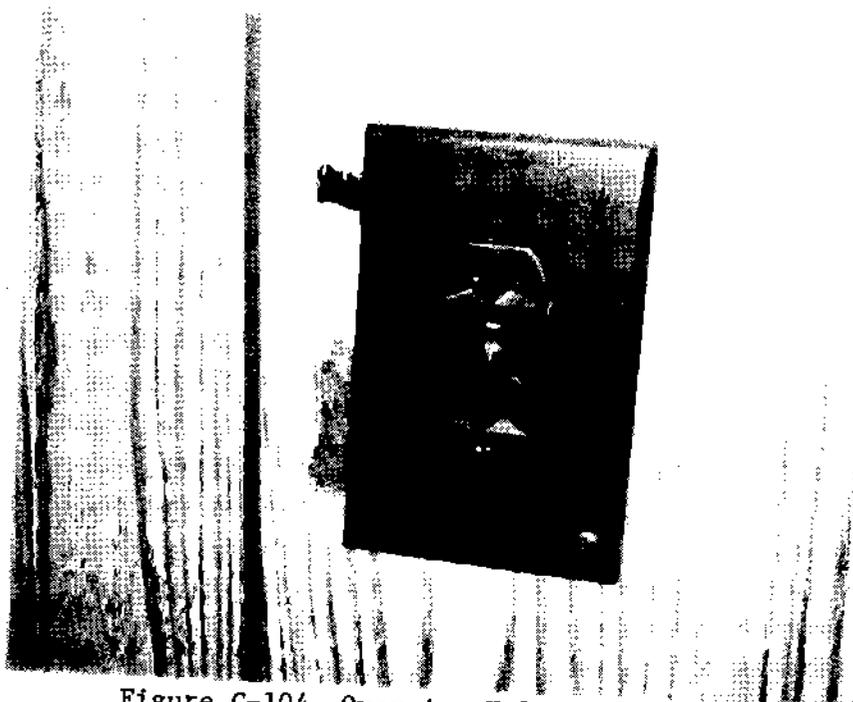
Figure C-104 Oversize Hole Cut for
Outlet Box Installation
