PHYSICAL NEEDS ASSESSMENT AND ENERGY AUDIT

WOODHILL HOMES

2488 Morris Black Place
Cleveland, Ohio 44104

EMG Project #: 109304.14R-025.308
Date of Report: April 22, 2015
On site Date: March 16 - 19, 2015

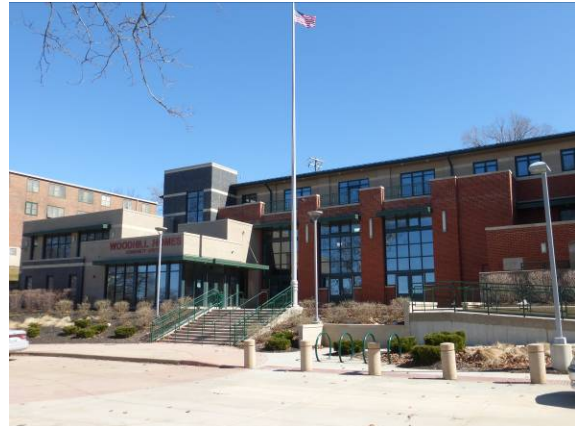
Photo #2: Community center - front elevation

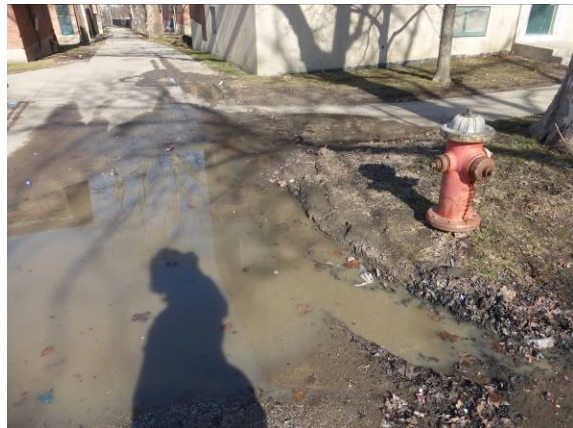
Photo #22: Erosion and ponding issue

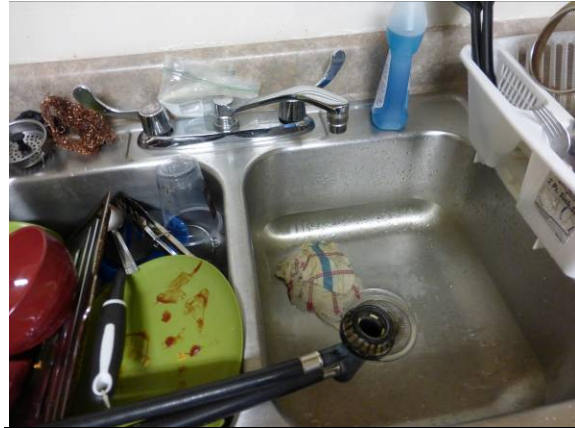
Photo #50: Washer hookup to kitchen sink

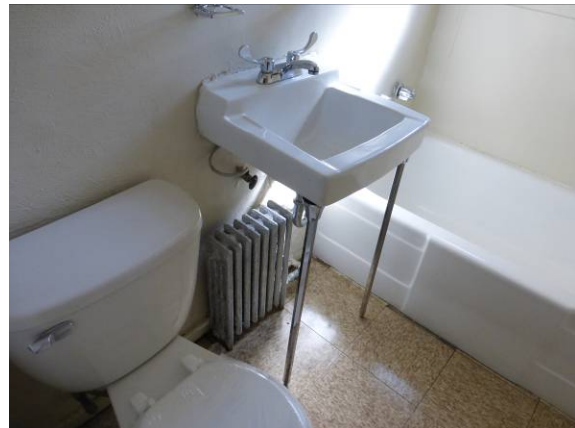
Photo #58:	Old pedestal sink
------------	-------------------

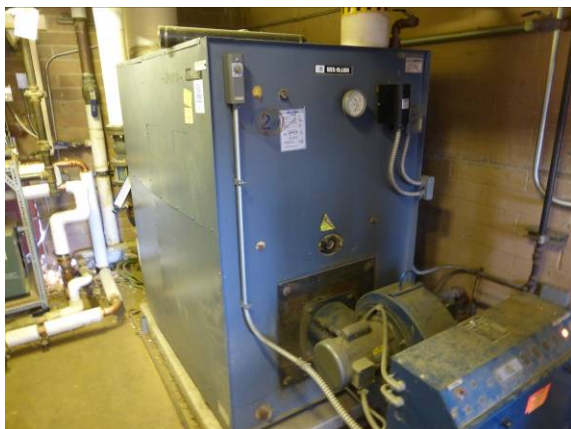
Photo #65: Central heating boiler
