AN ASSESSMENT OF DAMAGE TO MANUFACTURED HOMES CAUSED BY HURRICANE CHARLEY

March 31, 2005

Assessment of Damage to Manufactured Homes Caused by Hurricane Charley

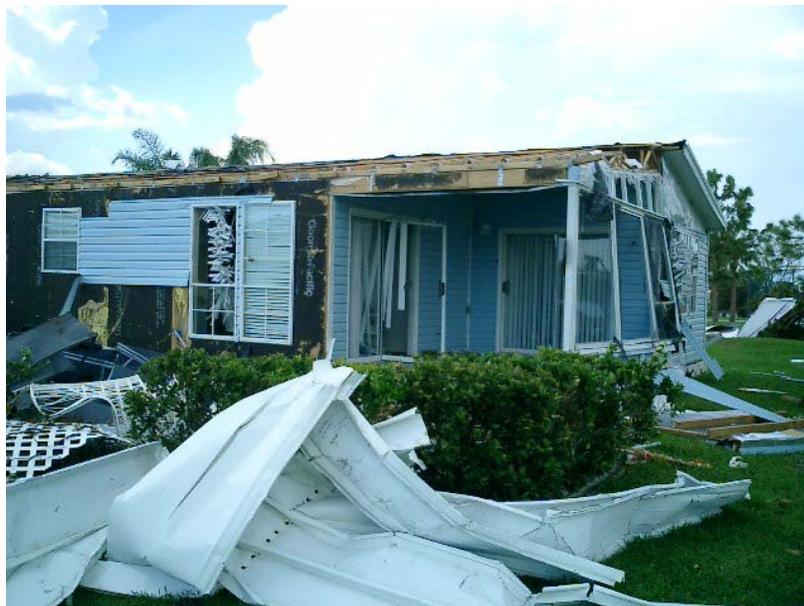
Figure 4.1: An Example of Level 3 Roof System and Level 2 Wall System Damage
[Note: In this case, the roof rating was primarily associated with extensive roof sheathing loss; the wall rating was based on some localized structural damage to sheathing in addition to extensive siding damage, even though the walls were essentially structurally intact.]

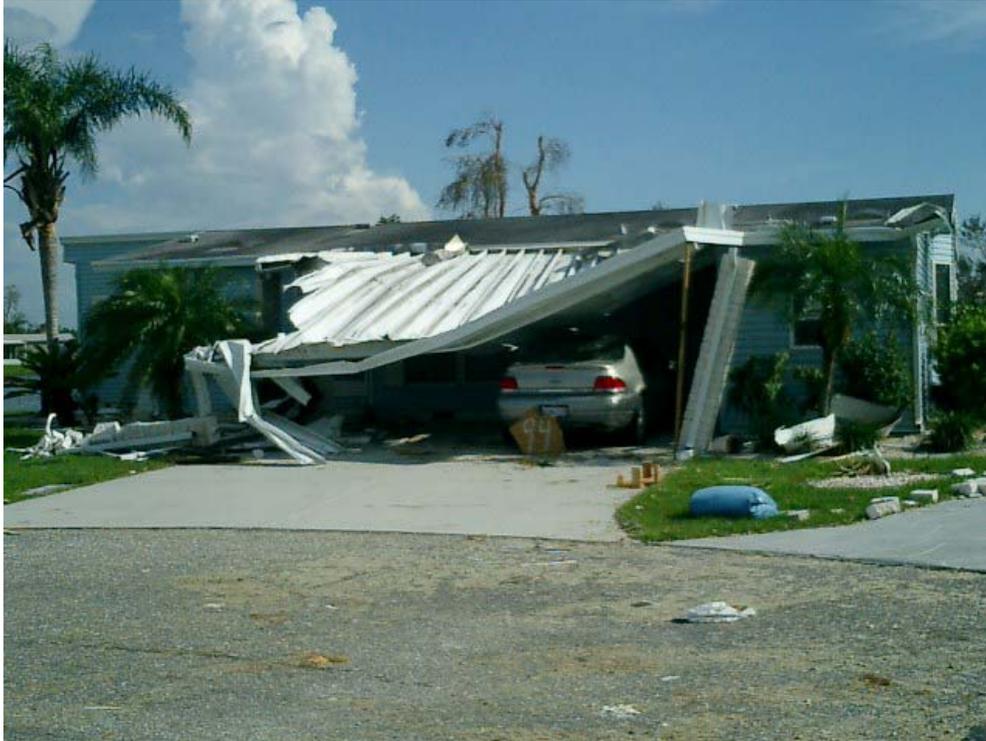
Figure 4.2: An Example of Level 3 Add-On Damage

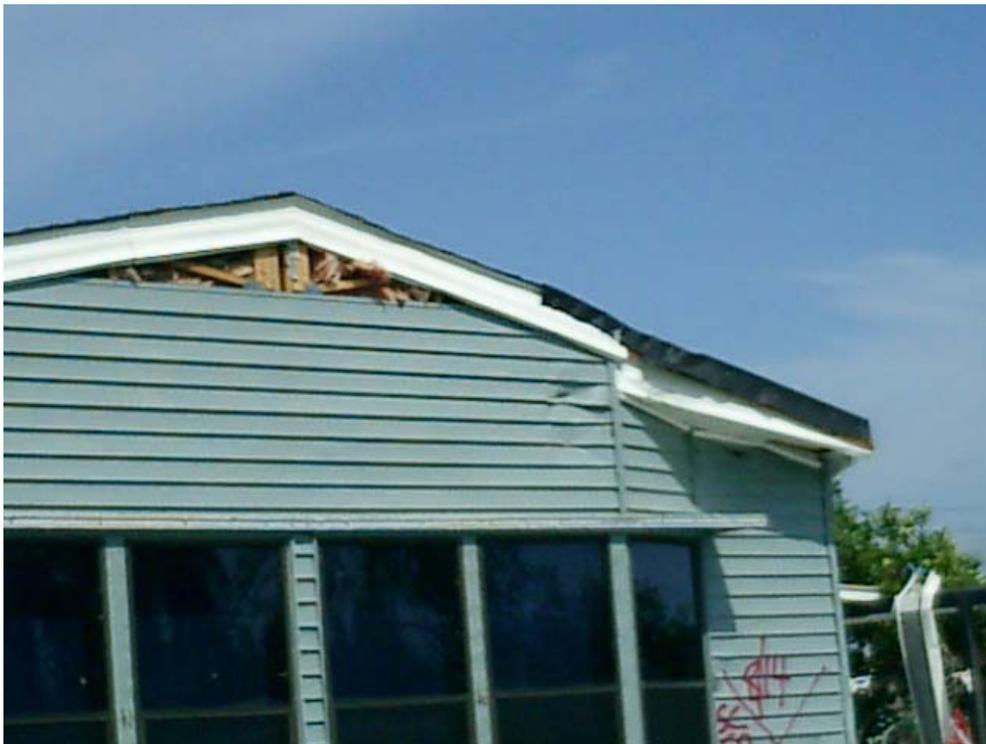
Figure 4.3: An Example of Level 1 Wall System Damage
[Note: Damage was limited primarily to wall finishes, i.e. vinyl siding damage]

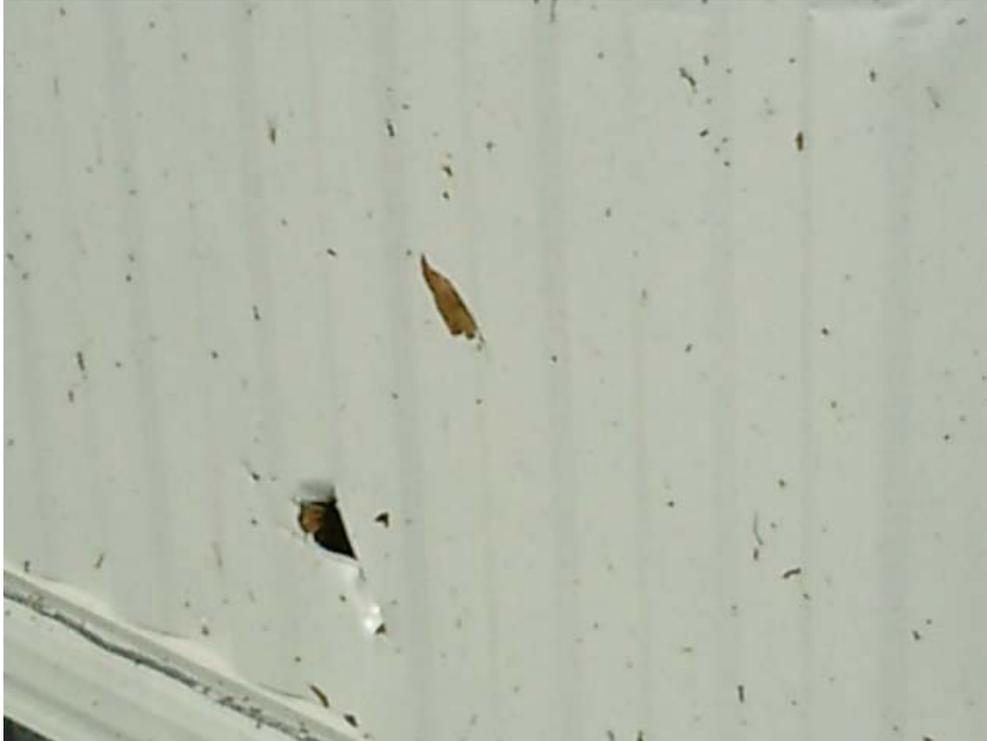
The second explanation is more likely to be a factor, because some of the observed broken glazing in older units may have been associated with a lower resistance to wind pressure. The higher wind pressure rating of windows in the newer construction probably improved the impact resistance of standard glazing by a small margin (e.g., better able to resist the impact of small debris such as roof shingle pieces, etc.) (Crandell, 2002). In addition, there are age effects to consider in the resistance of glazing to impacts and wind pressure, just as there are with other parts of a building. Impact damage ratings were also affected by the amount of damage incurred to walls, particularly siding fractures. In a relatively few cases, debris completely penetrating walls was found in the survey.

Figure 5.1: An Example of Debris Penetrating a Wall

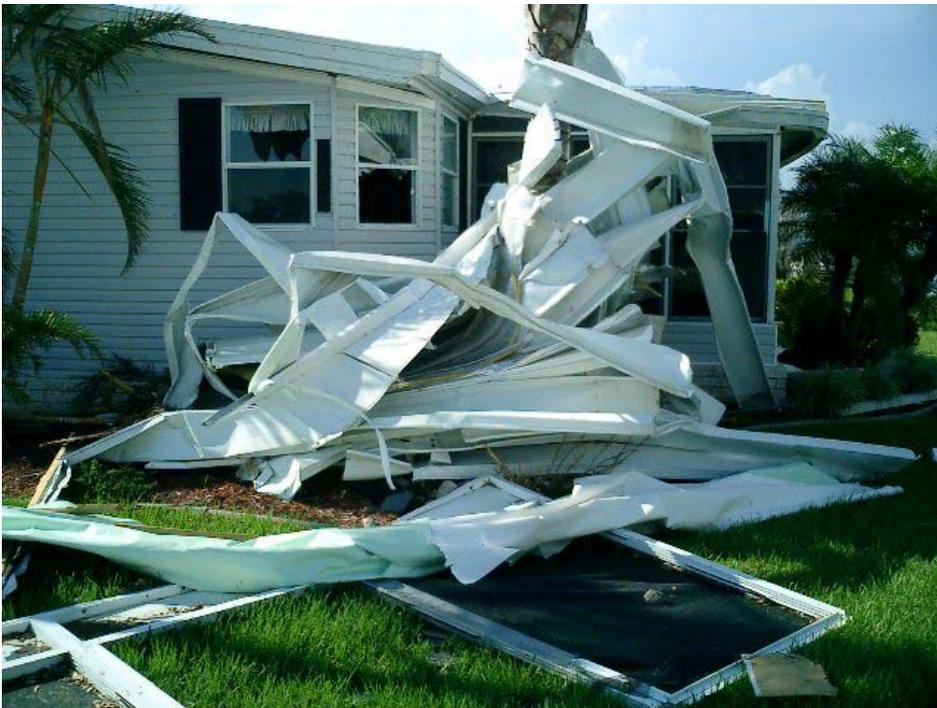
Add-on construction was comprised of building portions that were added on to the manufactured unit after installation. These features included garages, screened porches, and carports. Typical construction of porches or carports included aluminum tube framing and thin-gauge aluminum inter-locking roofing panels. As shown in the average damage ratings of Table 8, damage to these types of add-on structures was severe and did not vary appreciably across the different age groups of construction. This type of construction was a major source of wind-borne debris, as shown in Appendix E, Figures 7.1 – 7.6. There were a few cases in the survey where the add-on construction actually performed better than the manufactured home itself (usually an older unit), but these were rare exceptions. In cases where add-ons were substantially constructed (e.g., fully sheathed with wood structural panels and anchored to a foundation or slab), the performance was observed to be good.

Figure 5.2: An Example of Substantial (Level 3) Add-On Damage

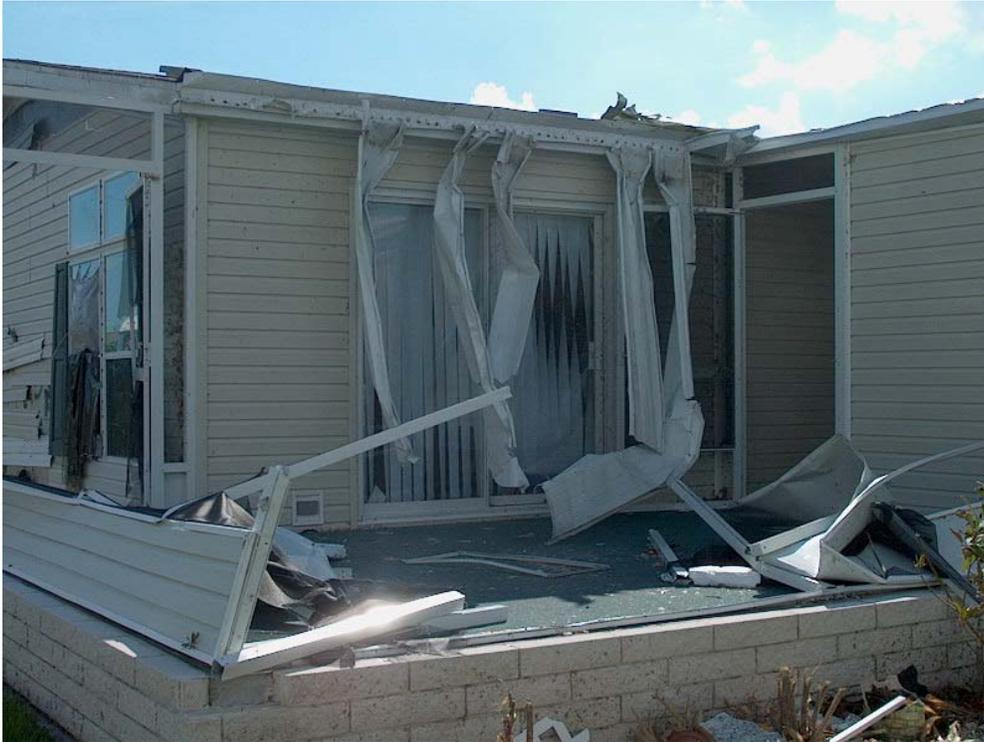
Figure 6.1: Destroyed Add-On Construction

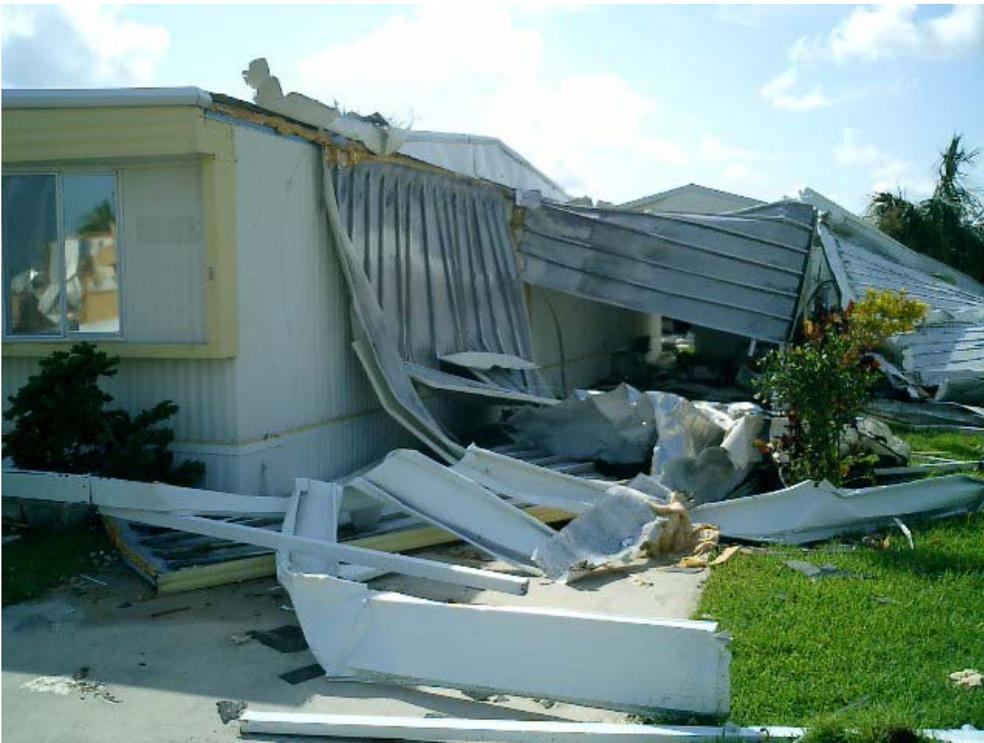
Figure 6.2: Destroyed Add-On Construction

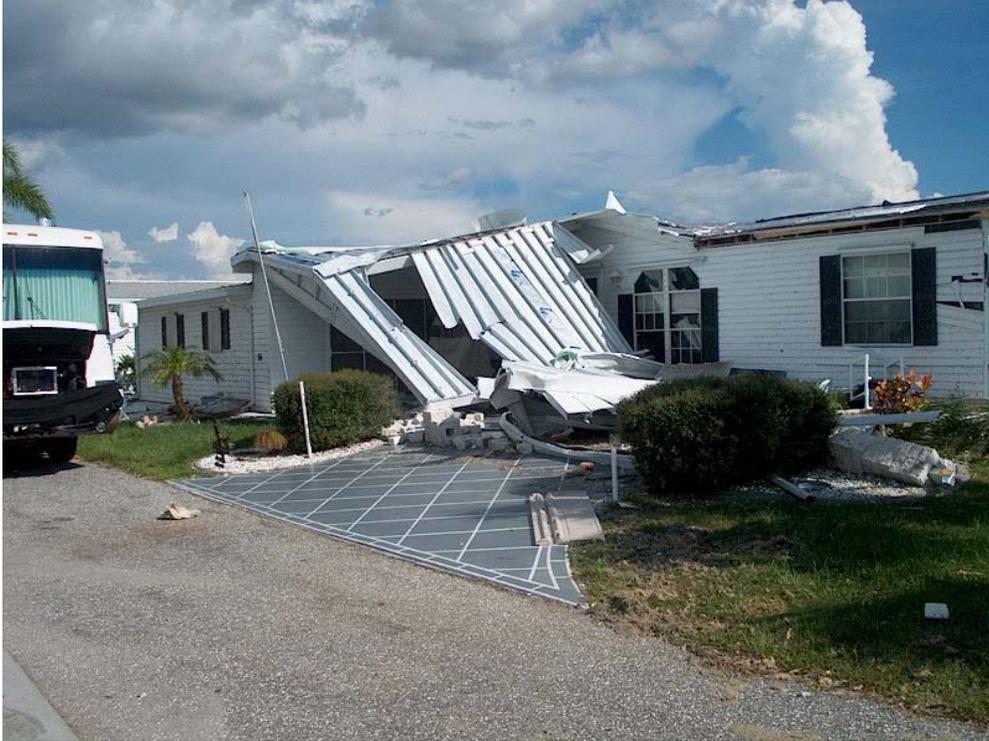
Figure 6.3: Destroyed Add-On Construction

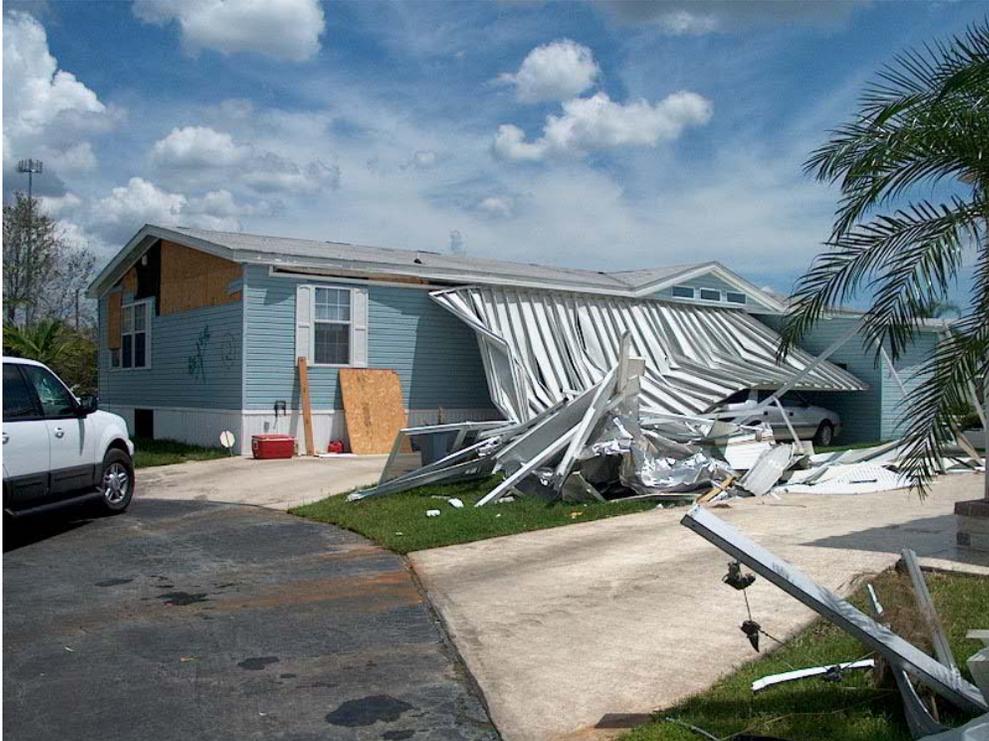
Figure 6.4: Destroyed Add-On Construction

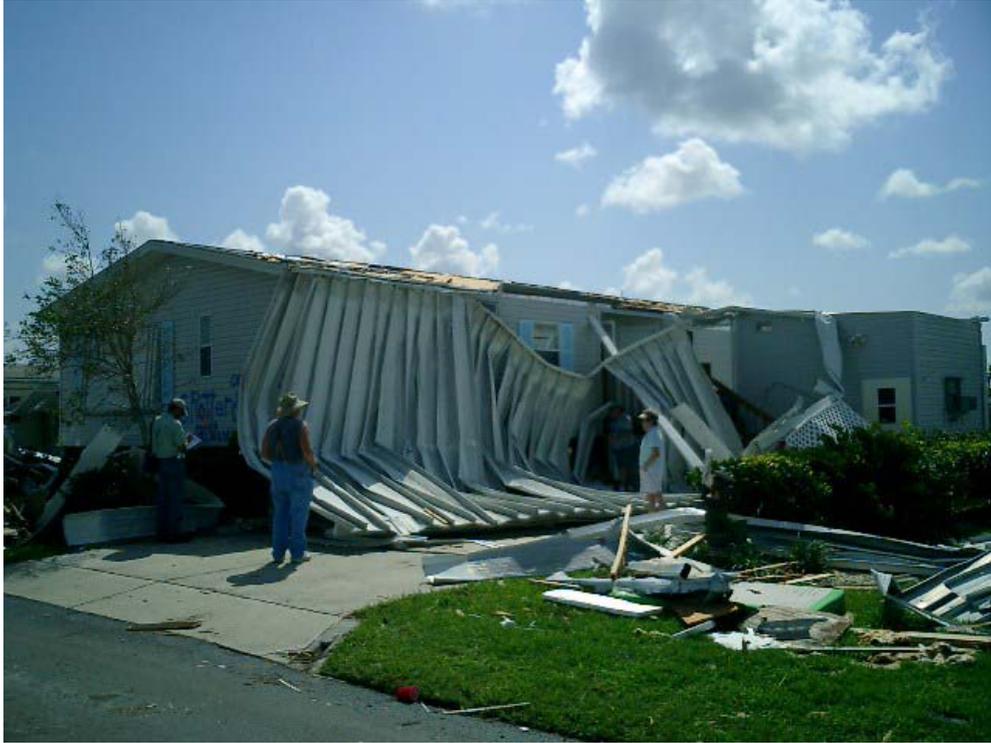
Figure 6.5: Destroyed Add-On Construction

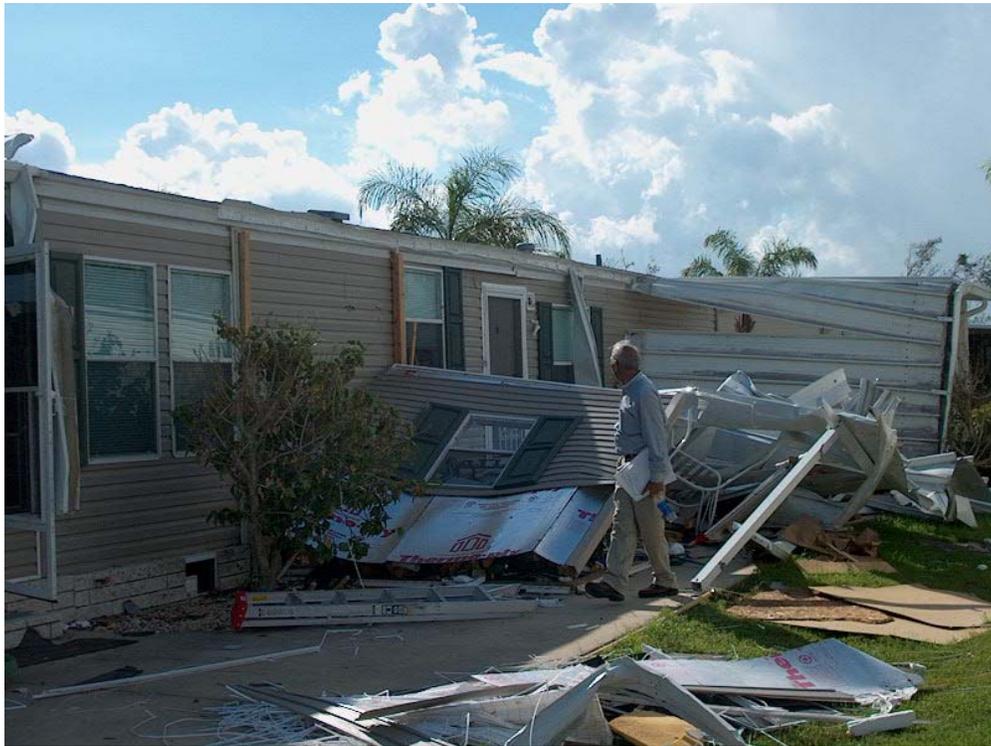
Figure 6.6: Destroyed Add-On Construction

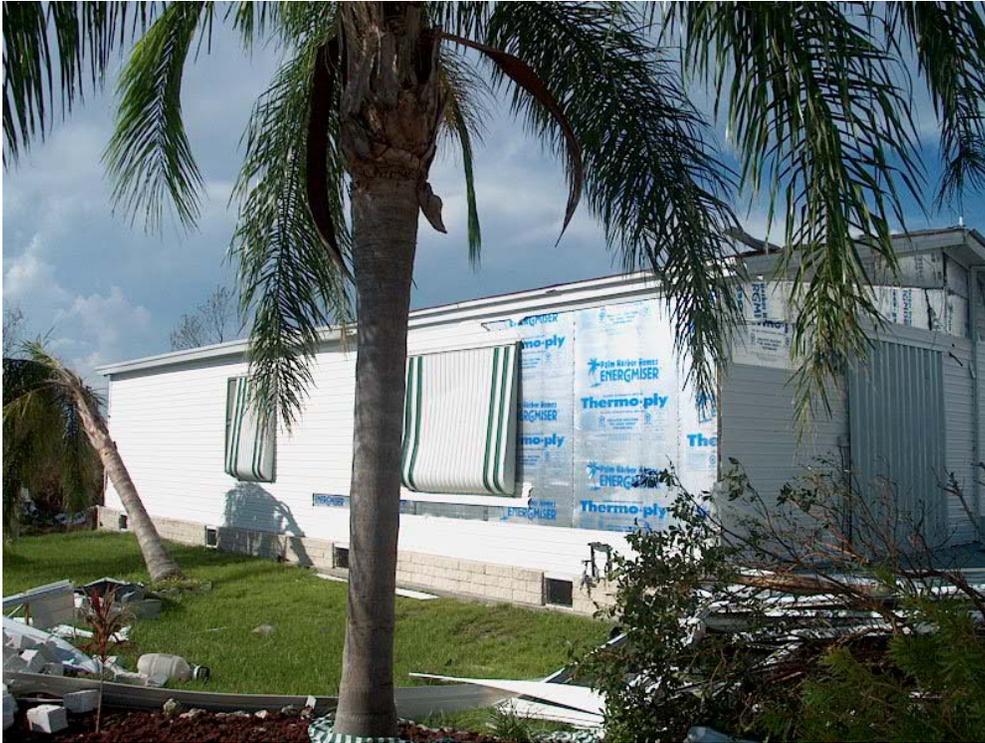
Figure 6.7: Damaged Sidewall and Endwall Siding

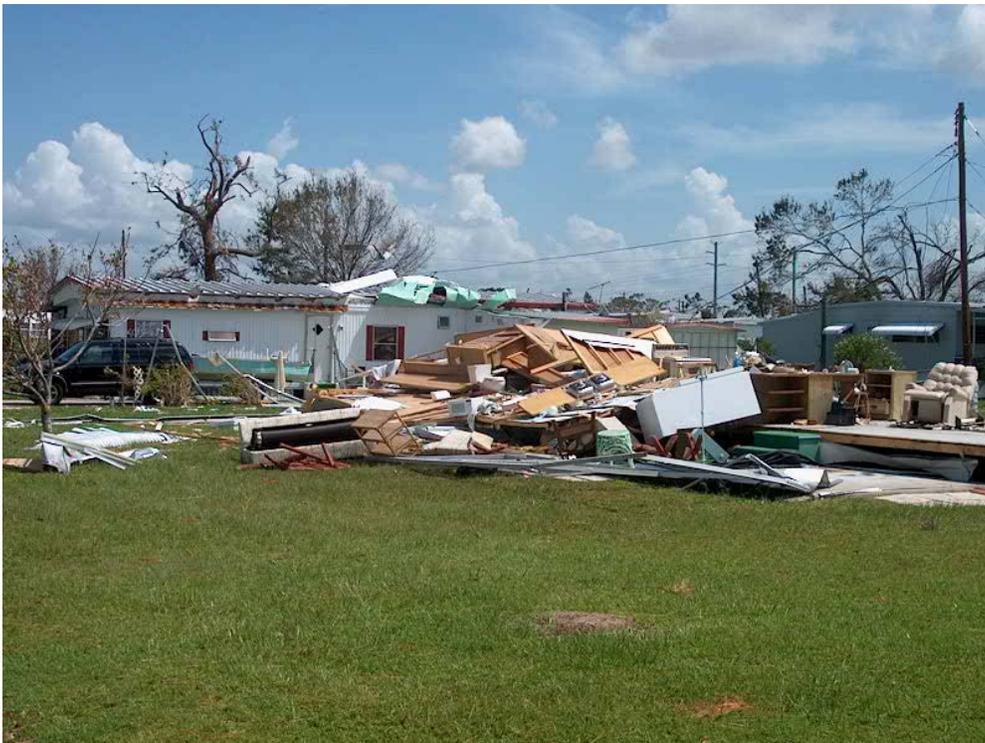
Figure 6.8: Destroyed Manufactured Home Built Prior to 1976

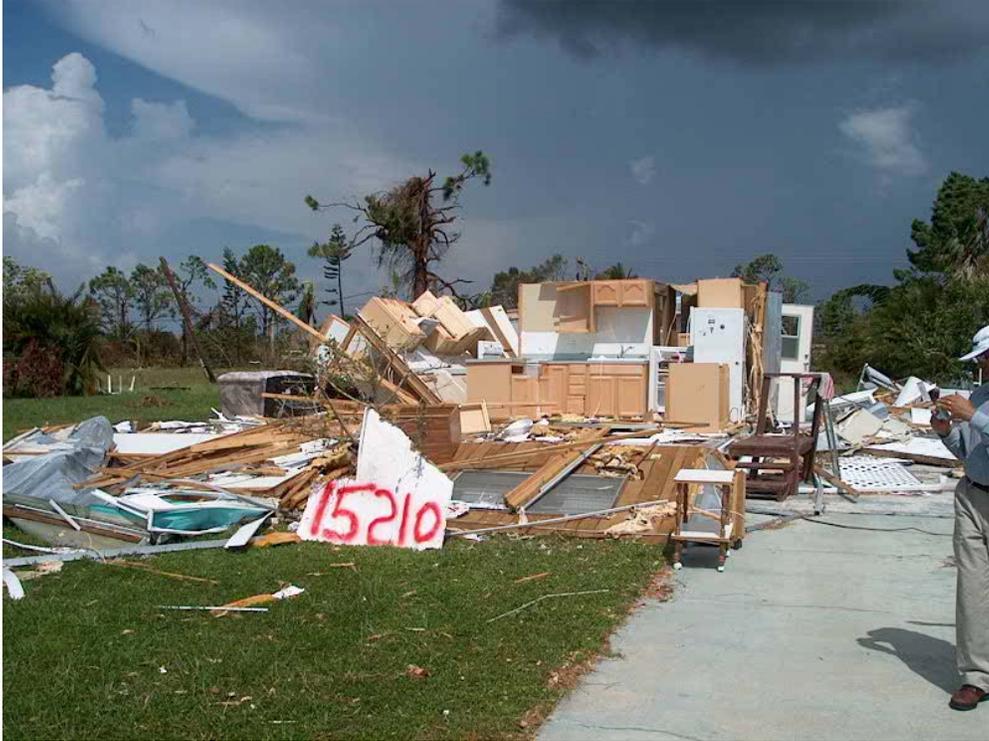
Figure 6.9: Destroyed Manufactured Home

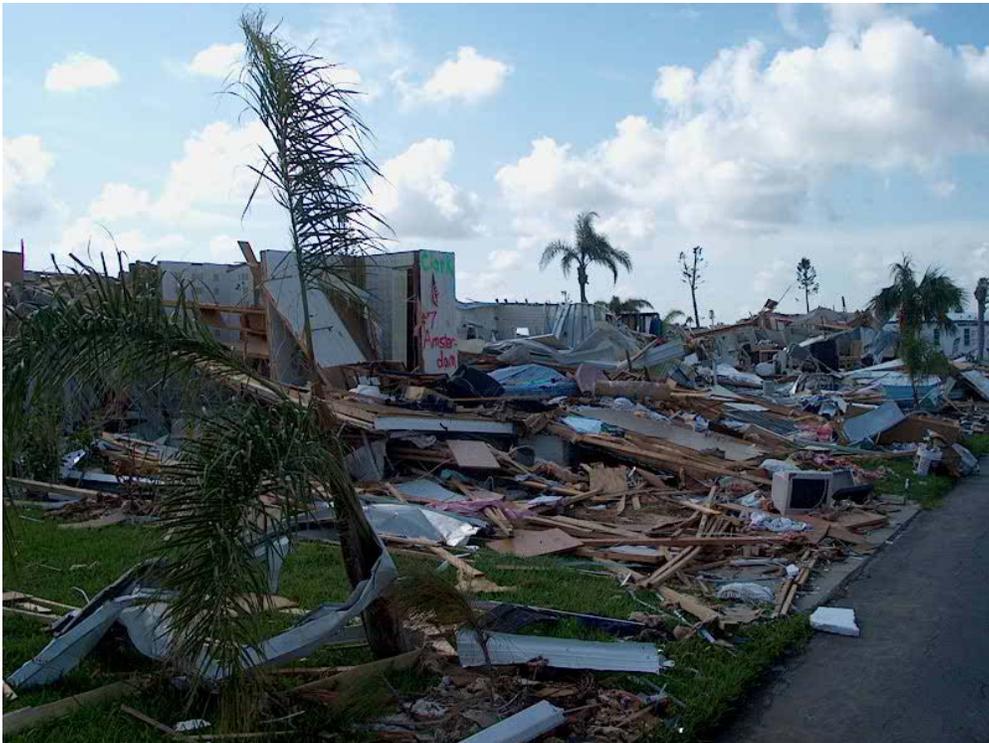
Figure 6.10: Destroyed Manufactured Home

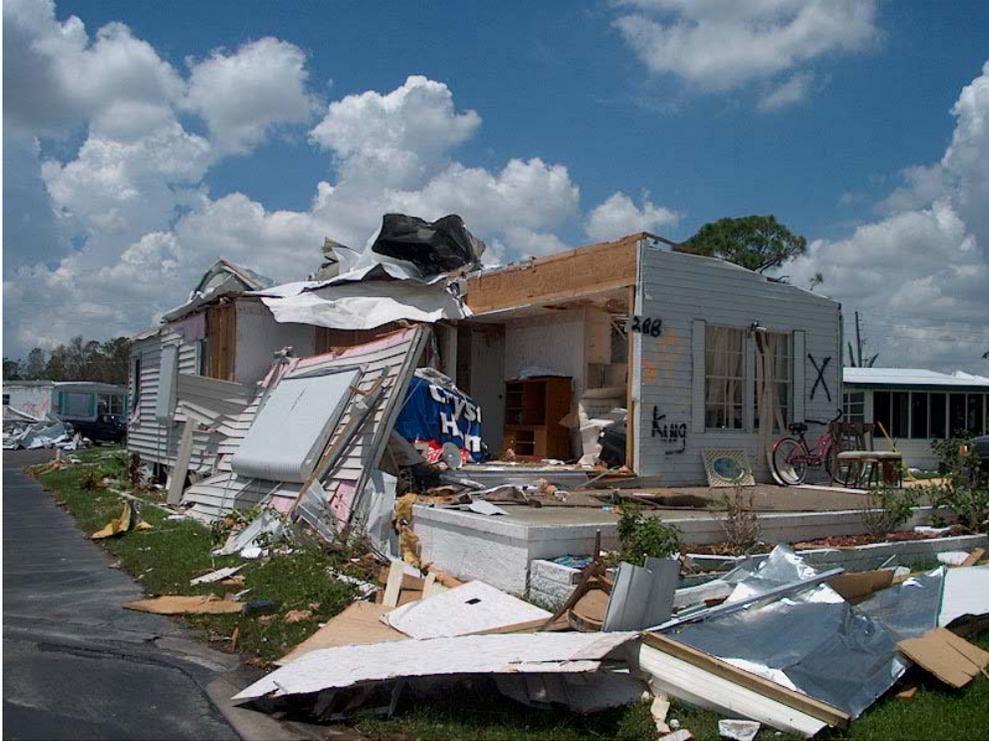
Figure 6.11: Failure of Wall and Roof System

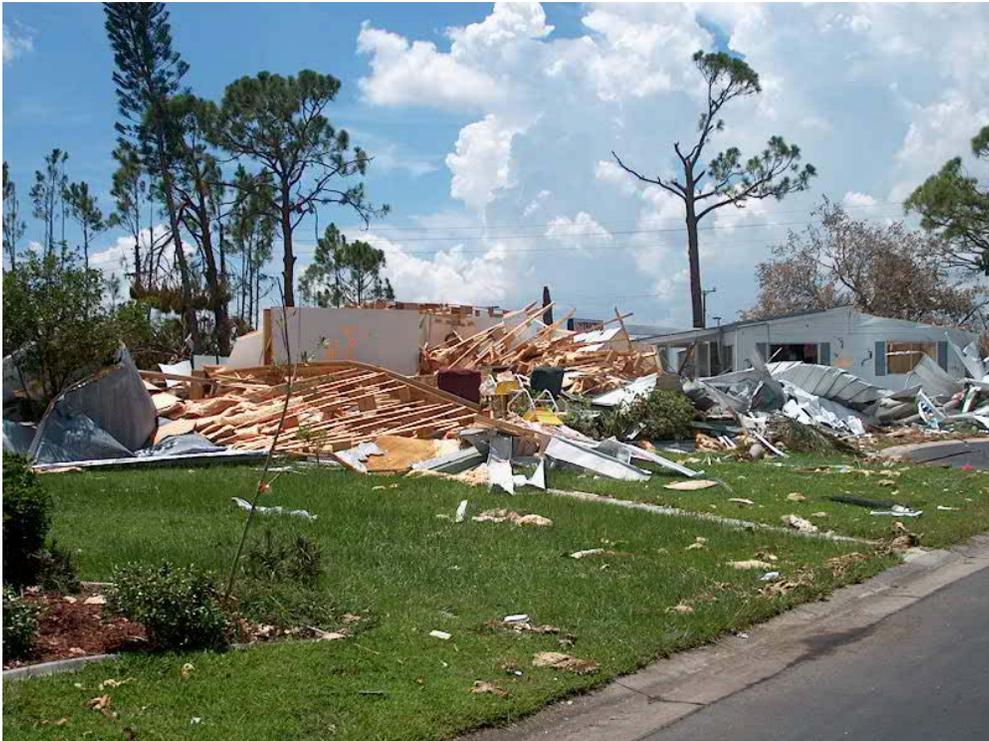
Figure 6.12: Destroyed Manufactured Home

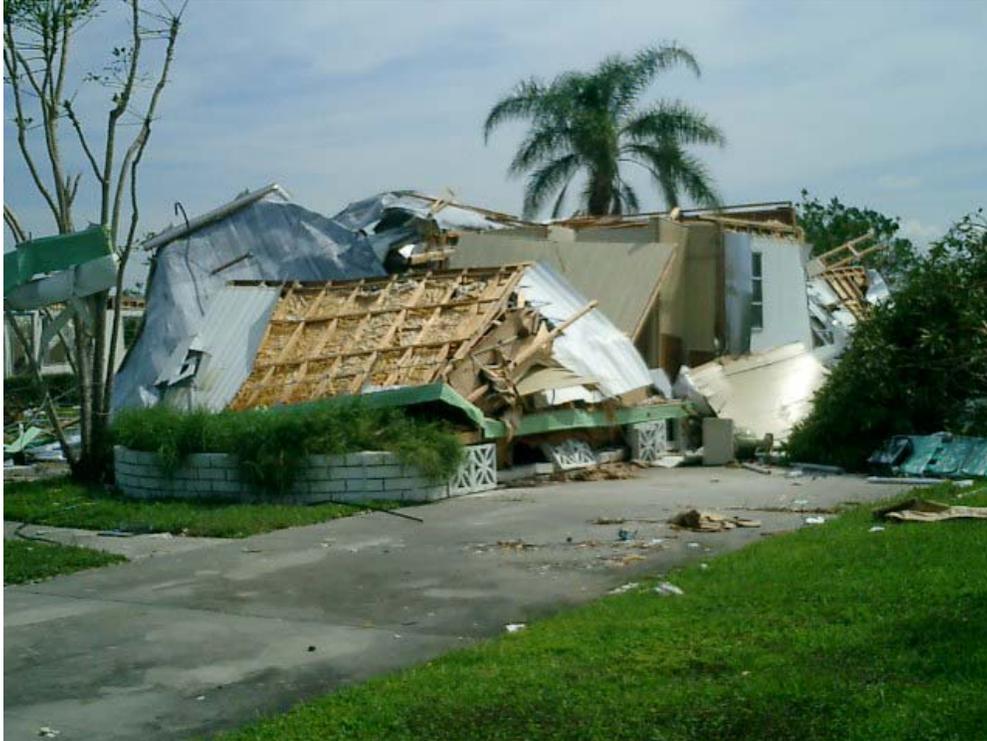
Figure 6.13: Destroyed Manufactured Home Built Prior to 1976

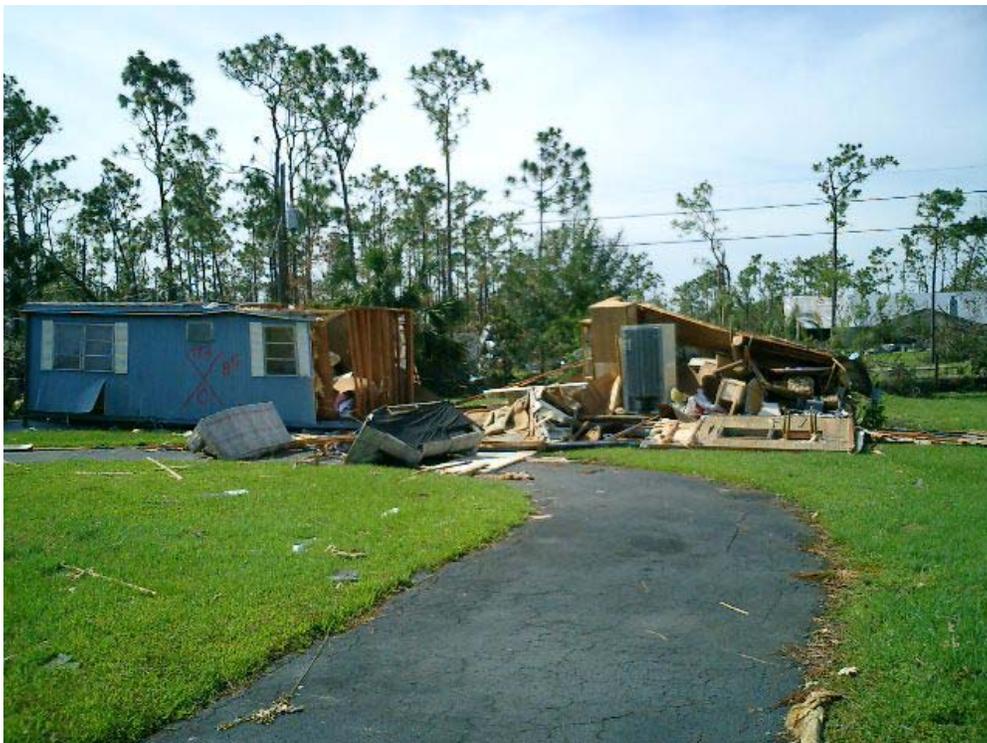
Figure 6.14: Destroyed Manufactured Home Built Prior to 1976

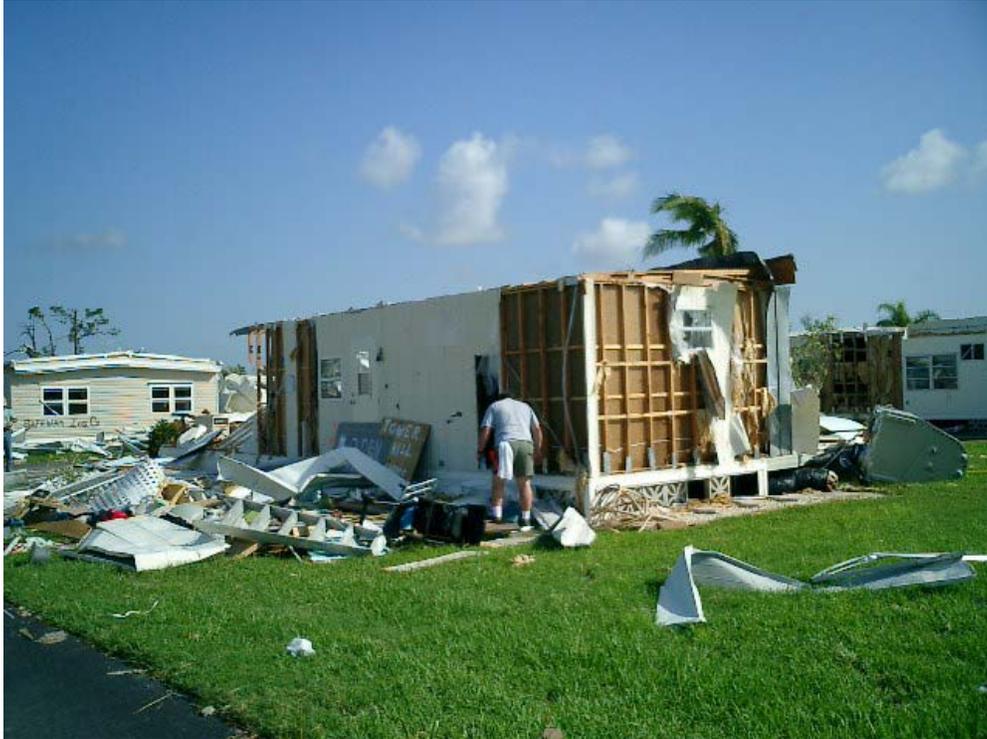
Figure 6.15: Destroyed Manufactured Home Built Prior to 1976

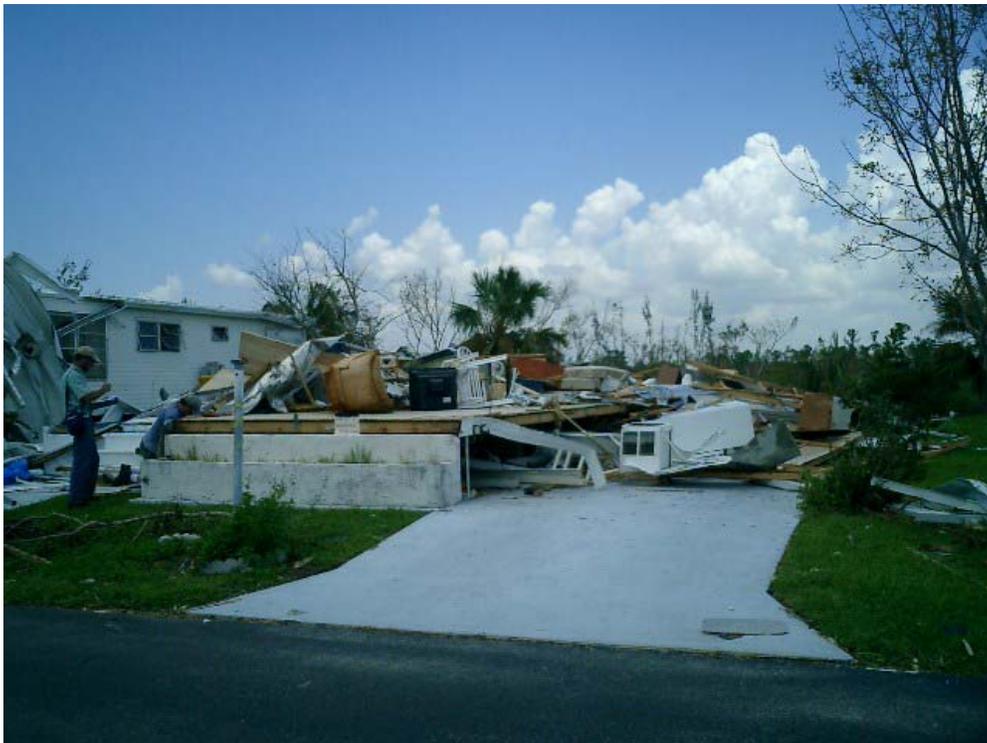
Figure 6.16: Destroyed Manufactured Home

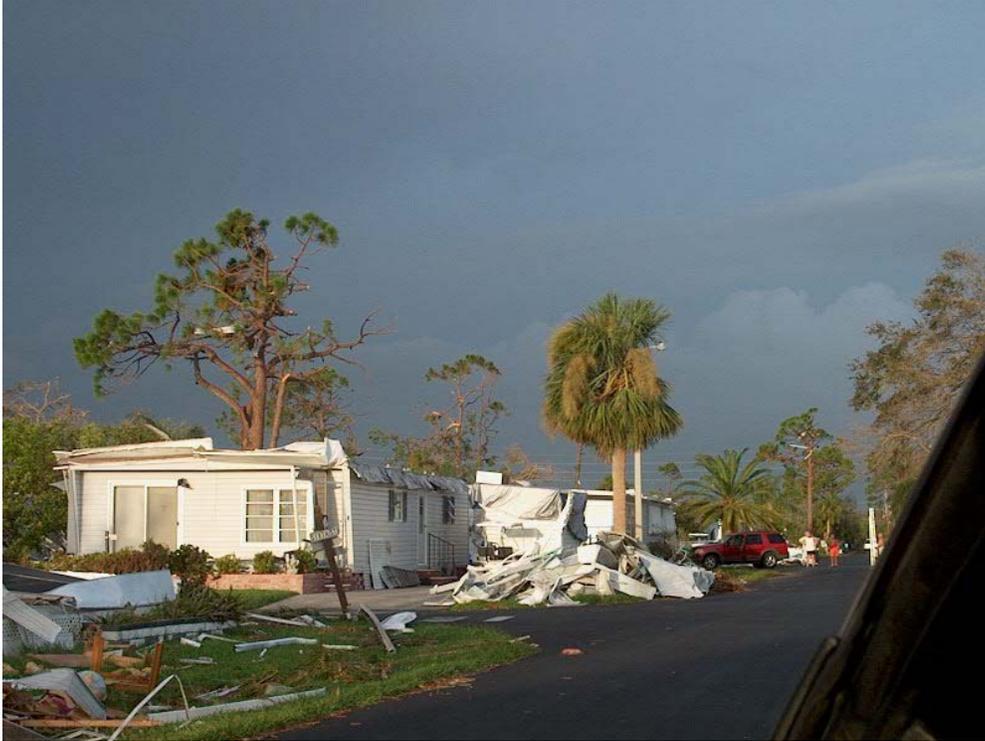
Figure 6.17: Failure of Roof System

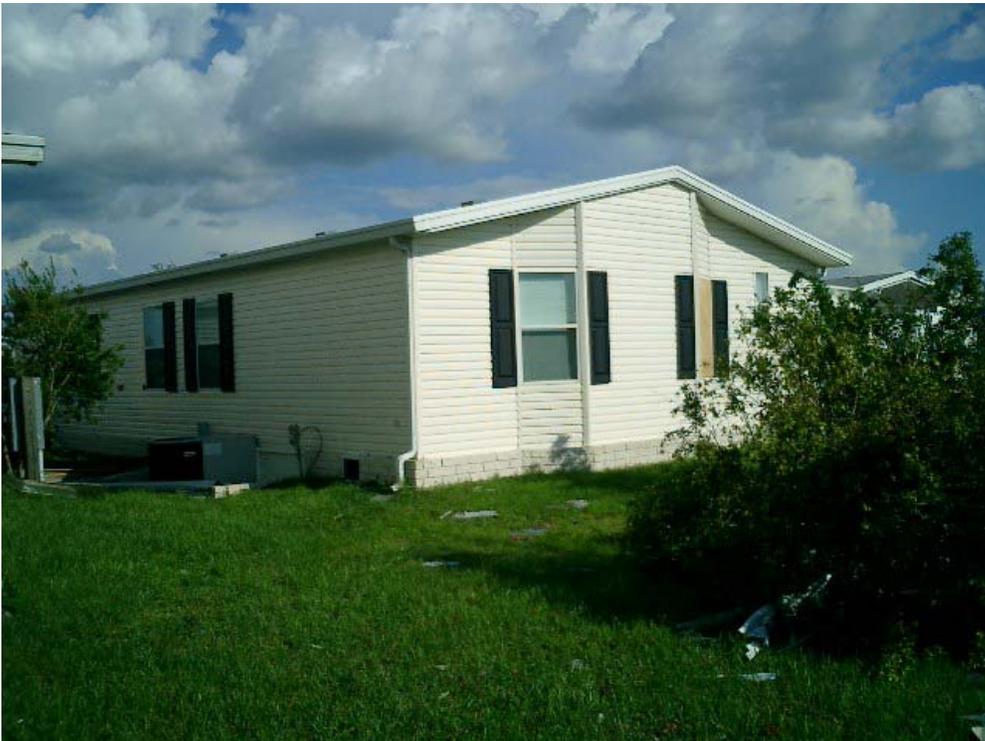
Figure 6.18: Manufactured Home Survived the Hurricane Wind Forces

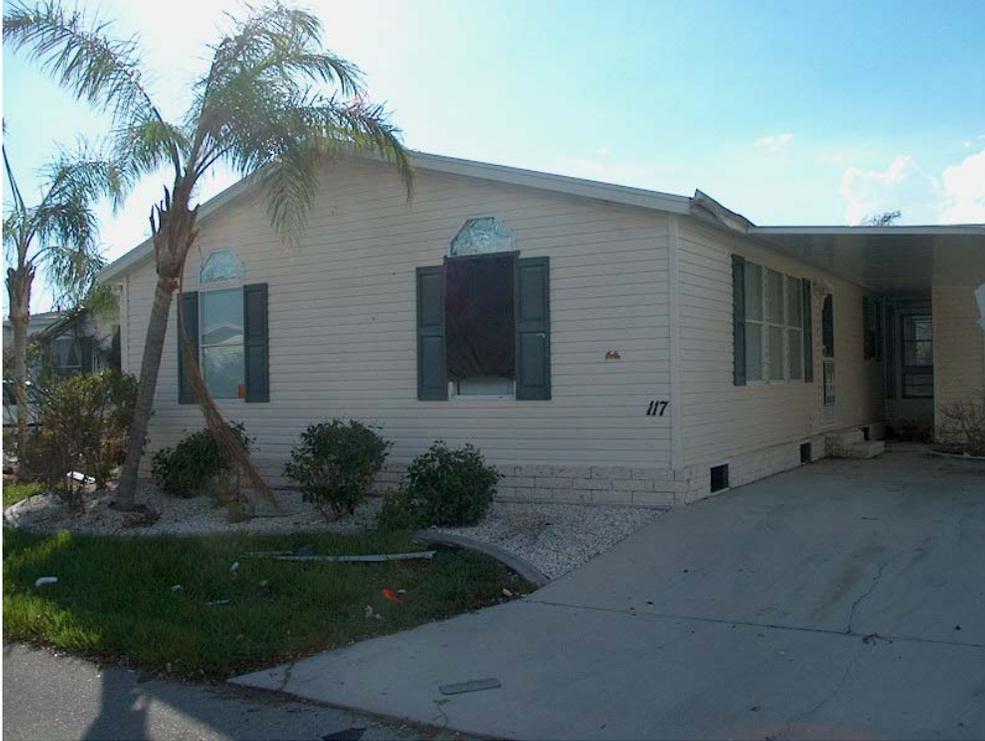
Figure 6.19: Manufactured Home Survived the Hurricane Wind Forces

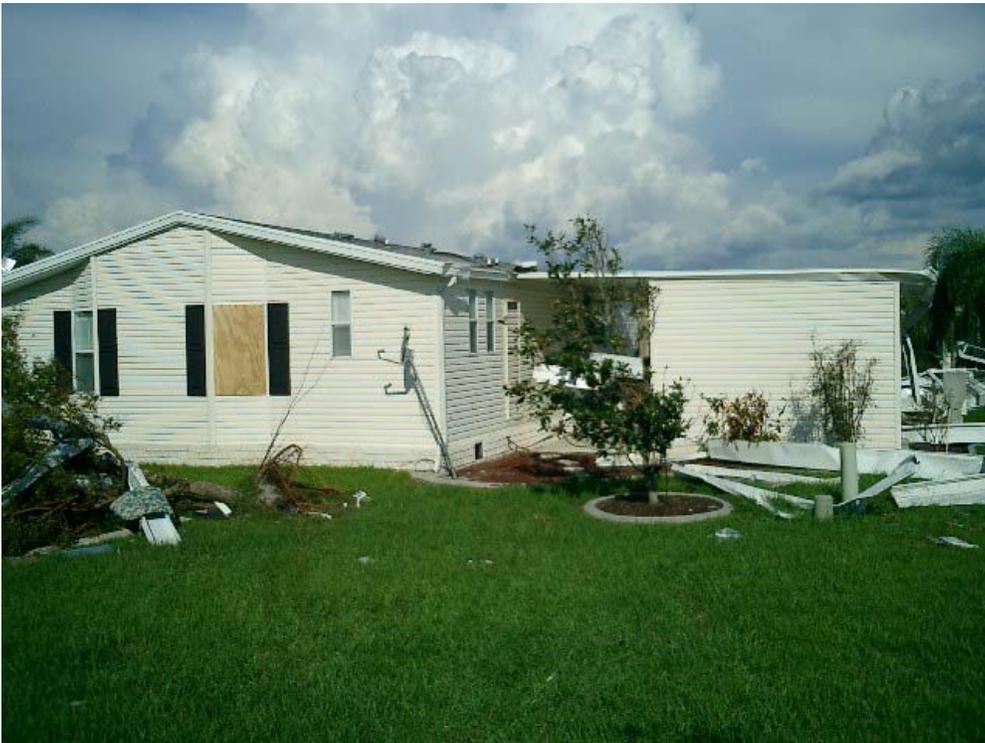
Figure 6.20: Manufactured Home Survived the Hurricane Wind Forces

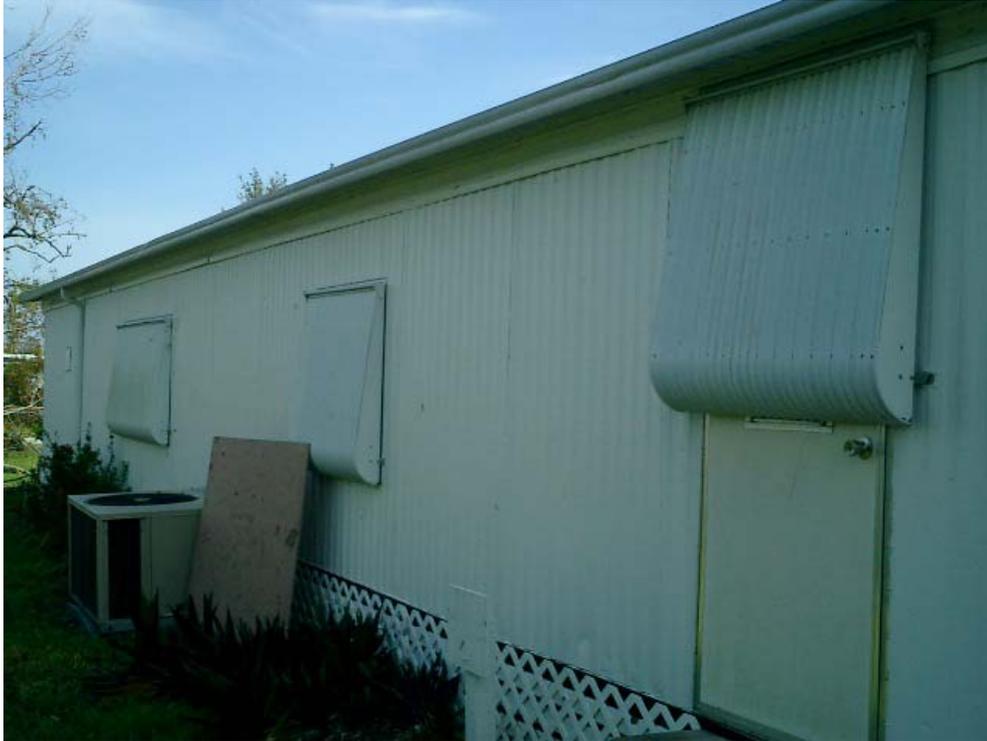
Figure 6.21: Manufactured Home with Shutters Survived Hurricane Wind Forces

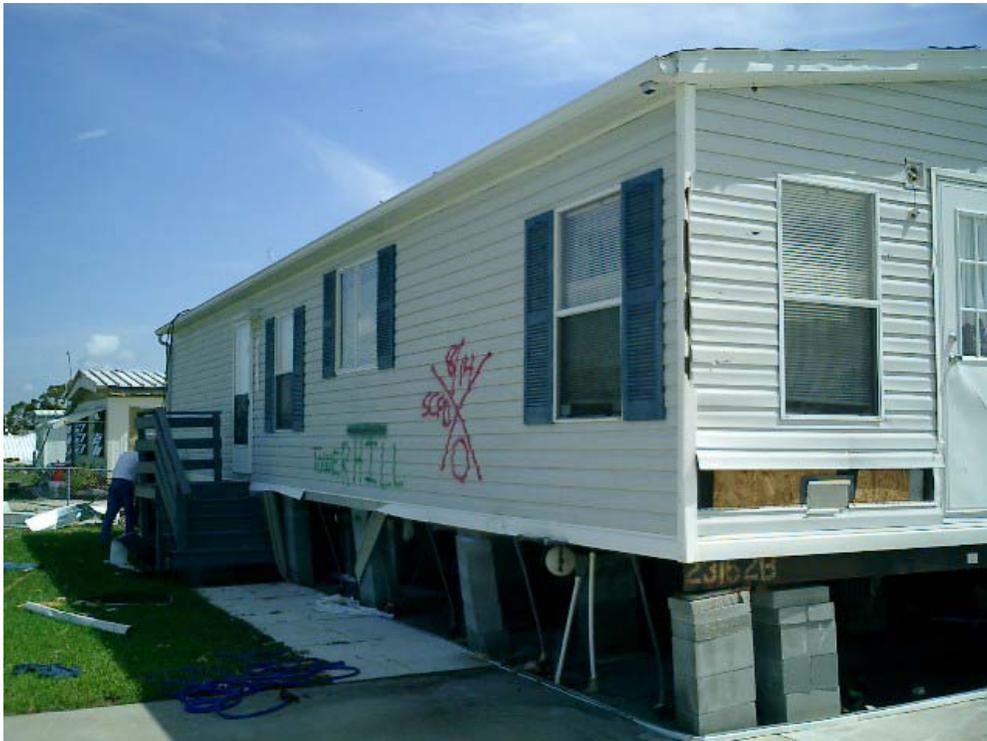
Figure 6.22: Manufactured Home Slightly Shifted from its Foundation

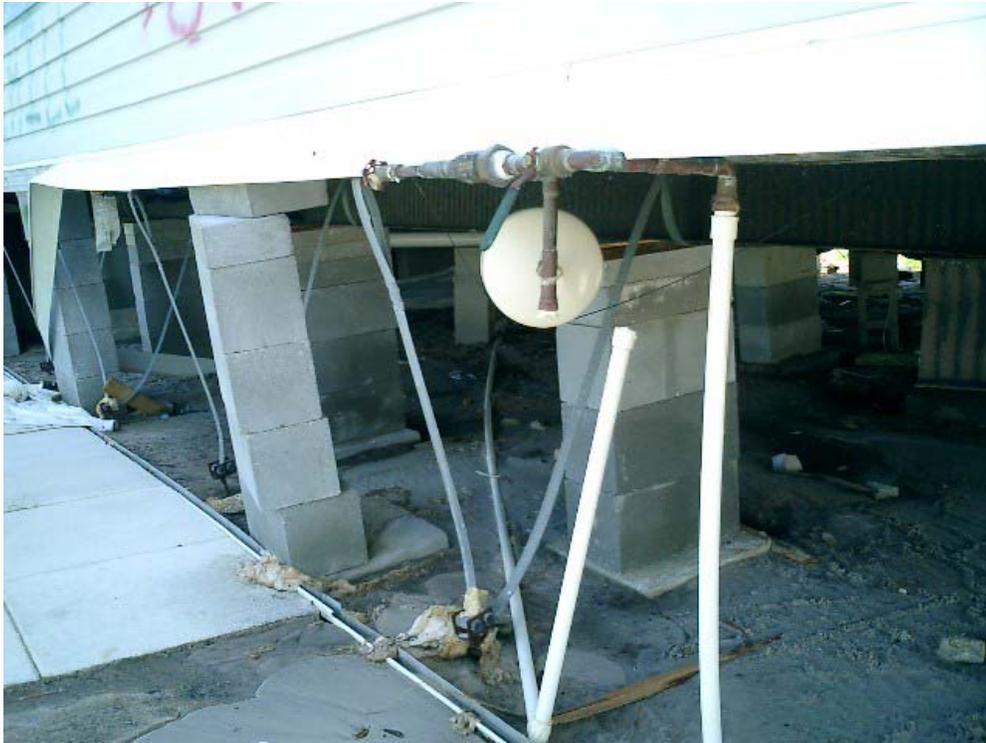
Figure 6.23: Manufactured Home Slightly Shifted from its Foundation

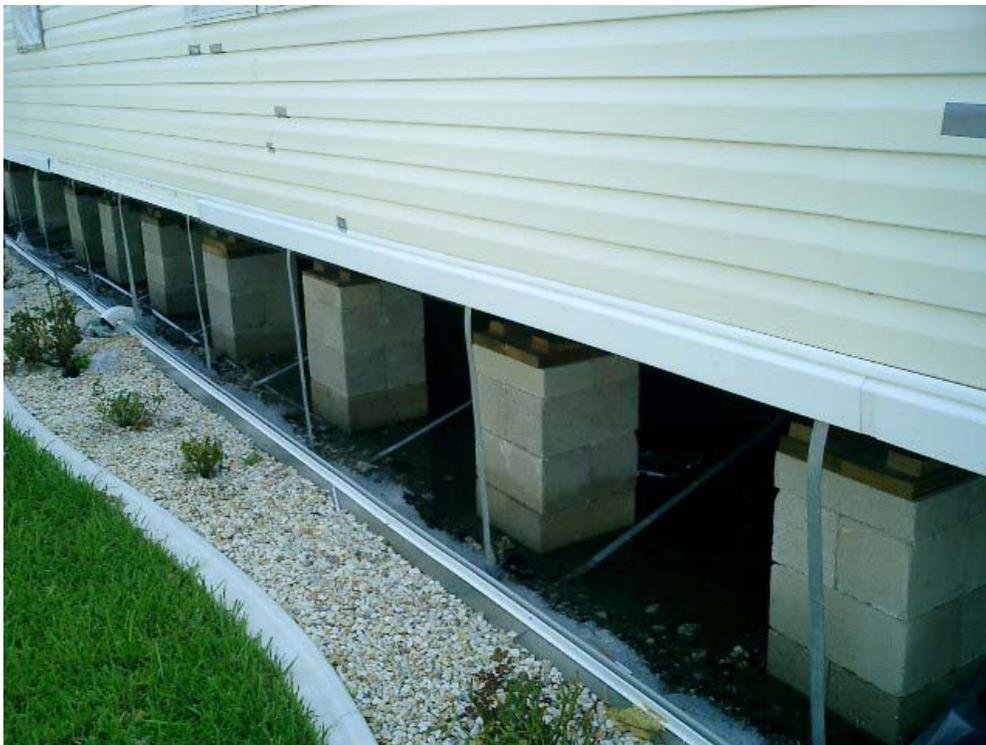
Figure 6.24: Manufactured Home Installed in Accordance with Florida Installation Law with Anchors at about 5 ft. on Center.

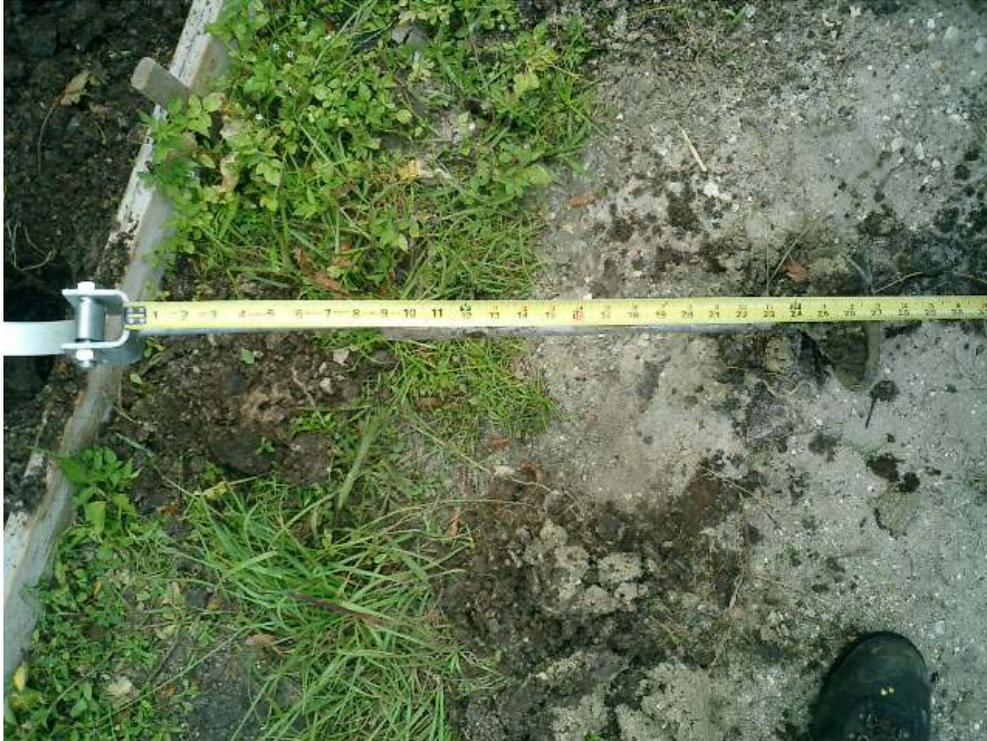
Figure 6.25: Manufactured Home Installed with Short Ground Anchors
