AN ASSESSMENT OF DAMAGE TO MANUFACTURED HOMES CAUSED BY HURRICANE CHARLEY

March 31, 2005

Assessment of Damage to Manufactured Homes Caused by Hurricane Charley

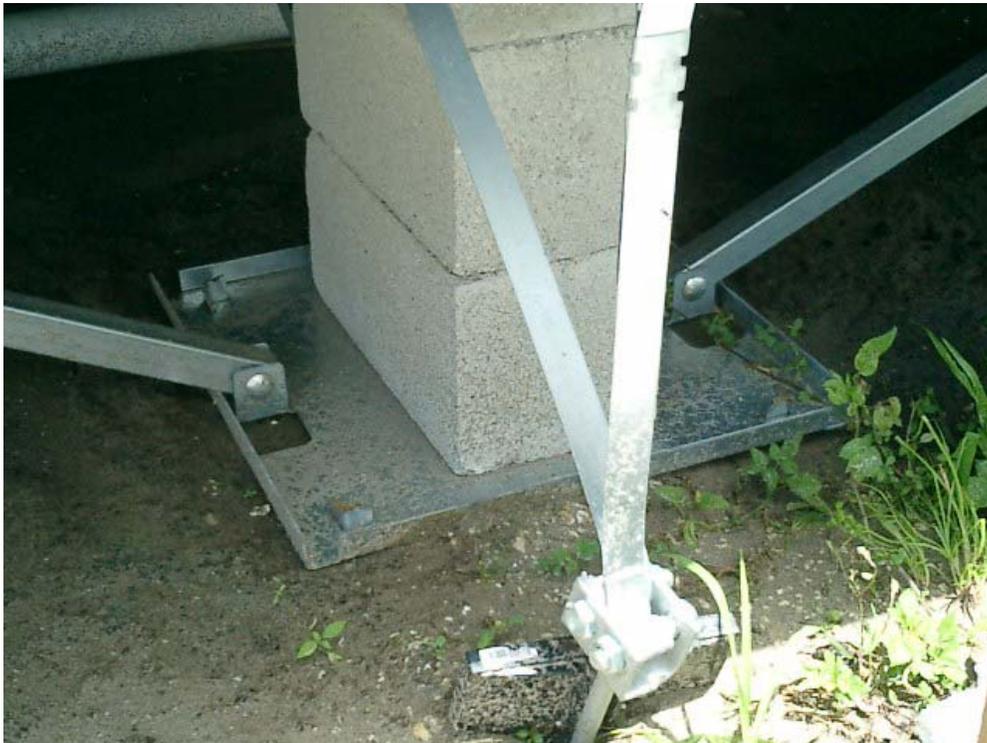
Figure 6.26: Manufactured Home Installed with Alternative Anchoring System

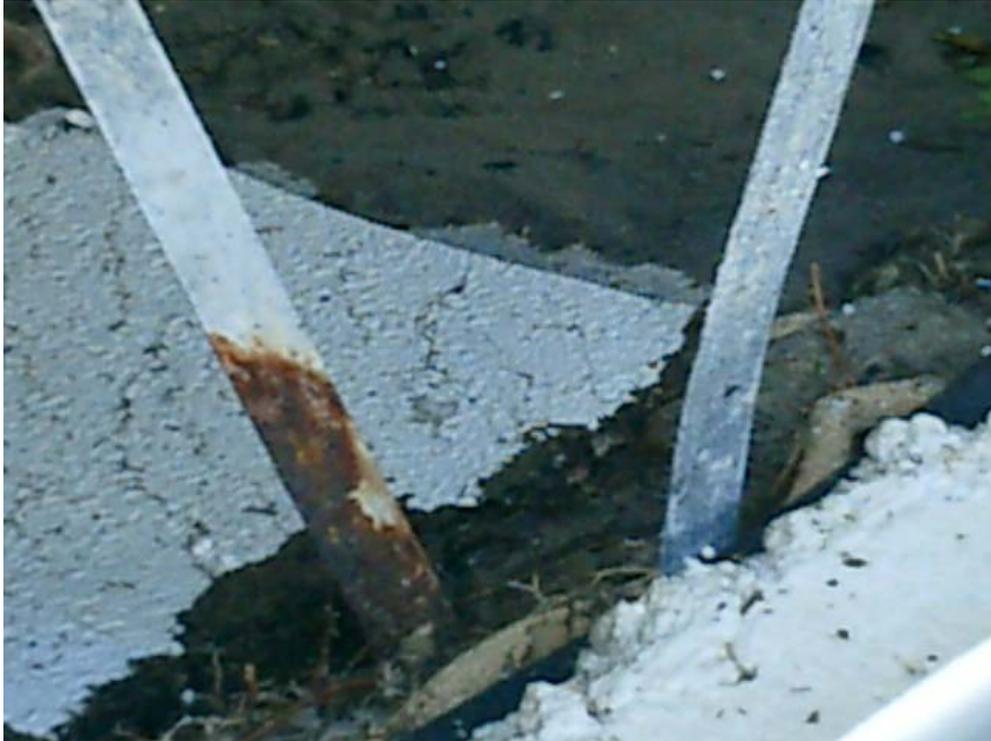
Figure 6.27: Corroded Ground Anchor Strap

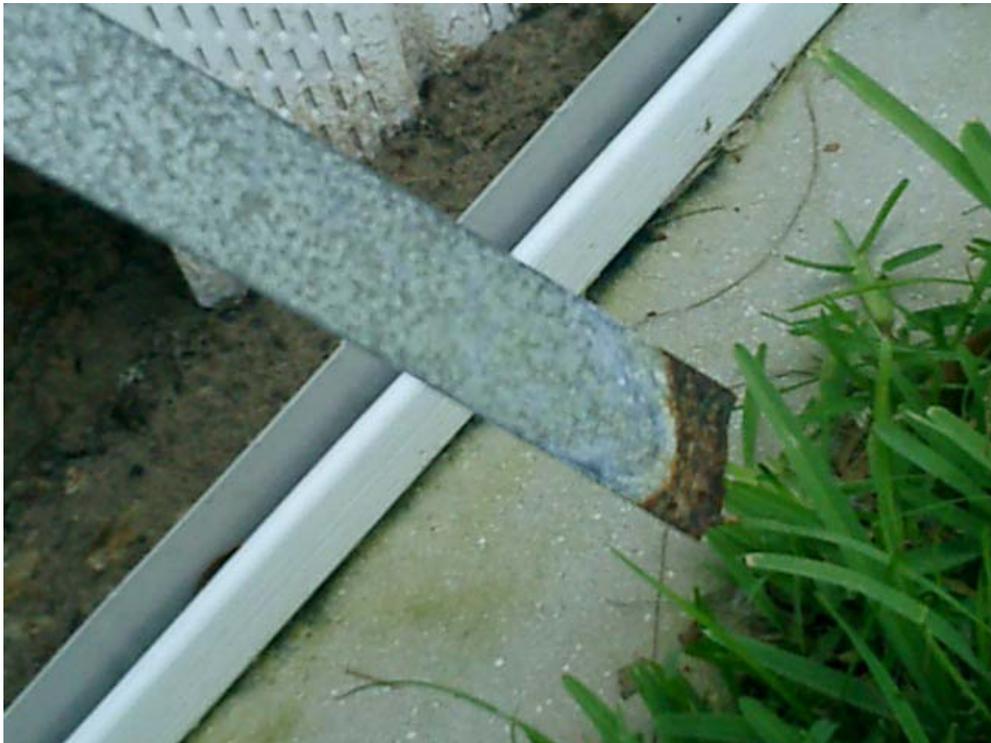
Figure 6.28: Corroded Ground Anchor Strap

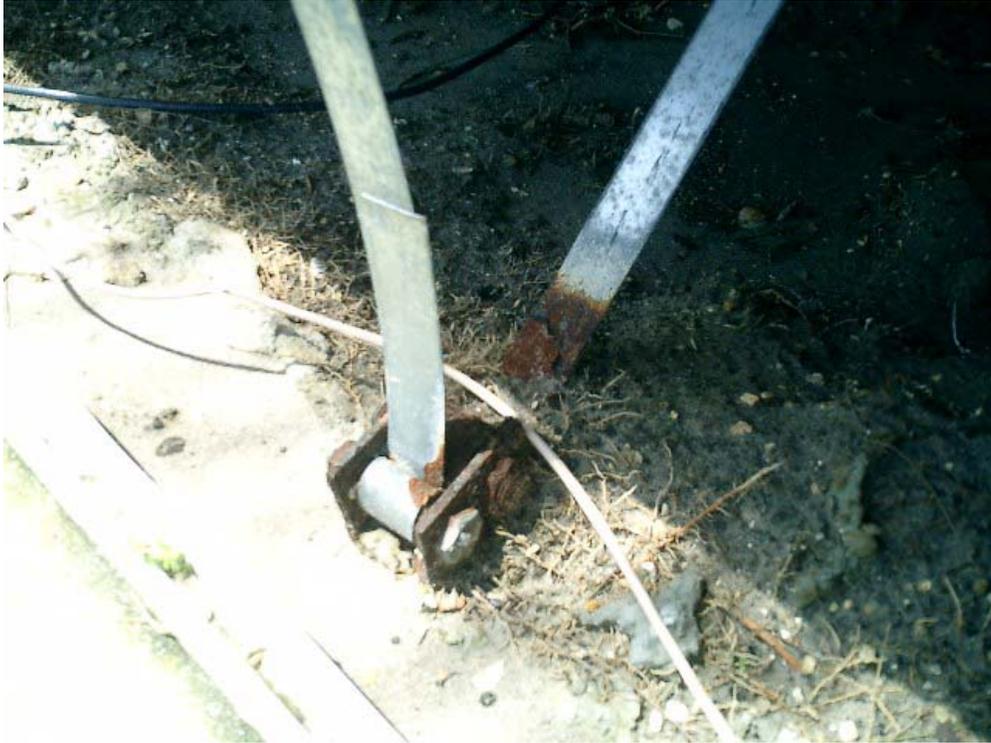
Figure 6.29: Corroded Ground Anchor Strap

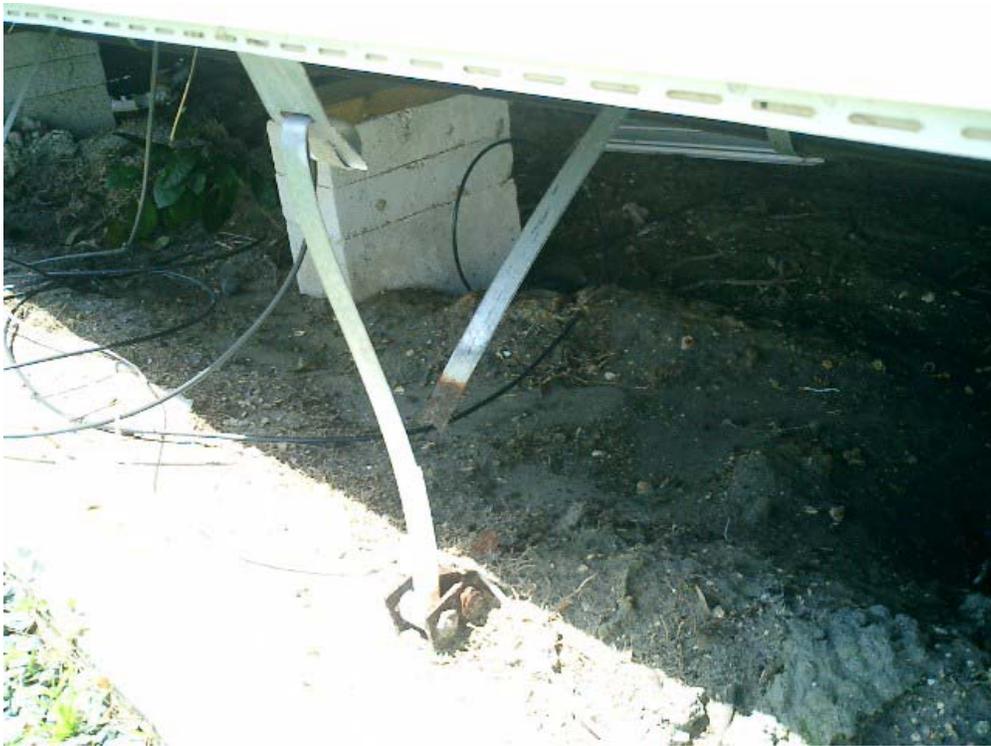
Figure 6.30: Corroded Ground Anchor Strap

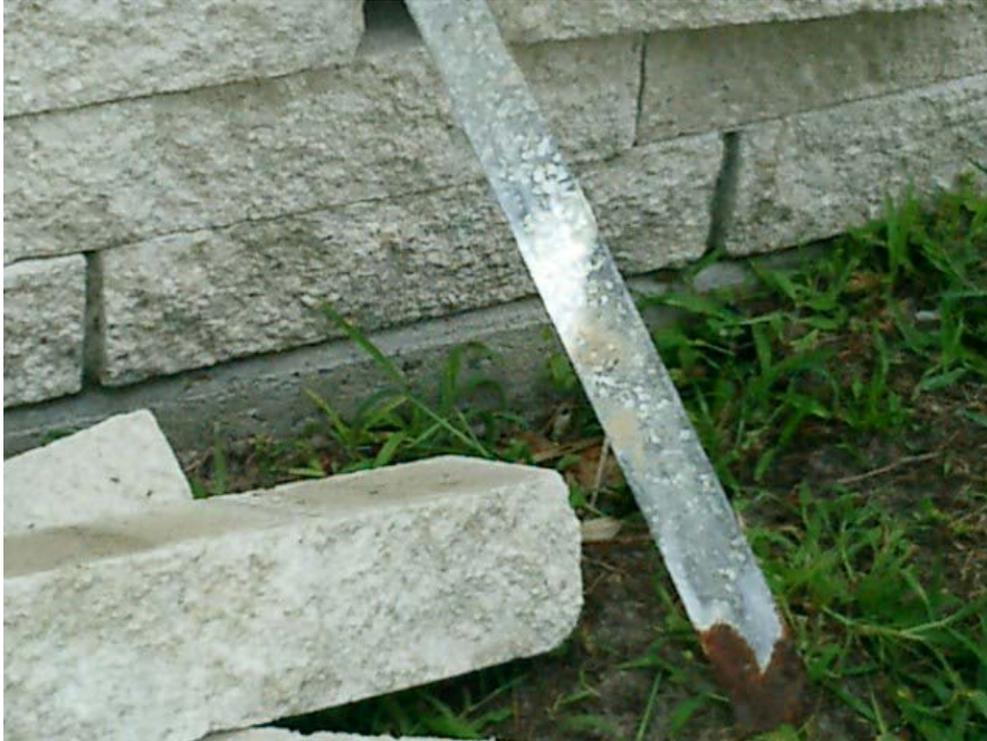
Figure 6.31: Corroded Ground Anchor Strap

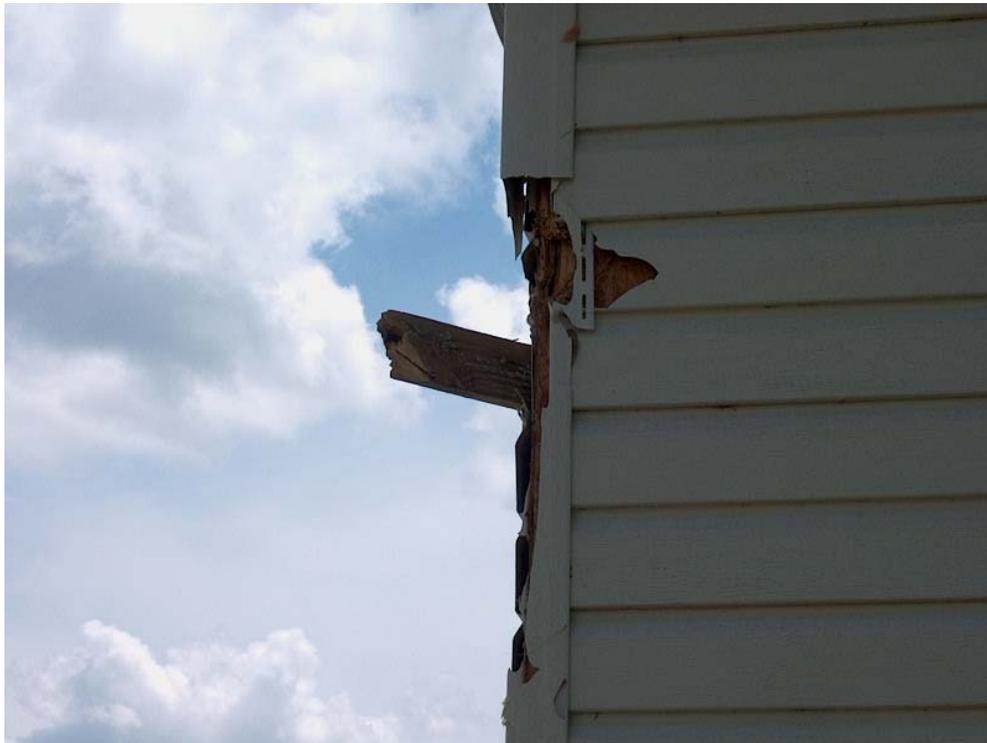
Figure 6.32: Damaged Corner Part of the Home

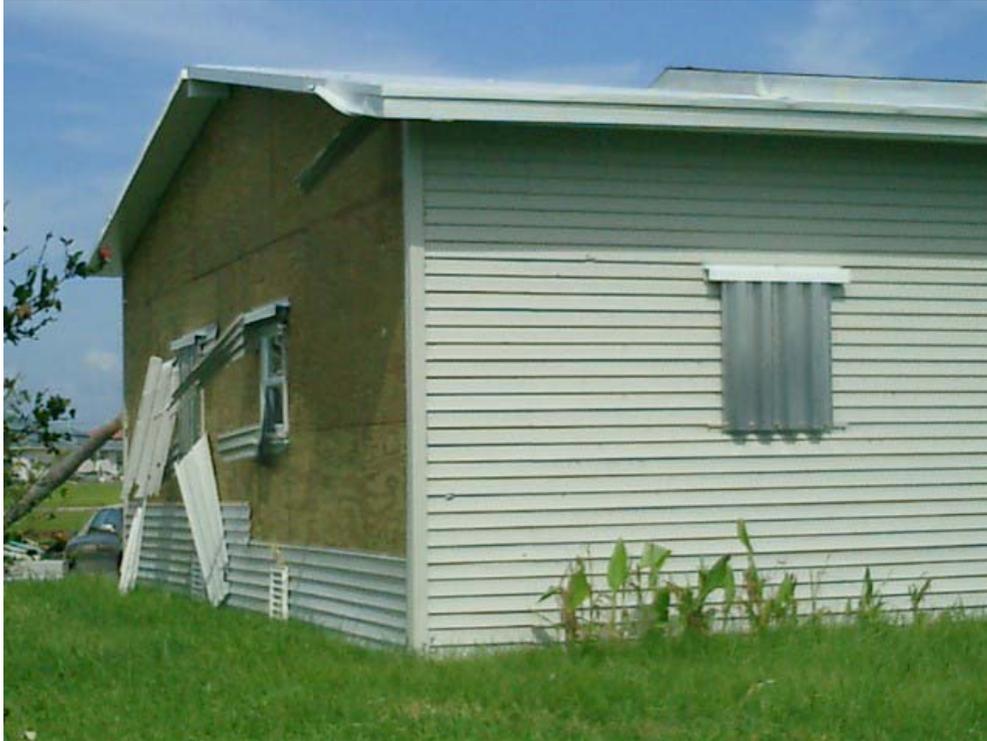
Figure 6.33: Damaged Endwall Siding

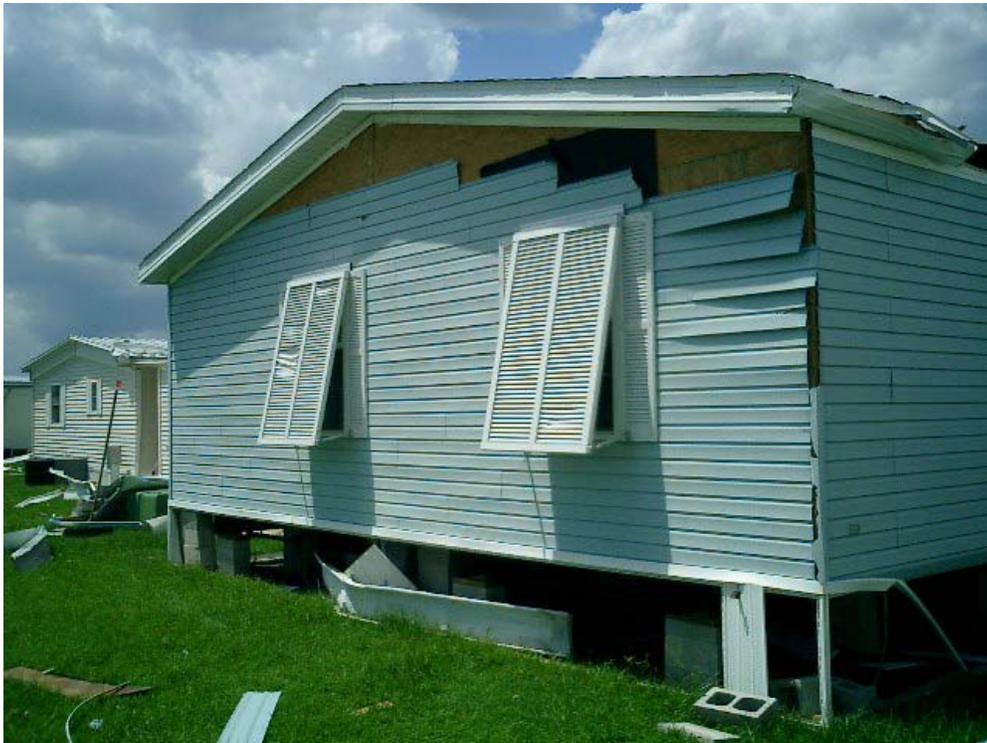
Figure 6.34: Damaged Endwall Siding

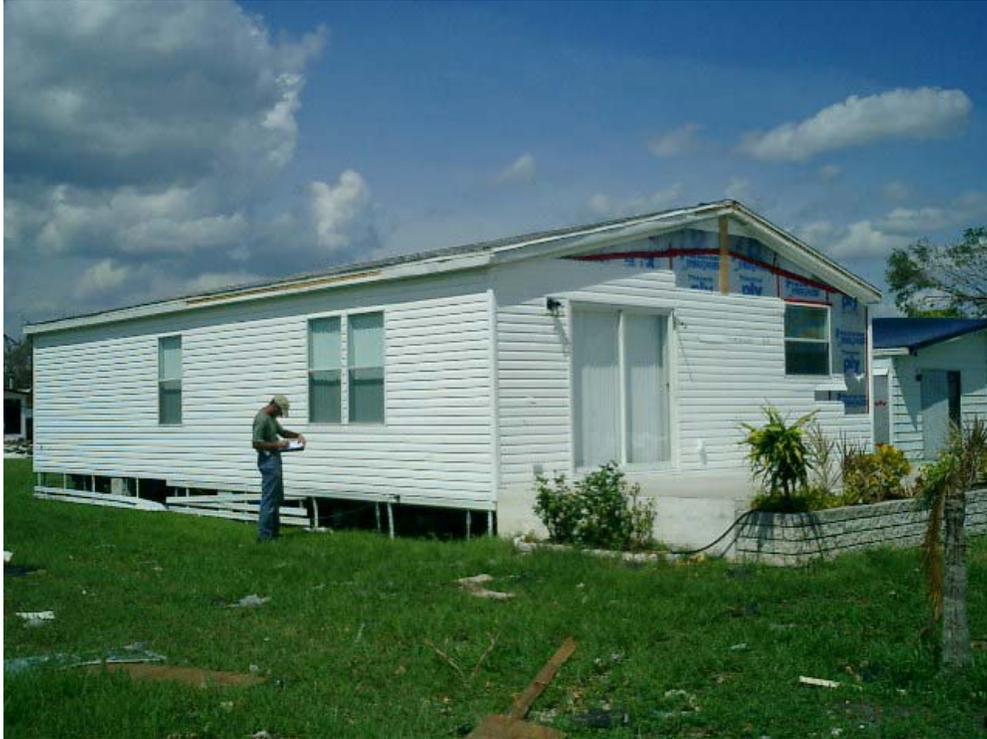
Figure 6.35: Damaged Endwall Siding

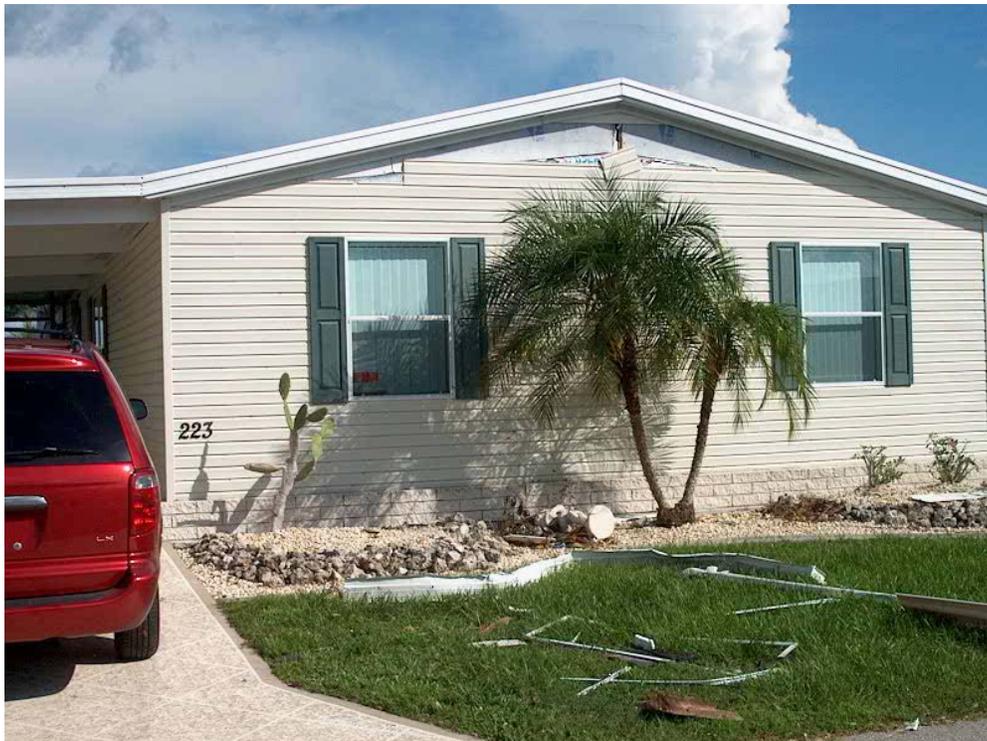
Figure 6.36: Damaged Endwall Siding

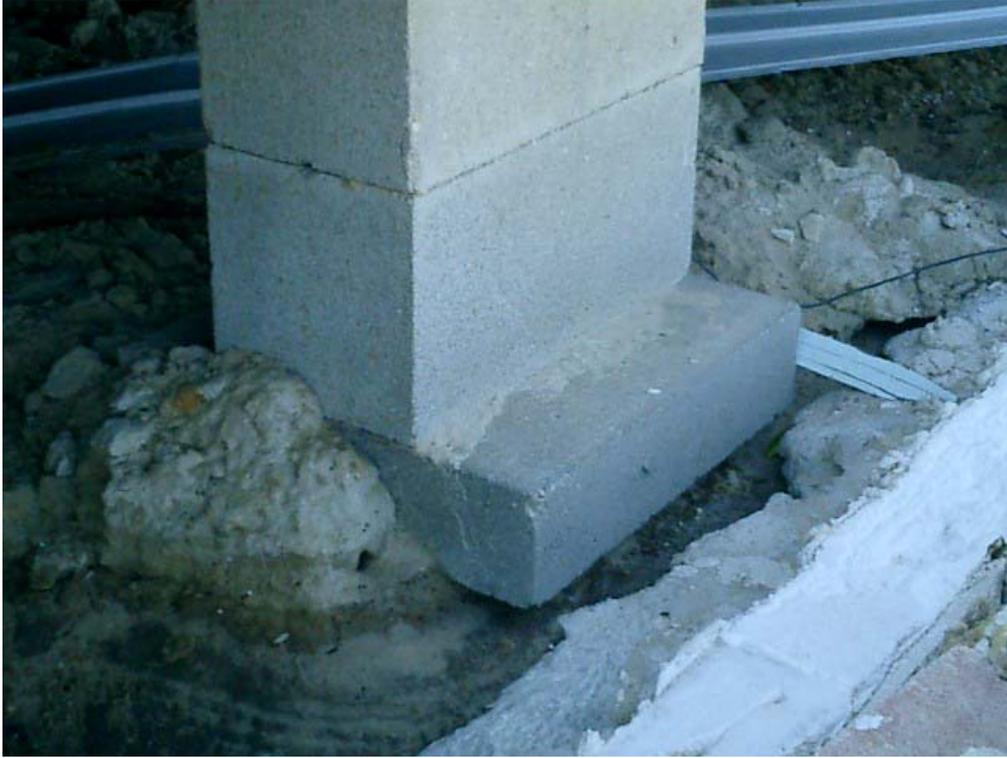
Figure 6.37: Scouring Action of Wind and Rain Water Runoff

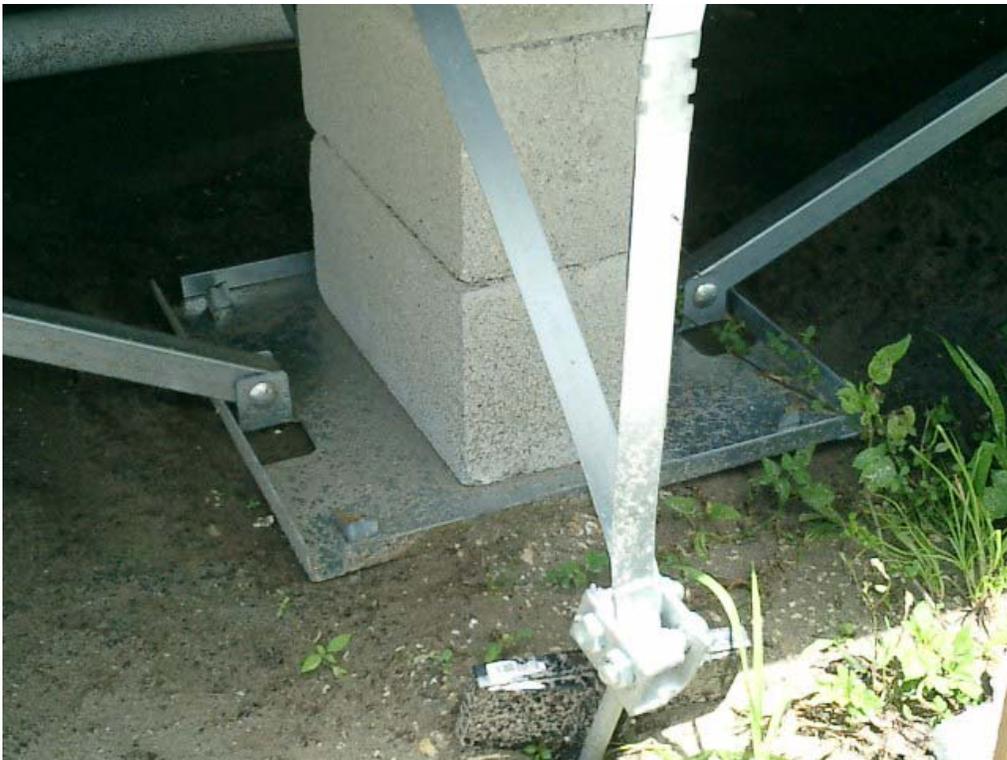
Figure 6.38: Scouring Action of Wind and Rain Water Runoff
