CHAPTER IV

EXISTING CONDITIONS SURVEY

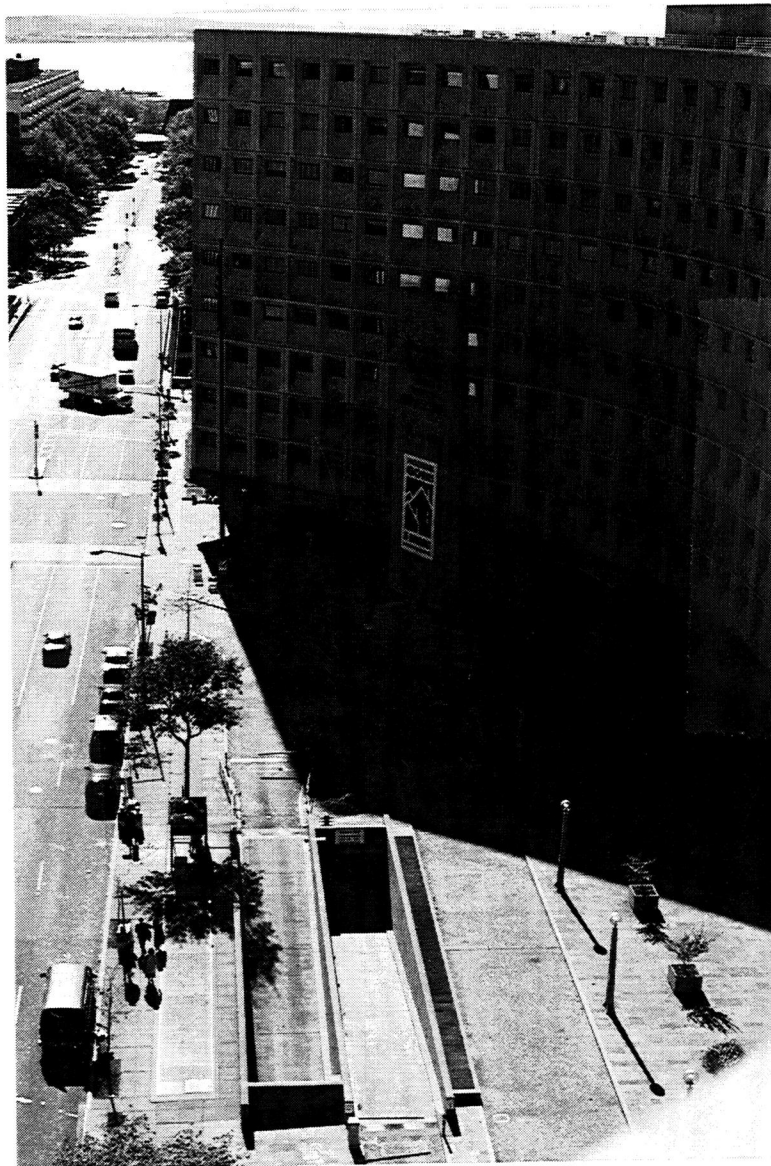
Illustration No. 4-1

The Seventh Street (east) elevation plaza has undergone major alterations since its original construction in 1968 (Illus. Nos. 4-1 through 4-6). At some time not long after completion of the building, the stanchions were removed and portable concrete planters set along the driveway area, due to complaints that the stanchions were too low to be seen by automobile drivers. The bluestone paving, which originally covered the entire plaza area from the edge of the building out to the concrete sidewalk along the street, was removed and replaced during replacement of the membrane and fill slab in 1978. Also during this renovation, the entrance and exit ramps and driveway pickup area were paved with concrete with a granite curb, and existing wrought iron handrails along the ramps were removed and replaced with two aluminum pipe rails (Illus. No. 4-6).

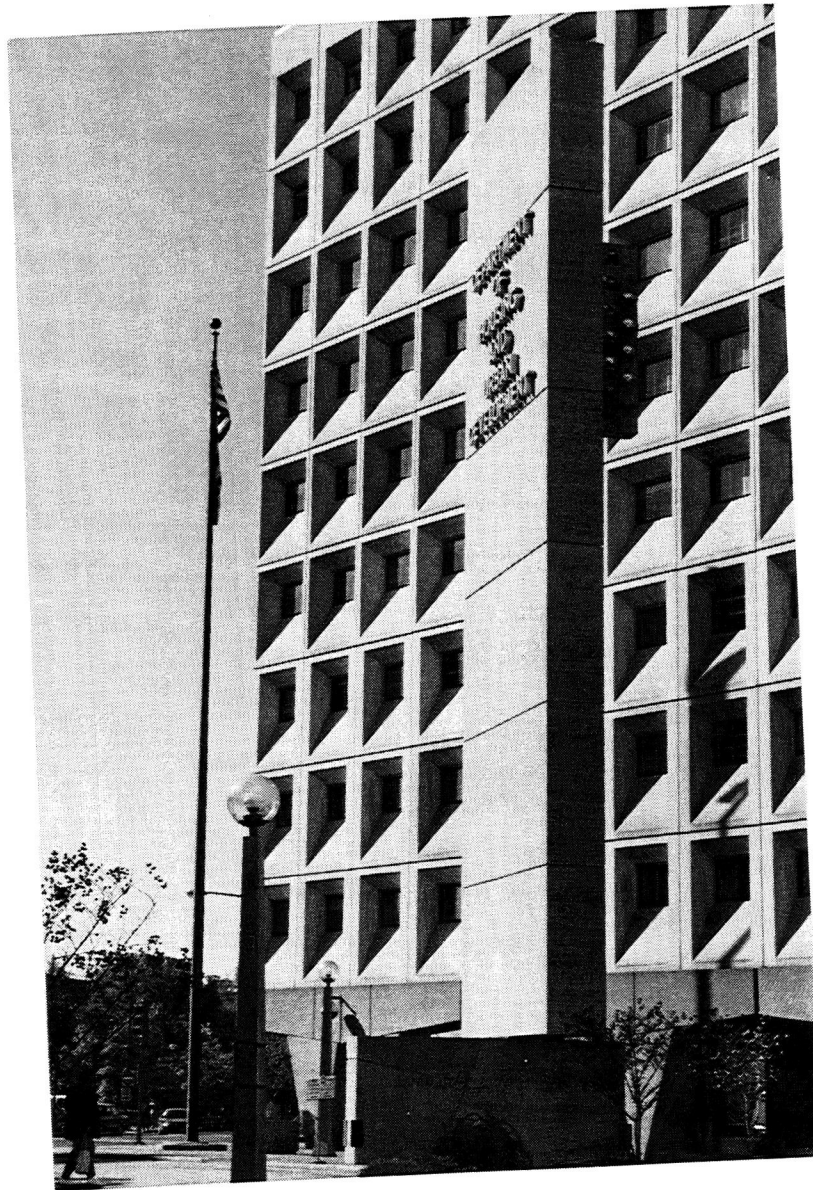
Illustration No. 4-7

On the southeast end of the east plaza, marking the main entrance, is a 76 foot tall ceremonial reinforced concrete sculpture, referred to as the "banner" (Illus. Nos. 3-49, 4-7 and 4-8). The banner consists of a rectangular concrete base, 20' x 4' x 8'-6" high and a 20' wide, 2'-8" deep and 76' high thin rectangular slab of concrete which sits perpendicular atop the base. Near the top on the front are 1'-6" tall, 18 gauge satin finish stainless steel letters which read "Department of Housing and Urban Development" (Illus. No. 3-2). On the back of the banner near the top is a small rectangular concrete section on which are mounted lights to illuminate the building and its main entrance at night (Illus. Nos. 3-50 and 4-9). On the base of the banner are protective galvanized steel angles with a bronze casting finish. The banner is in good condition, although dirty from pollution. There are water stains on the bottom of the main section which is cantilevered over the base, caused by rainwater running down the banner. A fabric banner celebrating 60 years of the Federal Housing Administration has been temporarily mounted to the front (Illus. No. 4-8).

A 40' tall tapered black anodized flagpole installed originally at the south end of the plaza was removed in 1971-72 and replaced with an 80' flagpole (Illus. No. 4-7), along with an additional 80' flagpole placed at the north end of the plaza at the edge of the driveway (Illus. No. 4-2). Except for height, the new flagpoles are similar in design to the original, constructed of tapered black anodized aluminum, 14" in diameter, with 14" black anodized aluminum balls on top, set in concrete bases with 5'-8" diameter black anodized cast aluminum collars. The south flagpole has a USA flag and the north flagpole has a HUD flag flying; both are in good condition.

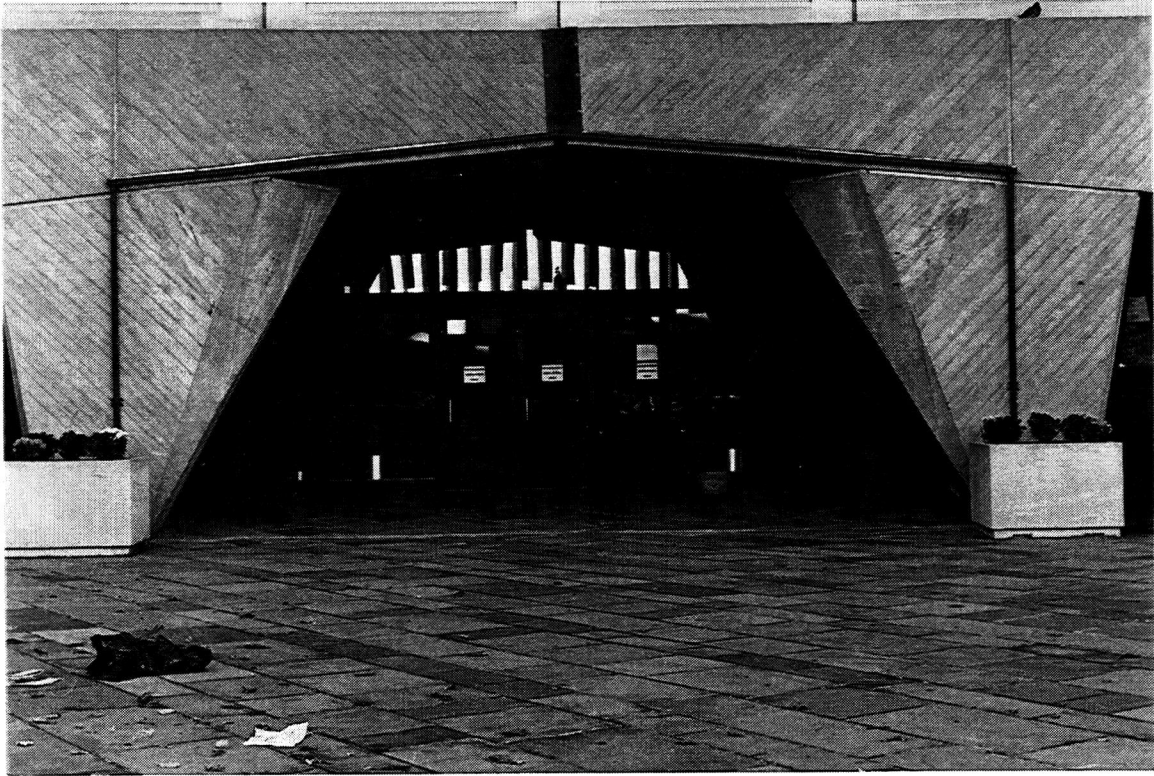
Illustration No. 4-12

The first floor of the building has glass curtain walls on the southeast and northeast entrances on the east elevation (Illus. No. 4-12) and along the cafeteria on the west elevation (Illus. No. 4-25). The walls are 3/8 inch polished plate glass panels set into black anodized aluminum frames. The walls on the east elevation at the entrances have been replaced during renovations to the entrances, although they replicate the original in materials, the design has been modified by the replacement of a portion of the aluminum and glass curtain wall. The curtain wall on the west elevation runs the length of the cafeteria. It is original and is made of 3/8 inch polished plate glass panels with black anodized aluminum frames. The window panels are in fair condition; the aluminum frames are pitted and soiled and the finish is worn.

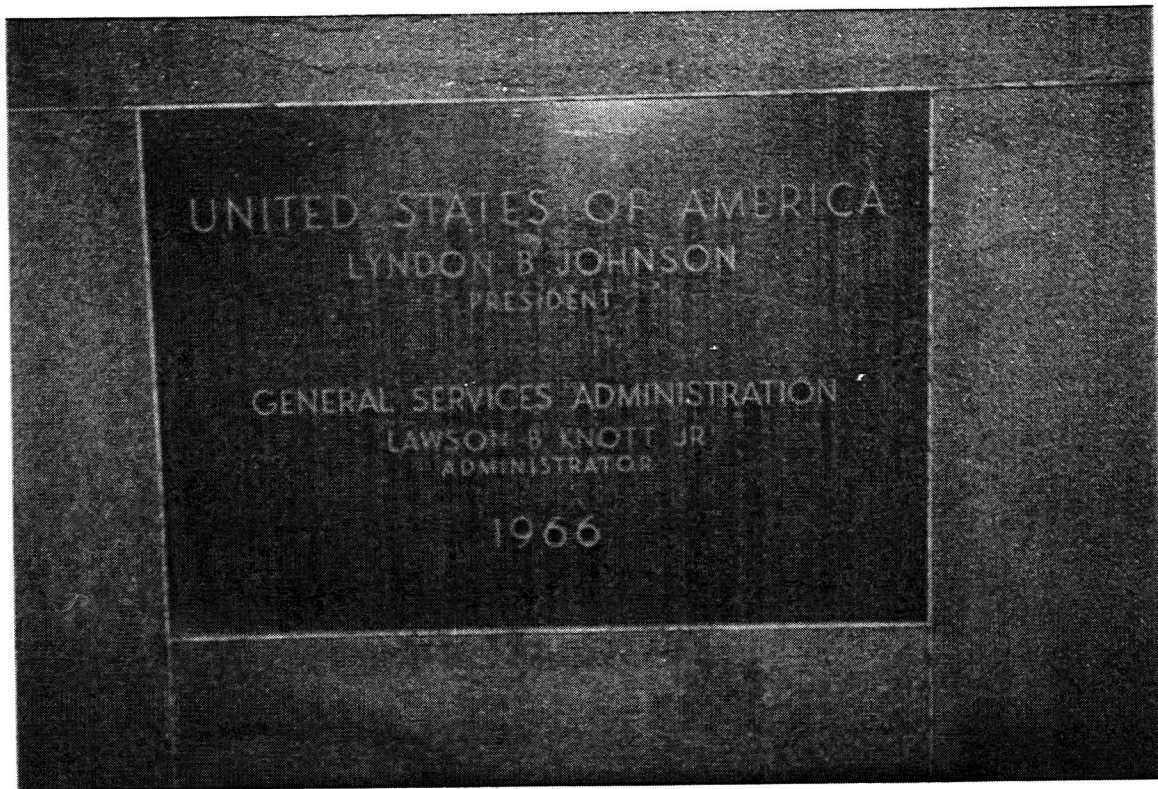
Illustration No. 4-15

The cornerstone, made of polished French Creek "Cherry Hill" granite, is located in center of the east facade on the first floor level (Illus. No. 4-15). It is in excellent condition with the exception of minor soiling.

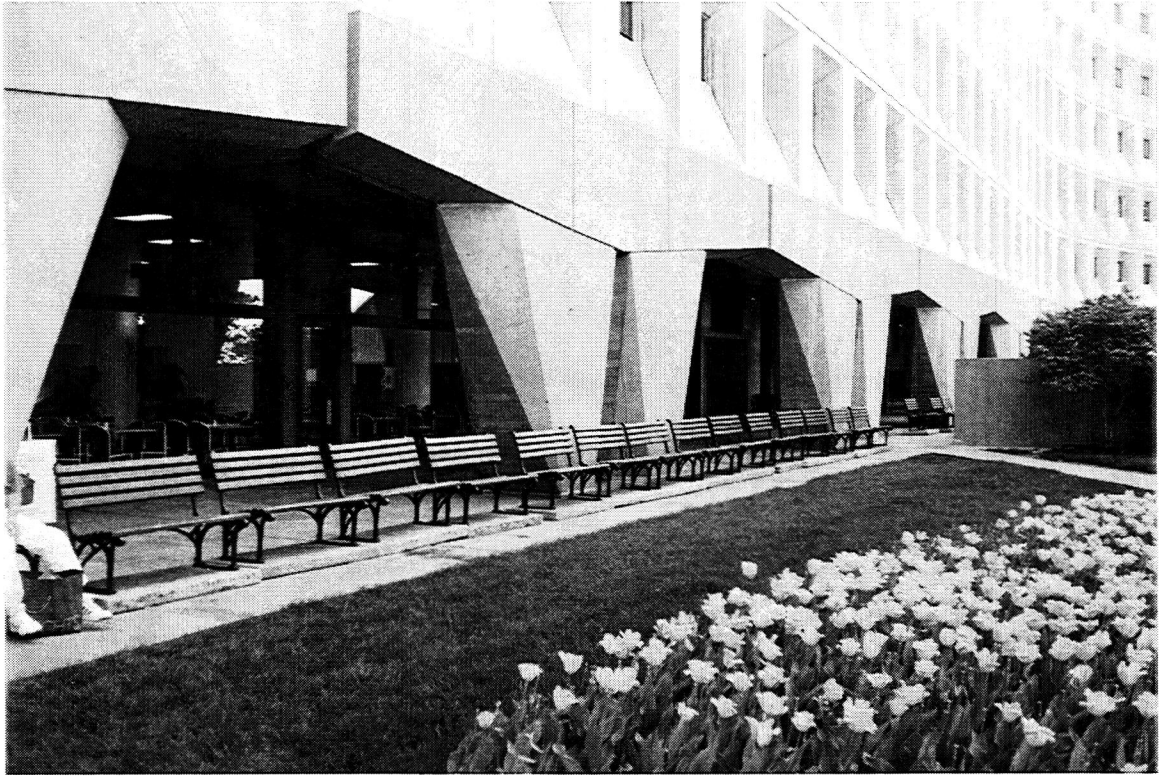
Illustration No. 4-20

Other changes to the original west elevation include the addition of 21 painted wood and metal park benches, mounted on concrete blocks, which currently sit along the edge of the building outside the pilotis (Illus. No. 4-20) and replacement of the bluestone paving under the colonnade. The benches are in need of painting. The bluestone paving on the west elevation does not have vehicular traffic and is in good condition.

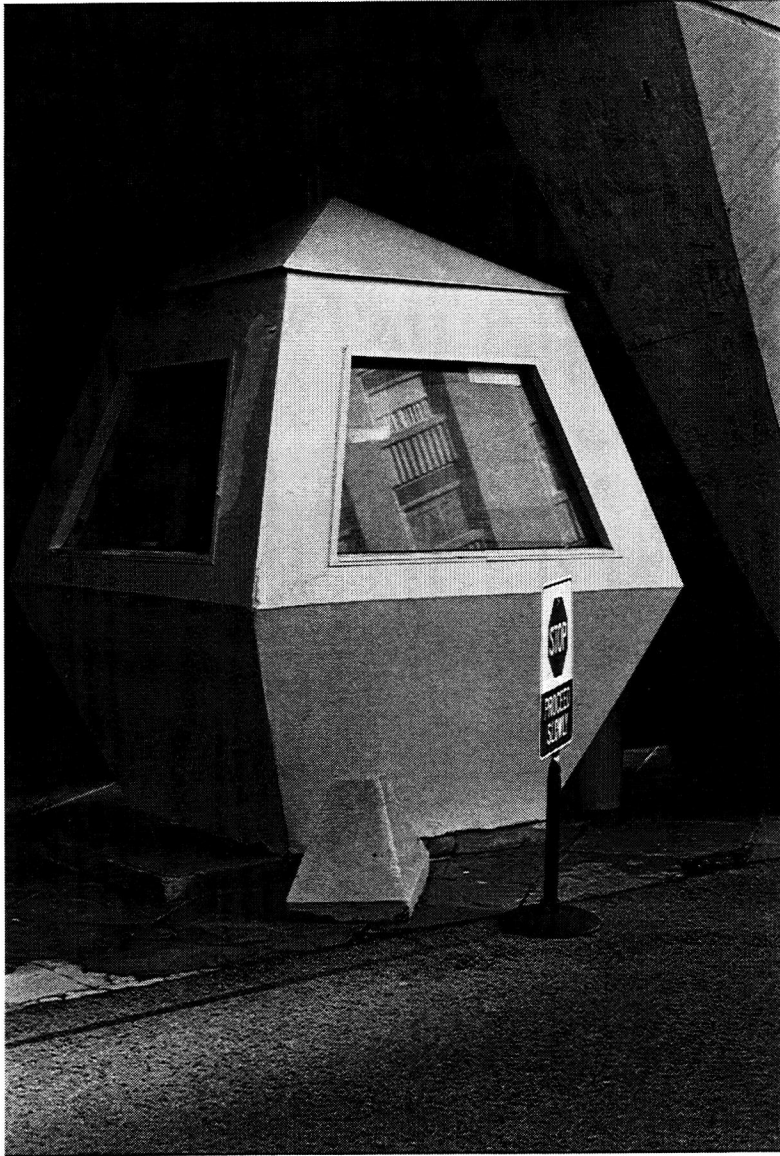
Illustration No. 4-33

A hexagonal shaped parking attendant booth, designed by Marcel Breuer and Associates and constructed shortly after the completion of the building in 1970, remains on the north elevation beneath one of the pilotis (Illus. No. 4-33). Built of wood frame construction and painted white with a stucco finish, it is in poor to fair condition, with stains, patched areas and gouges.
