FINAL REPORT OF THE MANAGEMENT SUPPORT CONTRACTOR  
FOR THE  
RESIDENTIAL SOLAR HEATING DEMONSTRATION

VOLUME III. HIGH TEMPERATURE EXPOSURE  
OF WOOD STRUCTURES IN SOLAR SYSTEMS

JUNE 1983

by  
BE&C Engineers, Inc.  
(A Boeing Subsidiary)

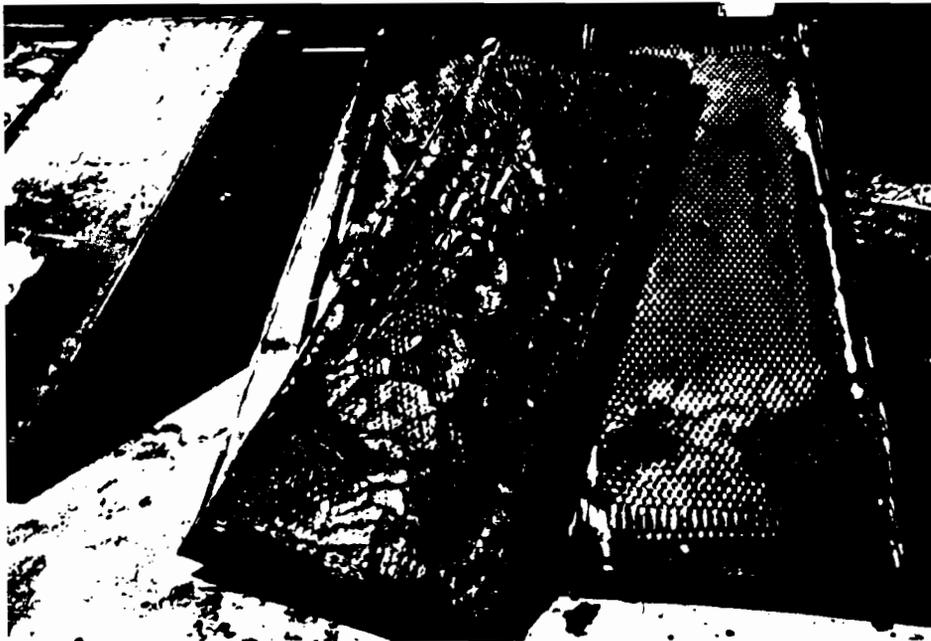
Figure 1-1. Burned Collector, Boulder Fire

This suspicion was further intensified by a fire which occurred in the collector of a solar system at Boulder, Colorado. The fire originated in a roof-mounted collector and was caused by degradation of the collector's foam insulation after it had experienced prolonged periods of stagnation. This exposed the collector's plywood case to high temperatures which, in time, caused the plywood to ignite. The National Bureau of Standards investigated the fire; the results of the investigation have been released in a report, Solar Collector Fire Incident Investigation (Reference 1). Figures 1-1 and 1-2 illustrate the nature of the damage involved.
