***WATER INTRUSION EVALUATION
FOR CAULKLESS SIDING,
WINDOW, AND DOOR SYSTEMS
WATER INTRUSION - LABORATORY TESTING RESULTS***

NAHB Research Center, Inc.
Upper Marlboro, Maryland

January 2002

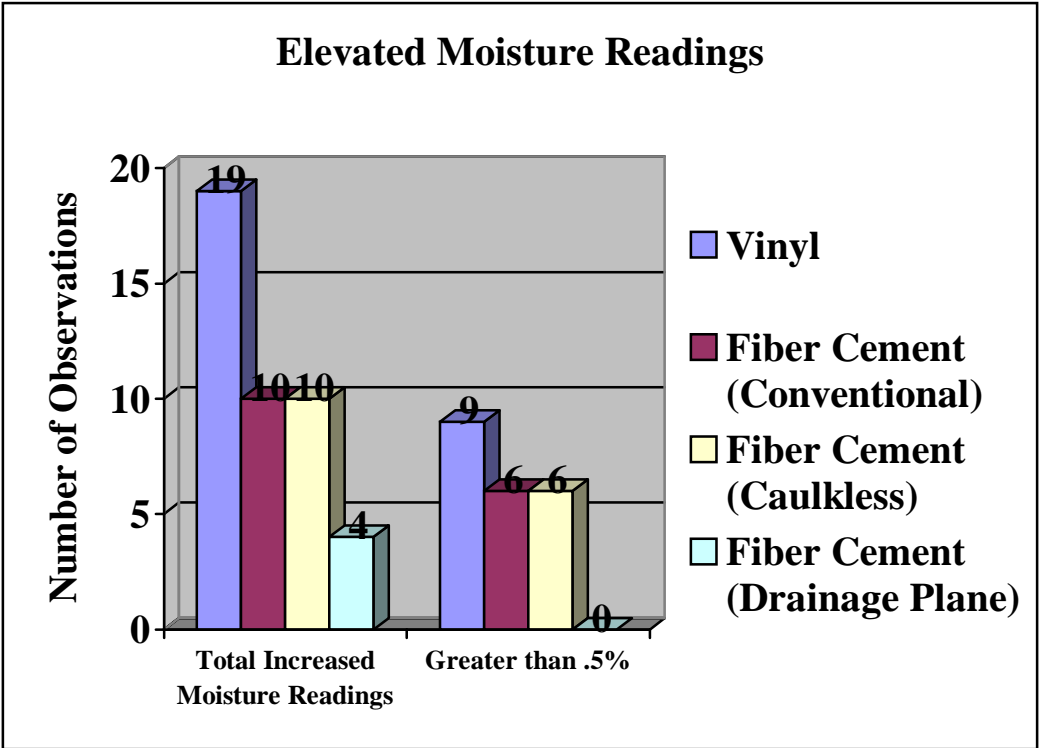
Figure 7
Summary of Elevated Moisture Readings

Table 2 presents the moisture readings before and after the testing. The negative changes recorded were most likely the result of areas that did not get wet during testing drying out overnight. Figure 7 provides a summary of the elevated moisture readings. The total increased moisture readings include all elevated moisture readings. The readings above .5 percent were separated to exclude those readings within the error potential for the measuring equipment. The vast majority of the readings showed no elevation in moisture levels. By referring to Table 2 and Figure 2, it can be determined that about a third of the elevated moisture readings occurred near the window opening and well over half occurred on the bottom half of the specimen. However, the number of elevated readings and their degree suggest the flashing systems performed adequately. This reinforces the fact that windows and other penetrations are the most susceptible to water intrusion and absorption.

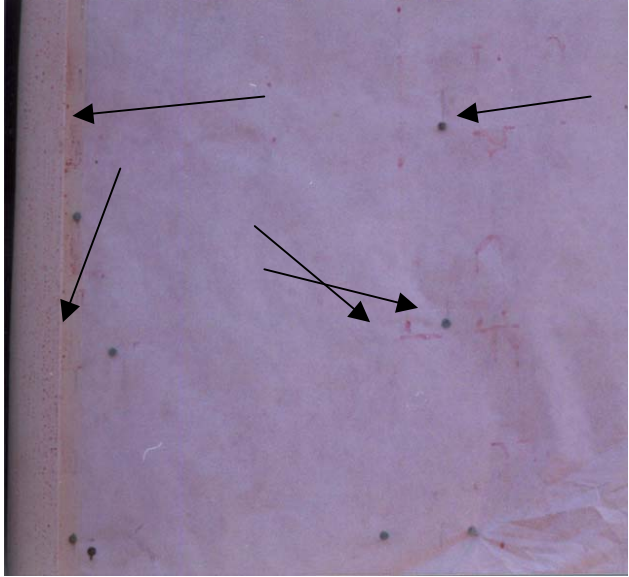
Figure 8
Vinyl Specimen - Window Corner

The vinyl-sided specimen allowed significant water intrusion. The primary leakage area was around the end treatments. Significant streaking was noted on the interior portions of the j-channel and split-corner post as well as the window’s integral j-channel (Figure 8). These visual observations are also supported by the results of the gutter collected water presented in Table 2. Significantly more water was collected on the window side of the wall. Some minor streaking was also noted at the intermediate splices in the siding on the clear wall side of the specimen (Figure 9).

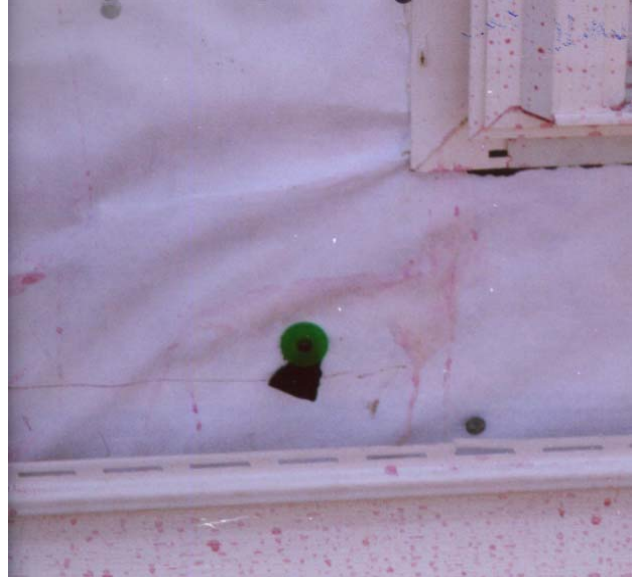
Figure 9
Vinyl Specimen

The majority of the streaking was almost completely vertical. This confirms that the vinyl siding provides an unobstructed drainage plain.

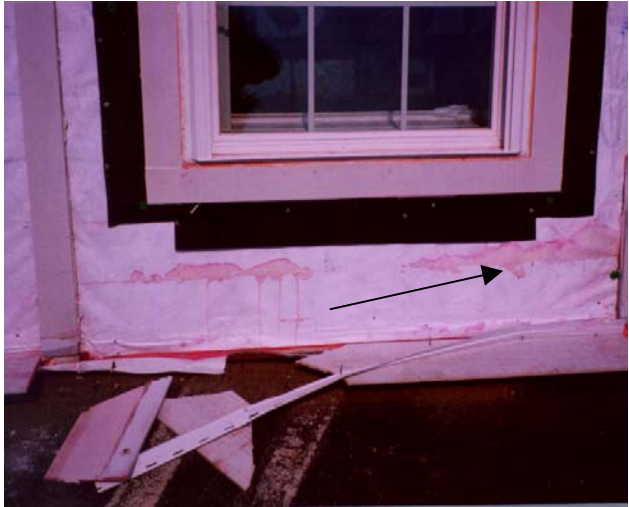
Figure 10
Conventional Fiber Cement Specimen - Window

Visual inspection indicated that water penetrated to varying extents at the majority of the caulk joints. However, the majority of water intrusion appears to have occurred through the bottom of the laps of siding (Figures 10 and 11). This leakage path was more pronounced in this specimen when compared to either of the caulkless specimens (Figure 12). It is possible that the pressure difference between the front and backside of the siding was influenced by the caulk sealed areas. This could cause a greater pressure differential and concentration of air flow through less crack length areas. The high pressure difference and airflow rate could explain why water traveled up and over the siding laps. This would explain why this phenomenon did not occur on the caulkless systems.

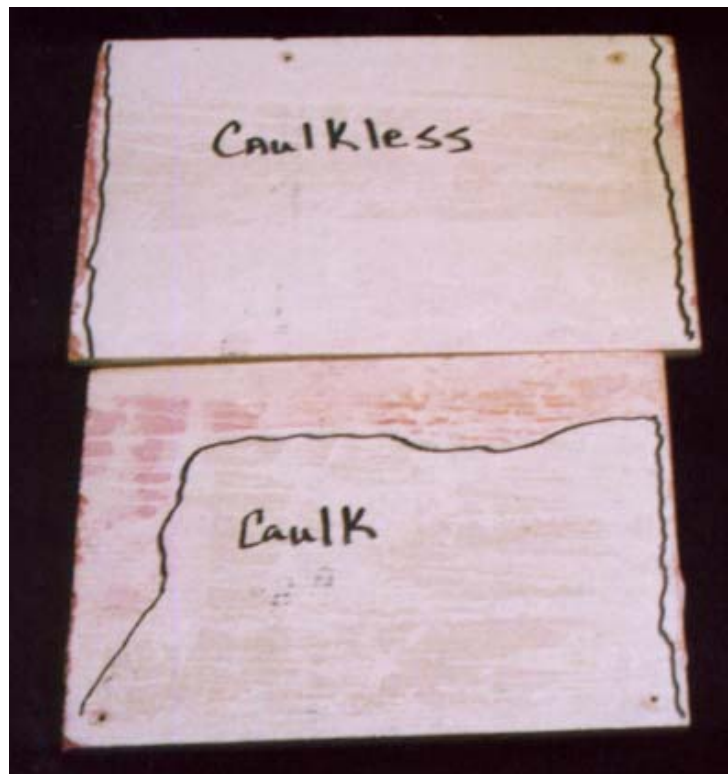
Figure 12
Fiber Cement - Staining on Back of Siding
(Extent of Staining is Outlined)

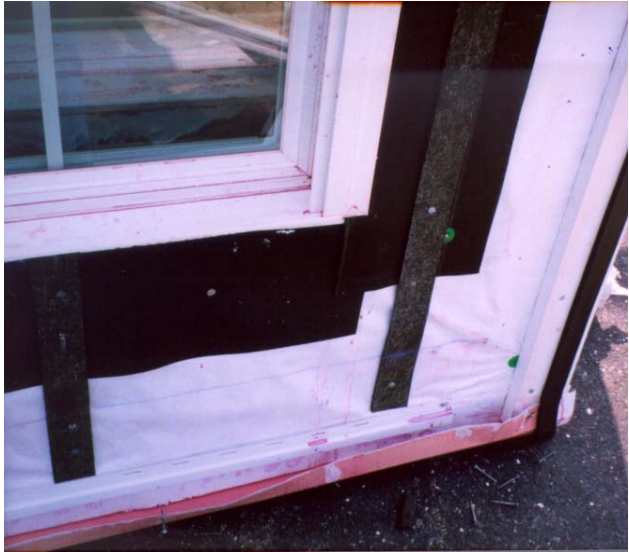
Figure 13
Fiber Cement with Drainage Plane (Window)

Both of the caulkless fiber cement samples performed very similar to the vinyl sided specimen. As with the vinyl sample, the corner posts and j-channel had significant vertical streaking (Figures 13 and 14). The vertical streaking indicates an unimpeded flow of water out of the wall system. This was expected on the specimen with the drainage plane, but not necessarily of the specimen without the drainage plane. The 1/4-inch-thick composite cornerpost and j-channel

appear to have created adequate separation at the edge details between the siding and weather barrier to allow the water to move freely.

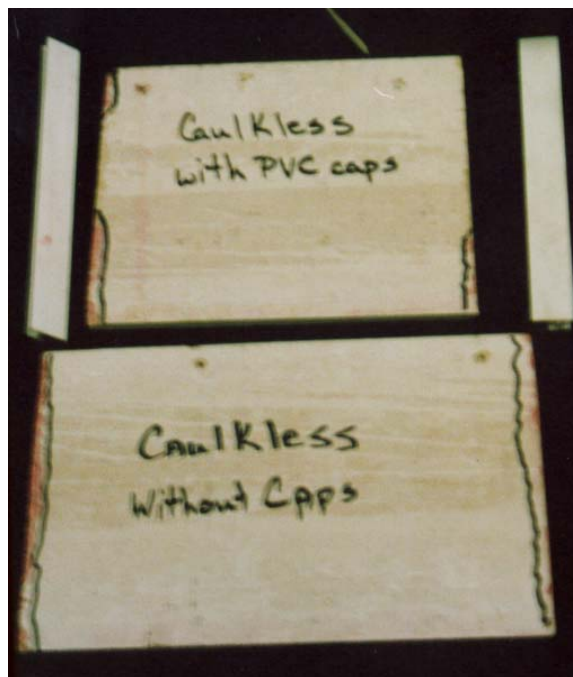
Addressing the manufacturers concerns, the wetting of the unprotected cut edges of the siding within the J-channel was not significant. The vinyl edge protectors reduced the wetting, but they were difficult to install (Figure 15). Figure compares the wetting of the unprotected portions of the siding both in the samples with and without caulk. The wetting of the ends in the caulkless samples without the edge protectors appears minor.

Figure 15
Edge Wetting (Staining Outlined)
