**NEW MADRID SEISMIC ZONE:
OVERVIEW OF EARTHQUAKE HAZARD
AND
MAGNITUDE ASSESSMENT BASED ON FRAGILITY
OF HISTORIC STRUCTURES**

NAHB Research Center
Upper Marlboro, MD

May 2003

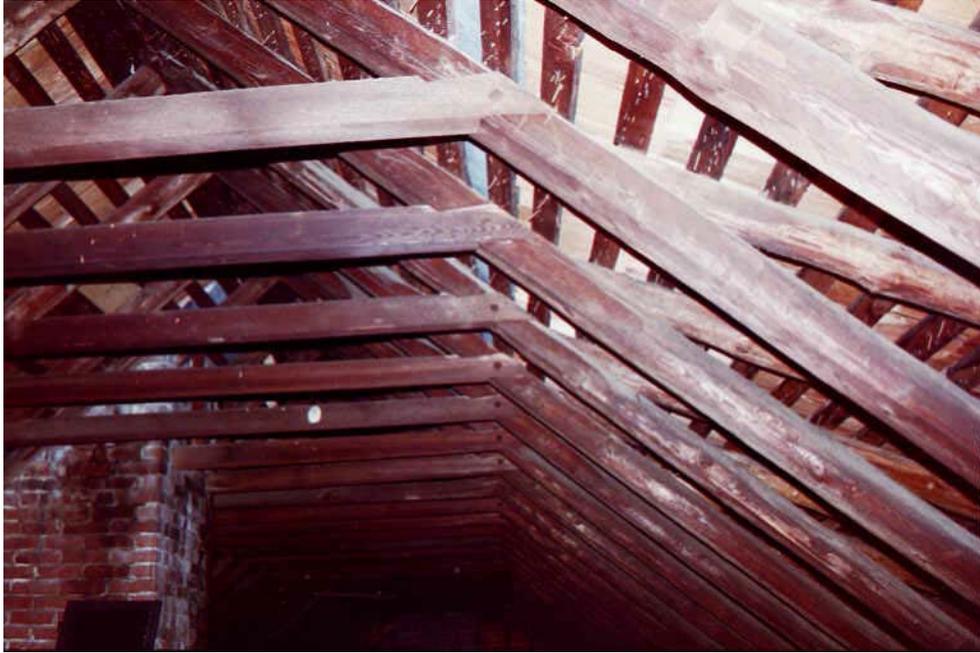
Figure A3
French colonial timber frame roof construction.

Two types of French Colonial construction were prevalent in the period of interest: post-in-ground (Poteau en terre) and post-on-sill (Poteau sur sole). These two methods of construction used logs placed vertically to form stout exterior walls (Figure A2). In post-in-ground construction, the posts served the dual purpose of an exterior wall and a foundation; floors were supported separately on large beams and stone piers. In post-on-sill construction, the posts were joined at the bottom to a sill resting on a stone foundation wall. In some cases (usually post-on-sill), the corners were braced with an angled log in each direction. The logs in exterior walls were sometimes leaned inward at slight angle to provide stability. Between the vertical logs, clay and rubble stone (pierriotage) or clay and grass (bouzillage) was placed, sometimes including horse hair for reinforcement. In all cases, the logs were joined to a top sill. Roof framing varied in detail, but usually used heavy timbers joined in some type of a truss system with heavy ceiling beams (logs) or other timber roof cross members in the attic (Figure A3).

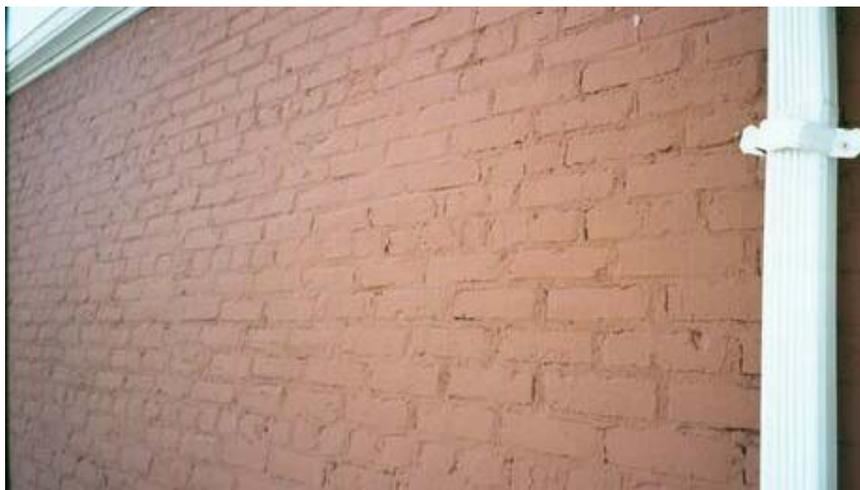
Figure A4
Brick wall construction.

Brick construction was evidently popular in some towns (e.g., St. Charles, MO) prior to 1811, despite the pioneering nature of the settlements. Brick walls usually consisted of two wythes, or as much as four wythes (i.e., thickness of four bricks). As shown in Figure A4, bricks were laid in running bond with every sixth or seventh course laid with bricks oriented across the wall thickness (i.e., a header or soldier course). Bricks were typically made from local clay pressed into brick forms and then fired in a brick furnace. Mortar consisted of locally mixed ingredients, primarily lime and sand. It appears that most brick structures were built on limestone foundation walls. On larger brick homes, usually one or more interior cross walls were also similarly constructed of brick.

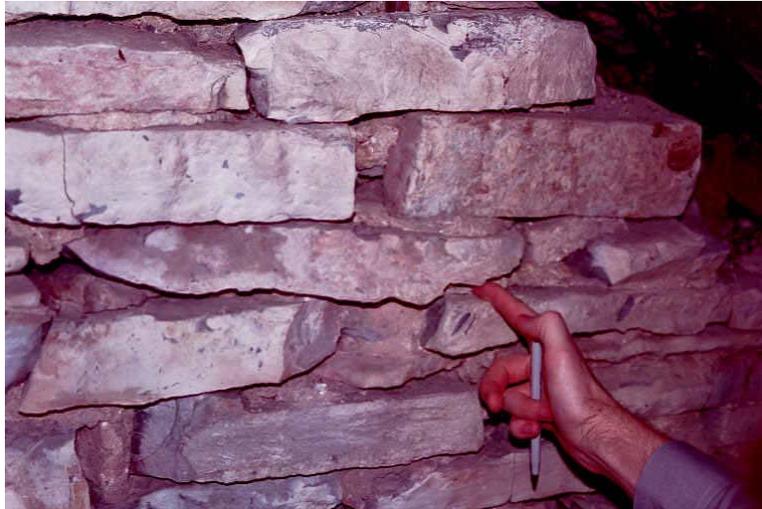
Figure A5
Example of limestone foundation construction.

inches thick with beam pockets or ledges to support timber floor framing (similar to that found in brick construction). Mortar appeared to be identical to that used for brick construction; however, some stone foundation walls appeared to use mortar very sparingly (i.e., the stones were essentially “dry-stacked”) as shown in Figure A5.

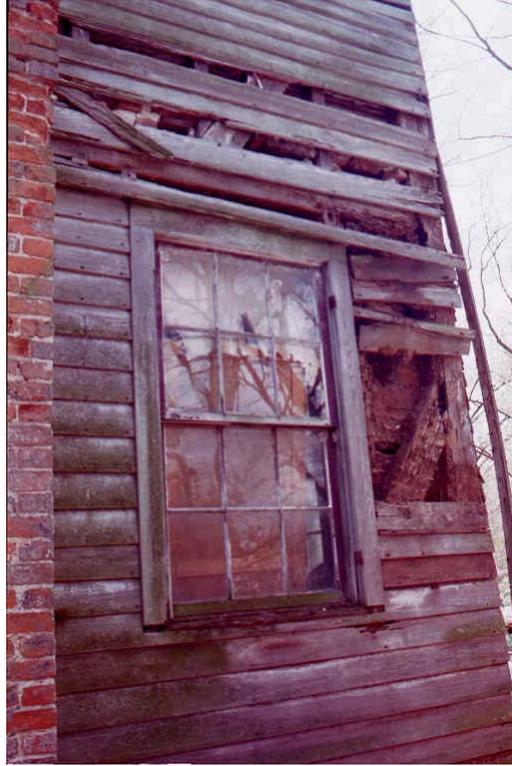
Figure A6

Partially exposed timber frame construction showing corner brace.

Braced timber frame construction—an early American form of construction that used timber more efficiently than vertical or horizontal log construction—was found in only two homes. The frame was apparent in one house and was in ill repair (Figure A6). The details of framing followed the convention of that time period. One horizontal log home was also found in the survey and, while it had a couple of unique details, the use of large rectangular shaped logs was conventional for the time period.

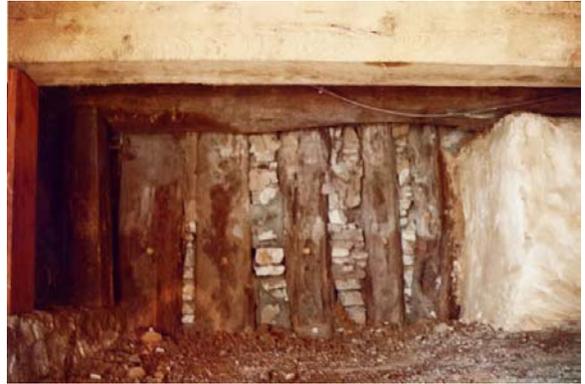
Figure A17
Post-in-ground foundation as viewed from the cellar of the Amoreaux House, Ste. Genevieve, MO; large horizontal floor beam is separately supported on stone piers (right) and timber posts on interior stone foundation wall (left); new support beam is shown in the foreground.

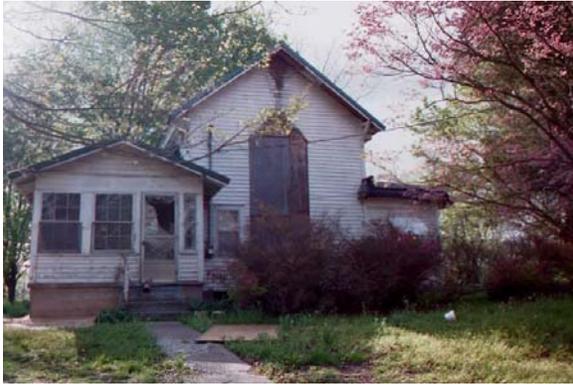
Figure A28
Side view of the Ashburn-Jefferies House undergoing remodeling and showing chimney recently removed; center portion is original log cabin.

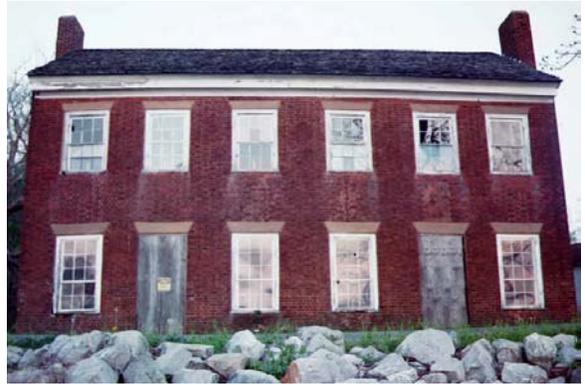
Figure A29
Front view of the Gower House, Smithland, KY; uneven lintels above windows show differential settlement of foundation.

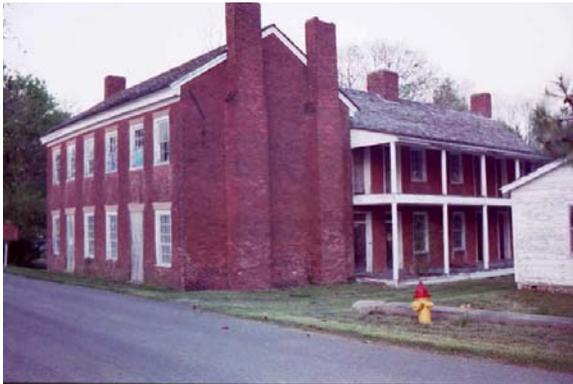
Figure A30
Side view of the Gower House; retrofitted wall anchor is shown in upper left corner of gable end.

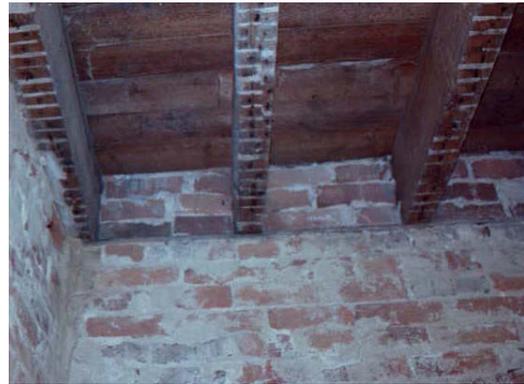
Figure A31
Second floor construction of the Gower House.

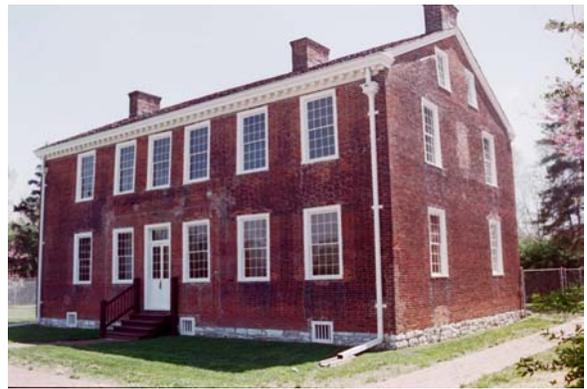
Figure A36
Front and side view of the Jarrot Mansion, Cahokia, IL.

22	1807 - 1810	Jarrot Mansion	Cahokia, IL	~138 mi.	Brick	2-1/2	4-wythe brick construction, had extensive repairs in 1930s and 40s; two main interior cross walls are same construction as exterior; reported to have repairs done to east chimney to "take down chimney cap and putting up" (evidently the chimney did not completely topple); two "seams" in rear (south facing) wall needed repair; documentation available and some current signs of repair of past seismic damage.
23	1799	The Holy Church	Cahokia, IL	~138 mi.	Post-on-Sill	1	Tall walls and steep cathedral style timber truss/frame roof; original building may have predated 1799 under different use; current building was rebuilt in 1830 and 1949; documentation may be available through parish records; no obvious signs of past seismic damage.
24	1790	Martin-Boismenu House	Cahokia, IL	~138 mi.	Post-on-Sill	1-1/2	Historic home found inside a newer home when remodeled; now restored to original condition; according to those involved in restoration it was repaired and restored in the "as found" condition; as such, the house and two end wall chimneys are shifted northward about 2 to 3 inches on a plane level with the top of the stone foundation wall; no documentation to support, but house may have shifted on foundation due to past earthquake.

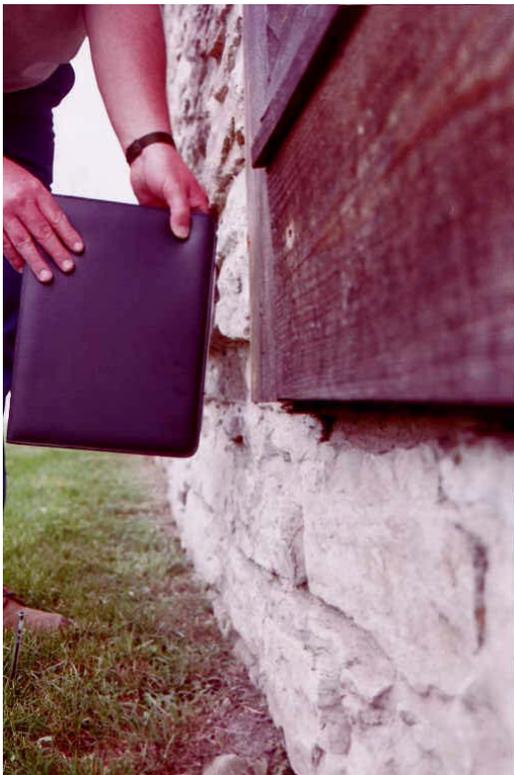
Figure A39
View of ~2 inches of slip (N-S) at foundation-sill plane as found prior to recovery and repair of the Martin-Boismenu House.

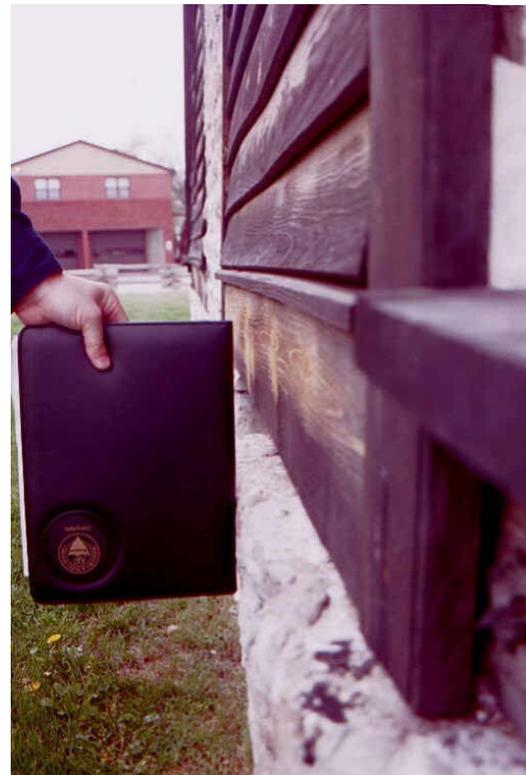
Figure A40
Opposite end of building in previous figure showing ~2 inches of southward slip of the building on its stone foundation wall.

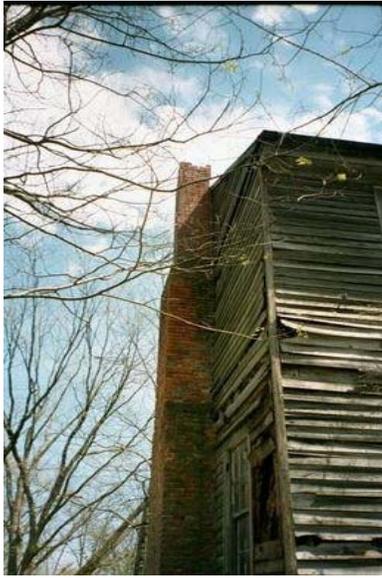
Figure A41
Illustration of a vulnerable brick chimney style on a
braced timber frame house
(Ratte-Hoffman House, Ste. Genevieve, MO).

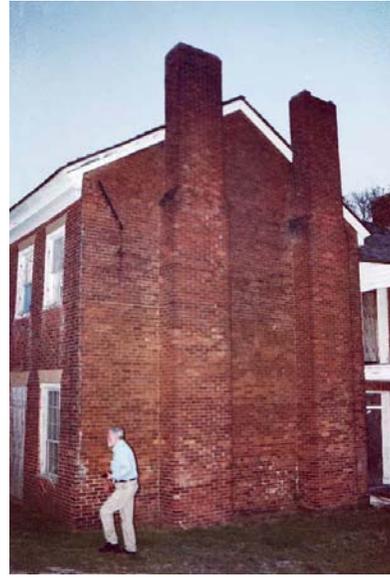
Figure A42
Vulnerable chimney construction on a brick house
(Smithland, KY).

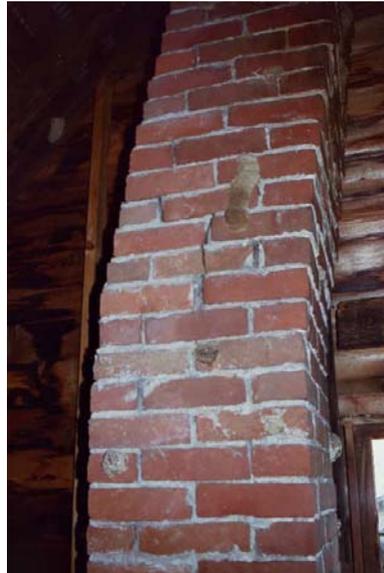
Figure A43
Illustration of vulnerable chimney construction;
reconstructed chimney is cracked at mid-height of
attic due to misalignment with offset roof penetration
to avoid interference with ridge beam
(Ste. Genevieve, MO).

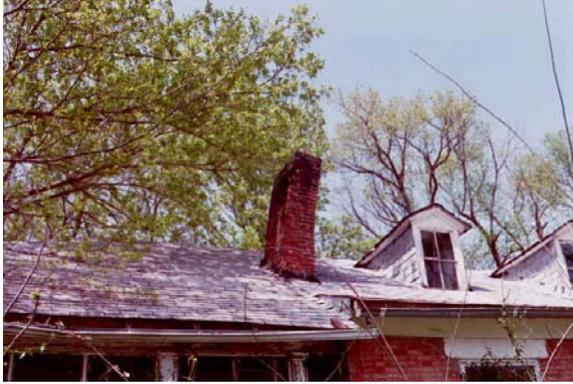
Figure A44

Illustration of vulnerable chimney leaning due to lack of maintenance and degradation of mortar; age of house is unknown (Smithland, KY).

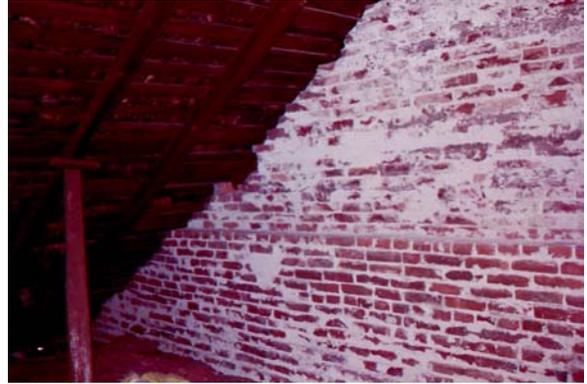
Figure A45

Illustration of a typical brick gable end wall without lateral support or anchorage to the roof framing, Ste. Genevieve, MO (Old Brick House); In this case, the brick wall thickness changes from two wythes to one wythe at about one-third of the height of the gable.
