Rehabilitation Guidelines 1982

10 Guideline on the Rehabilitation of Walls, Windows, and Roofs

National Institute of
BUILDING SCIENCES
Washington, D.C.

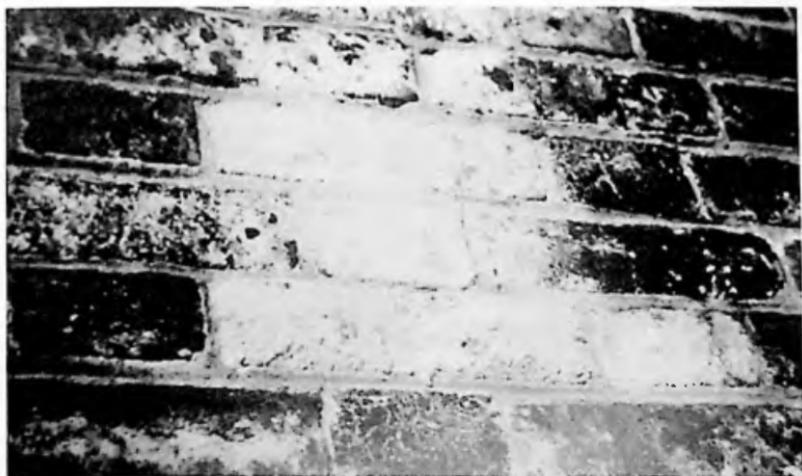
Figure 1

Other common cleaning problems include stains from oxidizing metals such as ferrous or copper, and organic matter such as the tendrils left on the masonry after removal or plant growth such as ivy. The source of dirt, such as coal soot, may no longer be a factor in planning for longer term maintenance, or it may be a continuing concern. Efflorescence, soluble salts deposited on the surface of the masonry, is another common problem. (See Figure 1.) These salts usually originate in the masonry or migrate from the ground below; they also may result from air pollution or from improper cleaning techniques. The salts may be in the masonry units, either the facing masonry units or the backup units, or in trim materials, such as caps, copings, sills, lintels and keystones. Also, they could be from any of the basic mortar materials, cement, lime, sand and water. In addition, there are other miscellaneous sources of salts, such as admixtures, calcium chloride, or the atmosphere.

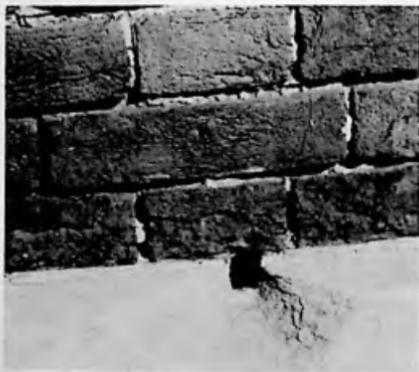
Figure 2

Other building materials also may be affected by the cleaning process; some chemicals, for example, may have a corrosive effect on paint and glass. Totally unseen items, such as iron cramps or ties which hold the masonry to the structural frame, also may be subject to corrosion from the use of chemicals or even from plain water. If these items rust, for example, the accompanying increase in volume can spall the masonry. (See Figure 2.)

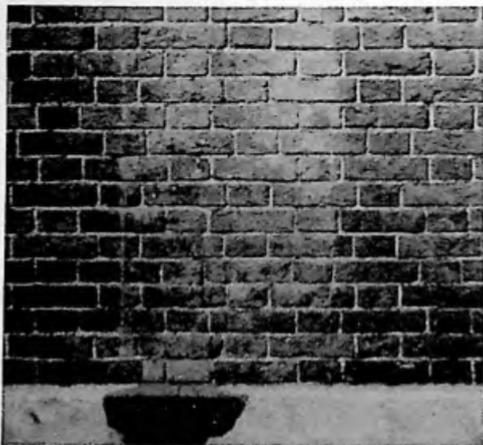
Figure 3 (Photo: Lee H. Nelson)

When feasible, test areas should be allowed to weather for an extended period prior to final evaluation. Some detrimental effects, such as the haze on the test patch shown in Figure 3, do not appear for some time. A waiting period of a full year is not unreasonable, so that the masonry and test area can be exposed to a full range of seasons. For a building which has been standing for many years, such a delay is insignificant when compared with the potential for damage and disfigurement resulting from inappropriate cleaning.

Another problem may be a change in the color of the masonry caused by the chemicals, not by removal of dirt; the cleaner also may leave a hazy residue, as shown in Figure 3, in spite of heavy rinsing. Chemicals can react with components of mortar, stone, or brick to release soluble salts which can form efflorescence.

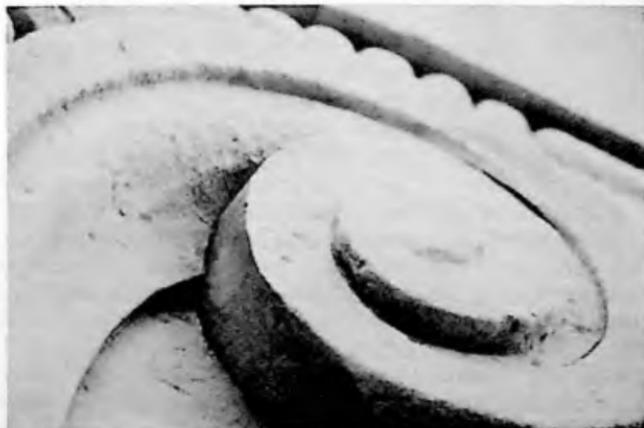
Figure 4

Grit blasters, grinders, and sanding discs all operate by abrading the dirt off the surface of the masonry, rather than reacting with the dirt and masonry as in water and chemical methods. Since the abrasives do not differentiate between the dirt and the masonry, some erosion of the masonry surface is inevitable with mechanical methods, especially blasting. See Figures 4 and 5. Although a skilled operator can minimize this erosion, some erosion will still take place. In the case of brick, glazed terra-cotta, soft stone, detailed carvings, or polished surfaces, even minimal erosion is unacceptable. Brick, a fired product, is hardest on the outside where the temperatures were highest; the loss of this "skin" of the brick exposes the softer inner portion to more rapid deterioration. Abrasion of intricate details causes a rounding of sharp corners and other loss of delicate features, while abrasion of polished surfaces removes the polished quality of those surfaces. Mechanical methods, therefore, should never be used on brick, soft stone, terra cotta, or carved or polished surfaces; extreme caution should be exercised in using them on other masonry.

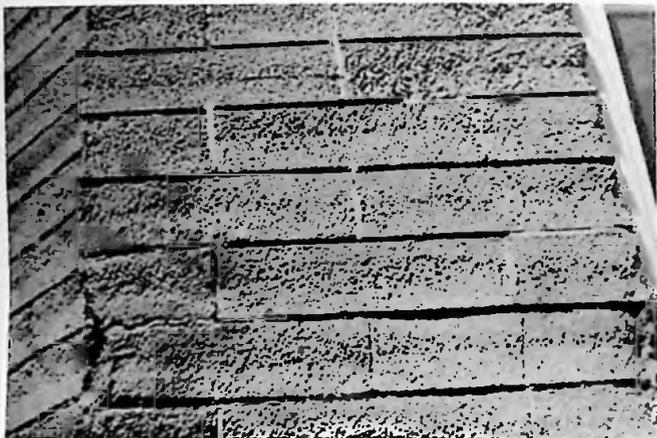
Figure 5

Grit blasting, unfortunately, still is widely used in spite of these serious effects. In most cases, blasting will leave minute pits on the surface of the masonry. This additional roughness actually increases water retention on the surface, facilitates the collection of dirt and increases the area on which pollutants can react.

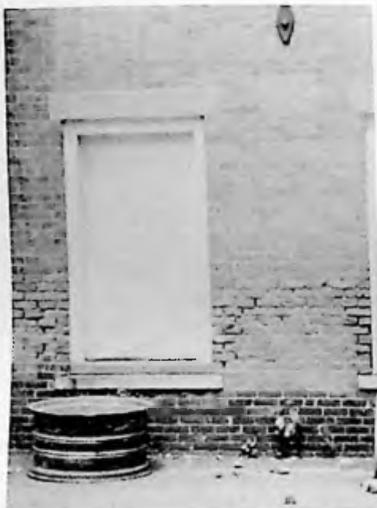
Figure 6 (Photo: Baird M. Smith)

All buildings and building materials are in a constant process of deterioration, as shown in Figure 6. Repointing is the process of removing deteriorated mortar and replacing it with new mortar, renewing the points and preventing further deterioration to the building. Properly done, repointing restores the visual and physical integrity of the masonry. Improperly done, repointing not only detracts from the appearance of the building, but may, in fact, cause physical damage to the masonry units themselves

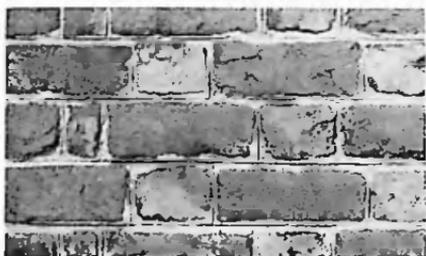
Figure 7 (Photo: Calder Loth)

Pointing styles and the methods of producing them should be examined. See Figure 7. It is important to look at both the horizontal and the vertical joints to determine the order in which they were tooled and whether they were the same style. Some late-19th- and 20th-century buildings, for example,

have horizontal joints that were tooled while the vertical joints were finished flush and stained to match the bricks, thus creating the illusion of horizontal bands. It is significant to note that pointing styles often differed from one facade to another. Front walls often received greater attention to mortar detailing than side and rear walls.

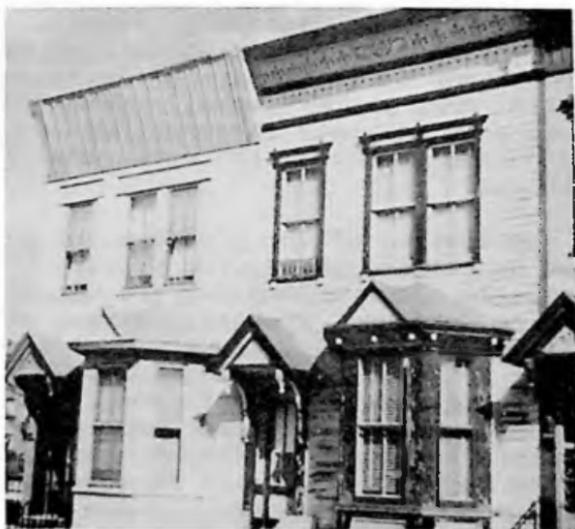
Figure 12 (Photo: Laurie Robin Hammel)

There is a natural desire to reduce the labor and expense required to maintain a building. To this end, a number of products have been developed for installation over existing wood siding or as a replacement for existing wood siding. Two common products for this purpose include aluminum and vinyl siding. When used improperly, some of these products can cause technical problems. In addition, their application may cause significant and often undesirable, changes to the appearance of some buildings, as shown in Figure 12. These issues will be discussed in greater detail in this subsection.

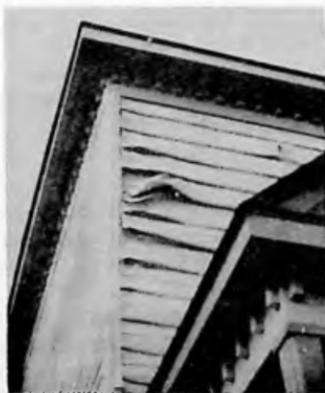
Figure 13 (Photo: Linda J. Flint)

Alternative replacement sidings are often marketed and purchased as maintenance saving alternatives; there are, however, certain types of damage to which these materials are susceptible. Aluminum siding scratches and dents easily, as a typical thickness is about .020 inches. Some vinyl sidings may melt when exposed to high temperatures; the siding shown in Figure 13 was damaged by a fire across the street. Some vinyl sidings may become brittle and susceptible to shattering in very cold weather, as shown in Figure 14. Durability should be considered by those responsible for a rehabilitation project.

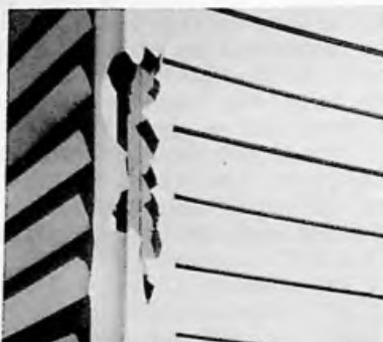
Figure 14 (Photo: Technical Preservation Services)

Typical repairs are made by cutting out the damaged area and splicing in a new piece of siding material, but new sections are often not an exact color match due to fading of the exposed surface and color variations in product runs.

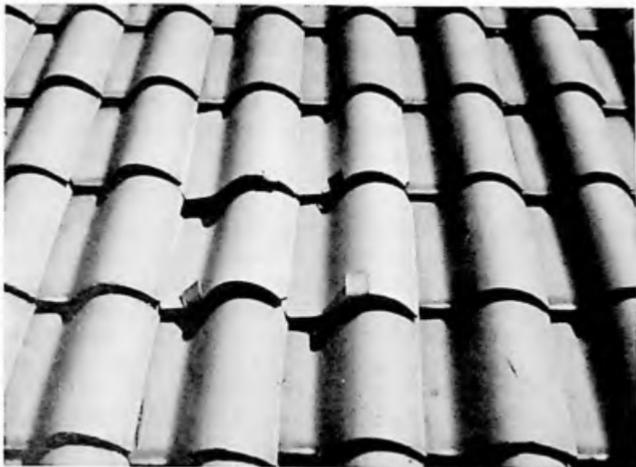
Figure 17

Understanding potential weaknesses of roofing material also requires knowledge of repair difficulties. Individual slates or tiles can be replaced normally without major disruption to the rest of the roof, as shown in Figures 16 and 17, but replacing the flashing on these roofs can require substantial removal of surrounding materials. If it is the substrate or a supporting member which has deteriorated, many materials such as slate and tile can be reused if removed carefully. Such problems should be evaluated at the outset of any project to determine if the roof can be effectively patched or if it should be completely replaced.

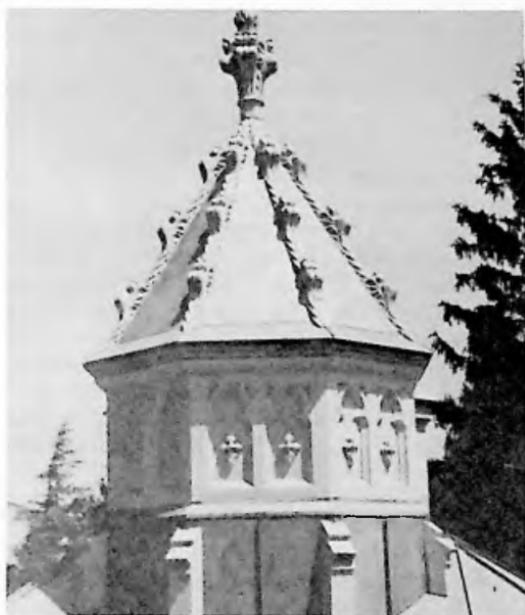
Figure 18 (Photo: National Trust for Historic Preservation)

on the inside. Decorative features, such as the cupola shown in Figure 18, require extra maintenance because they are more exposed to the weather and because their delicate features are susceptible to damage.

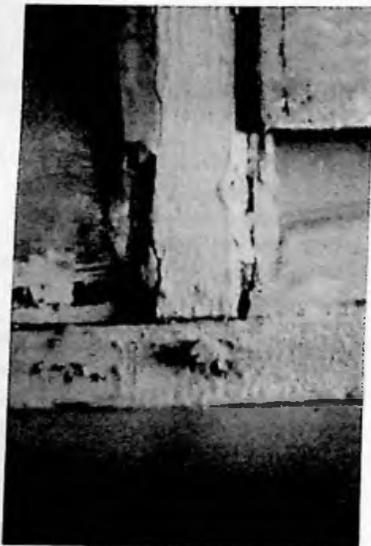
Figure A-1

The following series of photographs of the repair of a historic double-hung window use a unit which is structurally sound but has many layers of paint, some cracked and missing putty, slight separation at the joints, broken sash cords, and one cracked pane. Photo: John H. Myers

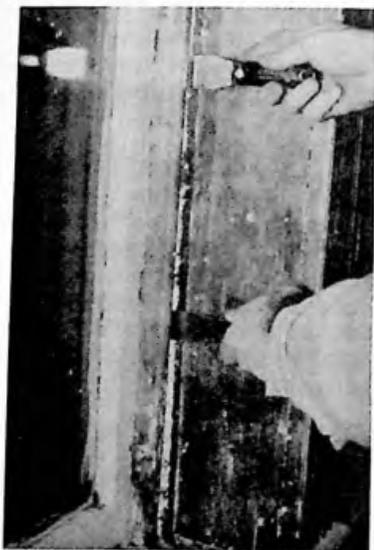
Figure A-2

After removing paint from the seam between the interior stop and the jamb, the stop can be pried out and gradually worked loose using a pair of putty knives as shown. To avoid visible scarring of the wood, the sash can be raised and the stop pried loose initially from the outer side. Photo: John H. Myers

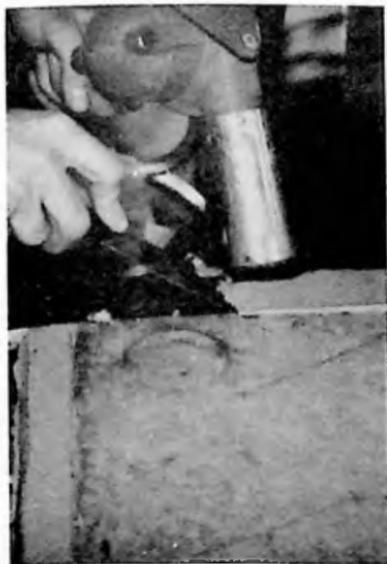
Figure A-3

Sash can be removed and repaired in a convenient work area. Paint is being removed from this sash with a hot air gun while an asbestos sheet protects the glass from sudden temperature change. Photo: John H. Myers

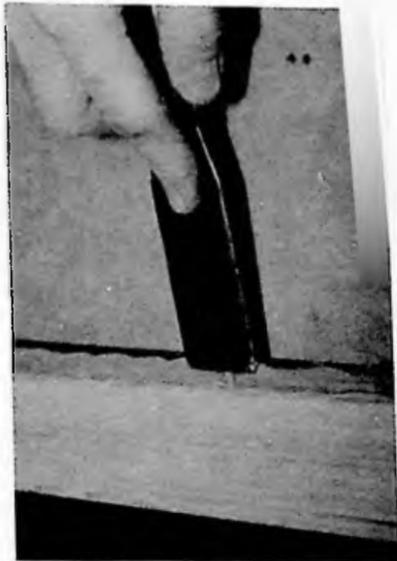
Figure A-4

Reglazing or replacement of the putty requires that the existing putty be removed manually, the glazing points be extracted, the glass removed, and the back putty scraped out. To reglaze, a bed of putty is laid around the perimeter of the rabbet, the pane is pressed into place, glazing points are inserted to hold the pane (shown), and a final seal of putty is beveled around the edge of the glass. Photo: John H. Myers

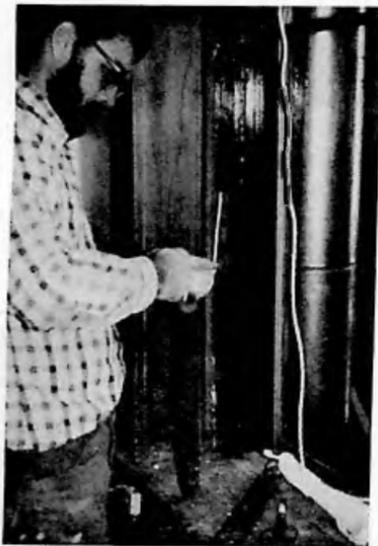
Figure A-5

A common repair is the replacement of broken sash cords with new cords (shown) or with chains. The weight pocket is often accessible through a removable plate in the jamb, or by removing the interior trim. Photo: John H. Myers

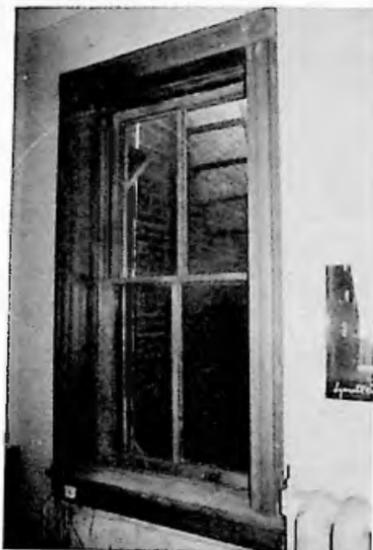
Figure A-6

Following the relatively simple repairs, the window is weathertight, like new in appearance, and serviceable for many years to come. Both the historic material and the detailing and craftsmanship of this original window have been preserved. Photo: John H. Myers
