Rehabilitation Guidelines 1986

10 Guideline on the Rehabilitation of Walls, Windows, and Roofs

National Institute of
BUILDING SCIENCES
Washington, D.C.

for the U.S. Department of Housing and Urban Development
Office of Policy Development and Research
under Cooperative Agreement H-5033 and H-5498

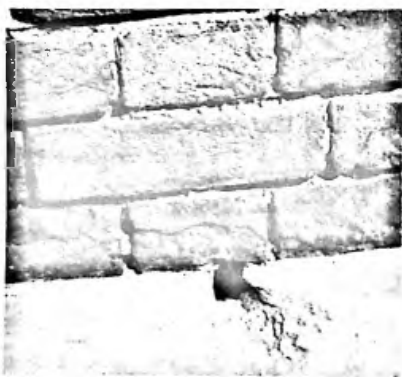
Figure 2

Other building materials also may be affected by the cleaning process; some chemicals, for example, may have a corrosive effect on paint and glass. Totally unseen items, such as iron cramps or ties which hold the masonry to the structural frame, also may be subject to corrosion from the use of chemicals or even from plain water. If these items rust, for example, the accompanying increase in volume can spall the masonry. (See Figure 2.)

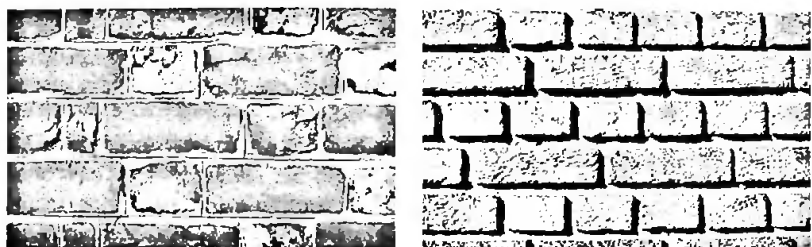
Figure 7 (Photo: Calder Loth)

Pointing styles and the methods of producing them should be examined. See Figure 7. It is important to look at both the horizontal and the vertical joints to determine the order in which they were tooled and whether they were the same style. Some late-19th- and 20th-century buildings, for example,

have horizontal joints that were tooled while the vertical joints were finished flush and stained to match the bricks, thus creating the illusion of horizontal bands. It is significant to note that pointing styles often differed from one facade to another. Front walls often received greater attention to mortar detailing than side and rear walls.

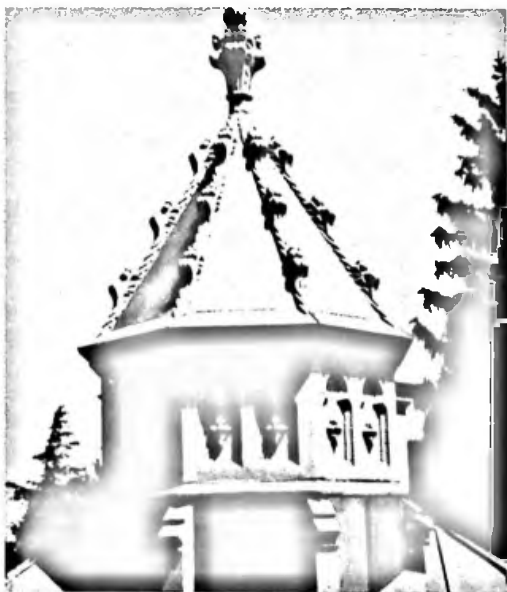
Figure 18 (Photo: National Trust for Historic Preservation)

on the inside. Decorative features, such as the cupola shown in Figure 18, require extra maintenance because they are more exposed to the weather and because their delicate features are susceptible to damage.

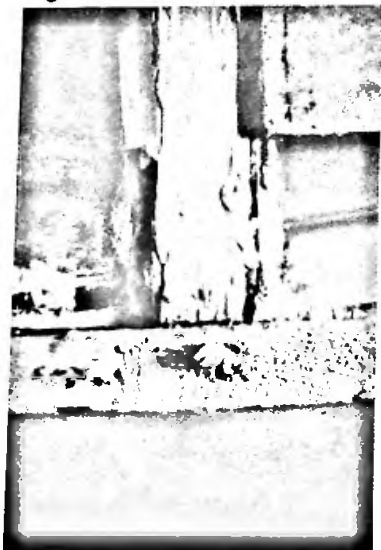
Figure A-2

The following series of photographs of the repair of a historic double-hung window use a unit which is structurally sound but has many layers of paint, some cracked and missing putty, slight separation at the joints, broken sash cords, and one cracked pane. Photo: John H. Myers

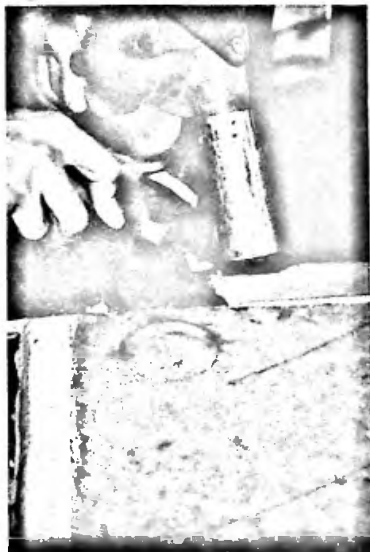
Figure A-4

Sash can be removed and repaired in a convenient work area. Paint is being removed from this sash with a hot air gun while an asbestos sheet protects the glass from sudden temperature change. Photo: John H. Myers

The sash can be stripped of paint using appropriate techniques, such as chemical strippers or heat. If any heat treatment is used, the glass should be removed or protected from the sudden temperature change which can cause breakage. An overlay of aluminum foil on gypsum board or cement asbestos board can protect the glass from such rapid temperature change. Deteriorated putty should be removed manually, taking care not to damage the wood along the rabbet. If the glass is to be removed, the glazing points which hold the glass in place can be extracted and the panes numbered and removed for cleaning and reuse in the same

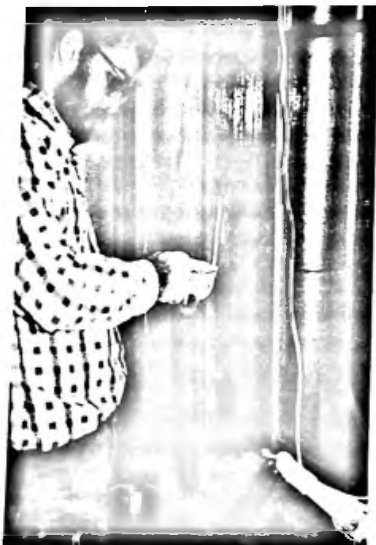
Figure A-6

A common repair is the replacement of broken sash cords with new cords (shown) or with chains. The weight pocket is often accessible through a removable plate in the jamb, or by removing the interior trim. Photo: John H. Myers
