PHYSICAL NEEDS ASSESSMENT AND ENERGY AUDIT

WOODHILL HOMES

2488 Morris Black Place
Cleveland, Ohio 44104

EMG Project #: 109304.14R-025.308
Date of Report: April 22, 2015
On site Date: March 16 - 19, 2015

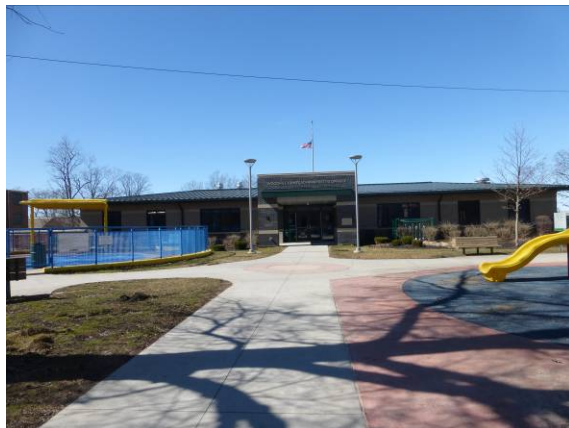
Photo #3: Community center - rear elevation

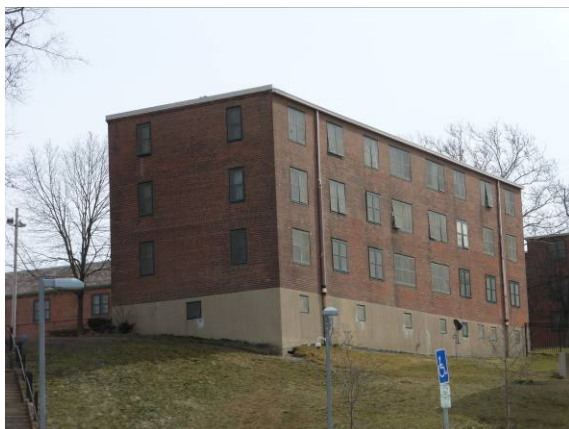
Photo #5: 3 story walk up - rear elevation

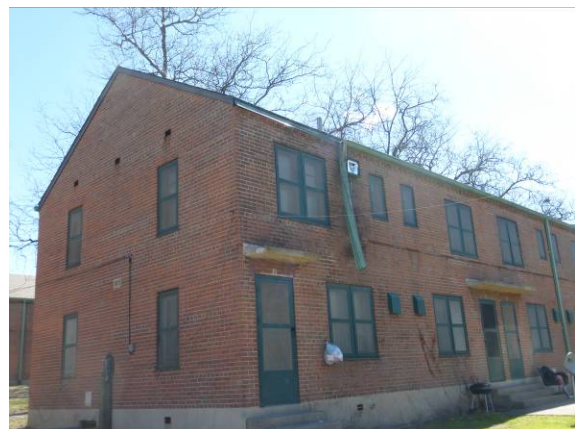
Photo #6: Pitched roof row homes - front and side elevation

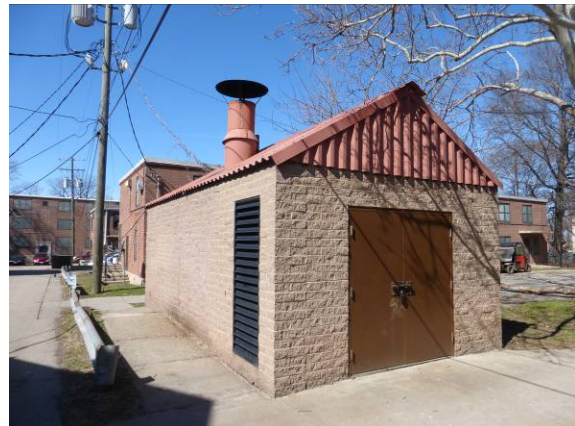
Photo #10:	Central boiler house
------------	----------------------

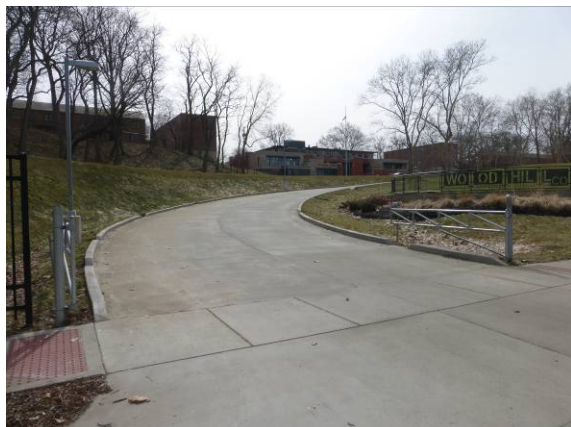
Photo #11:	Community center drive way
------------	----------------------------

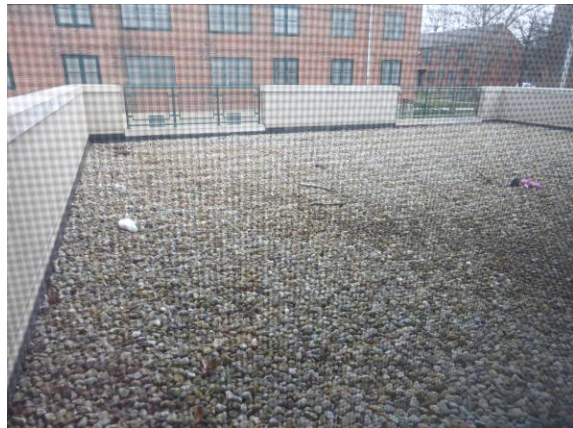
Photo #16:	Community center roof
------------	-----------------------

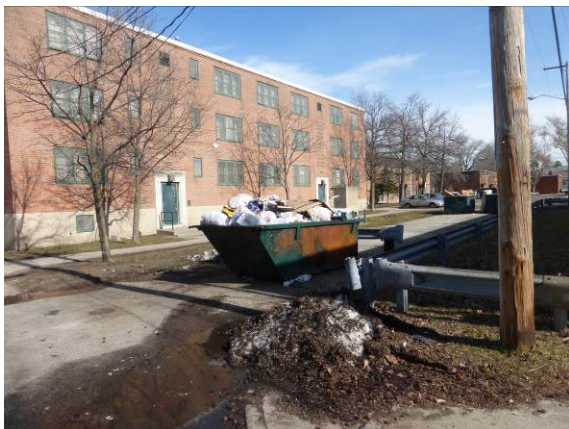
Photo #17:	Site dumpster
------------	---------------

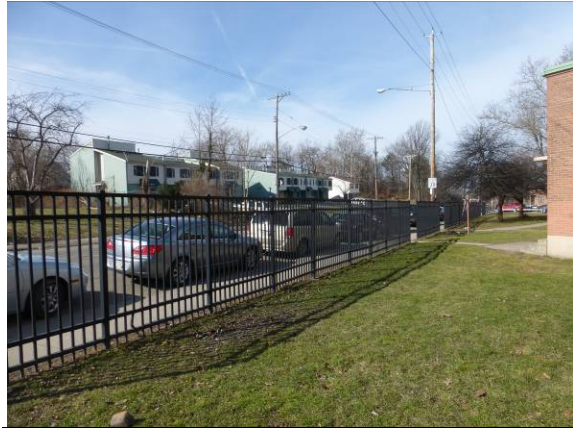
Photo #20: Perimeter fencing

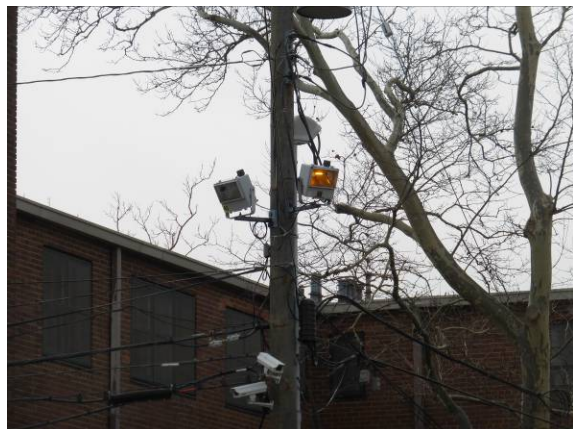
Photo #24: Site lighting

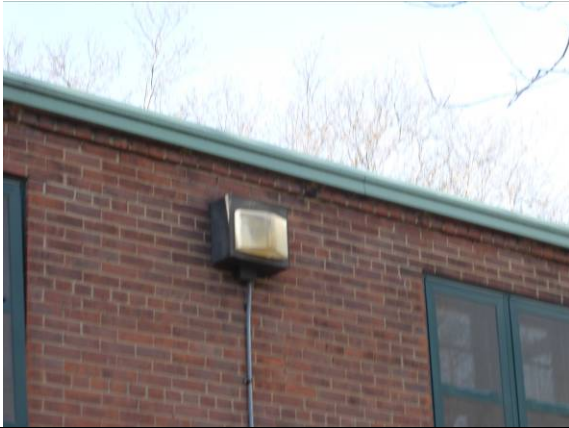
Photo #25: Building mounted site lighting

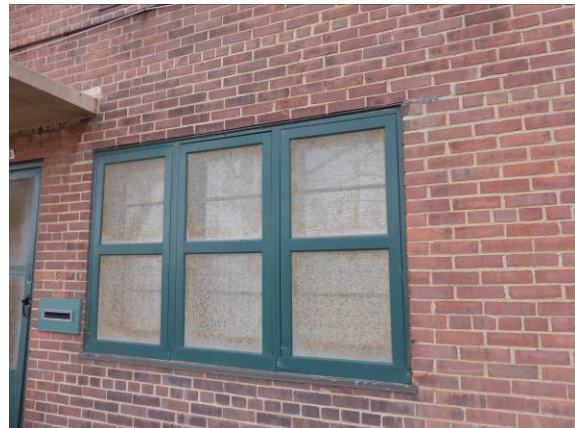
Photo #28: Tenant unit window

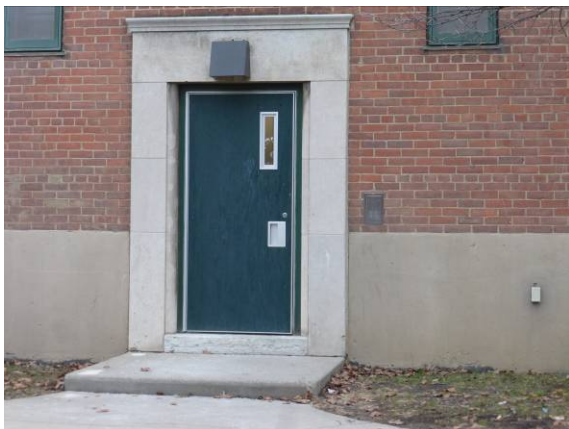
Photo #29: 3 story walk up - exterior door

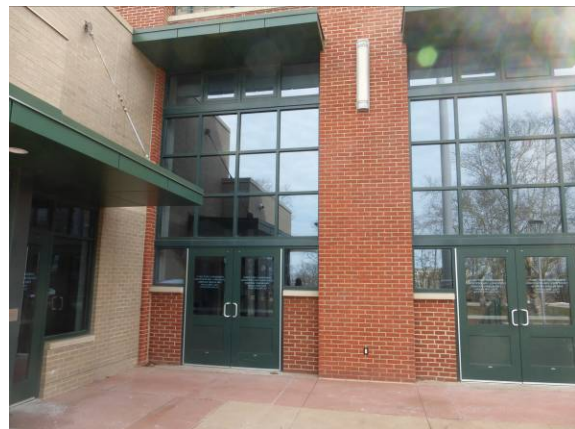
Photo #30: Community center - exterior doors and windows

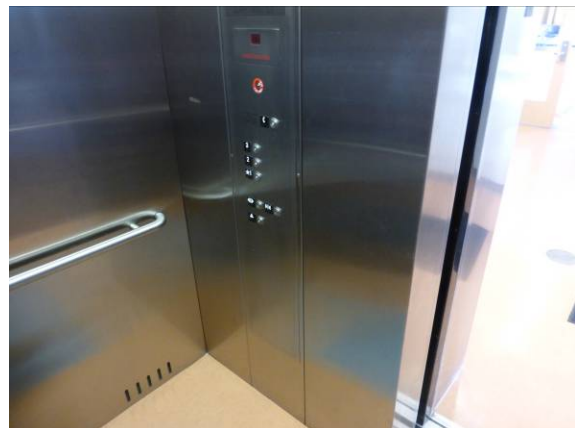
Photo #34: Community center - elevator

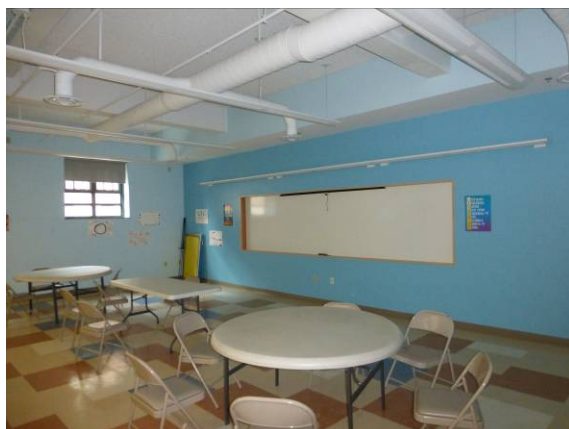
Photo #35: Community center - classroom

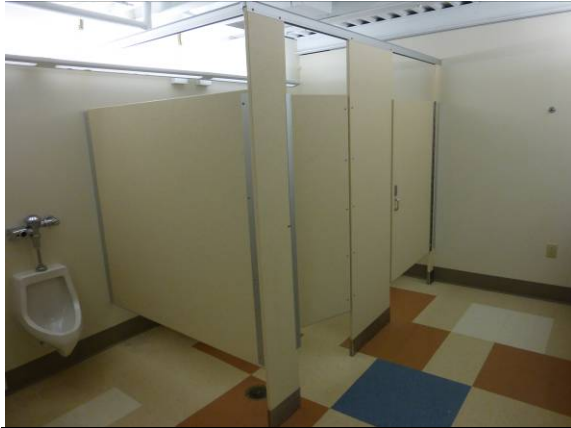
Photo #37: Community center - bathroom

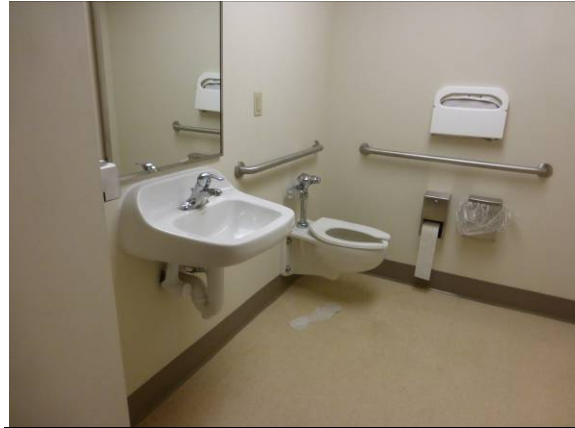
Photo #38: Community center - ADA bathroom

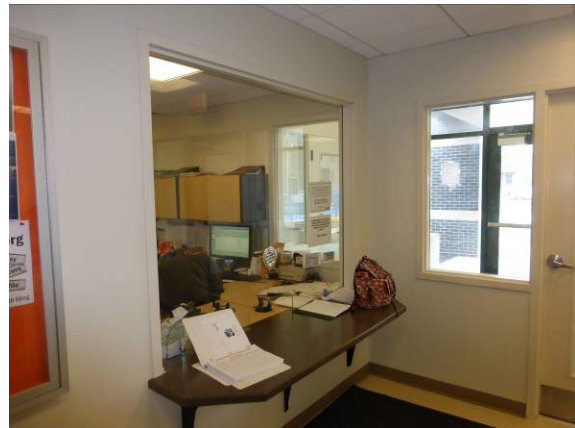
Photo #40: Community center - administration lobby

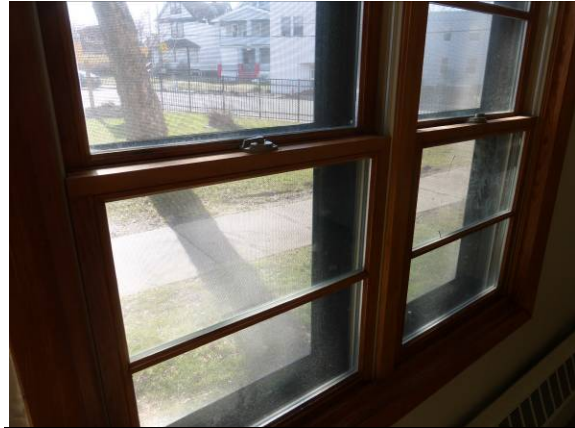
Photo #44: Tenant unit window

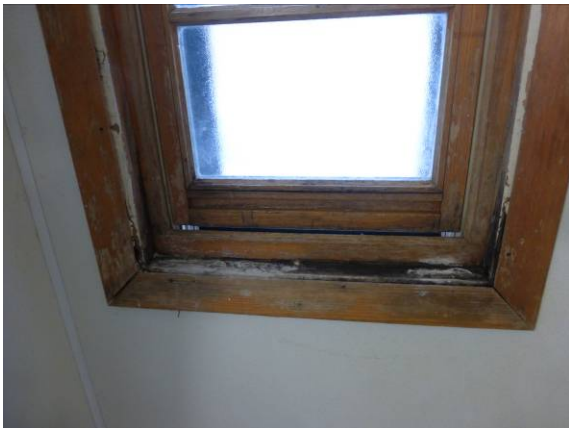
Photo #45: Tenant unit window

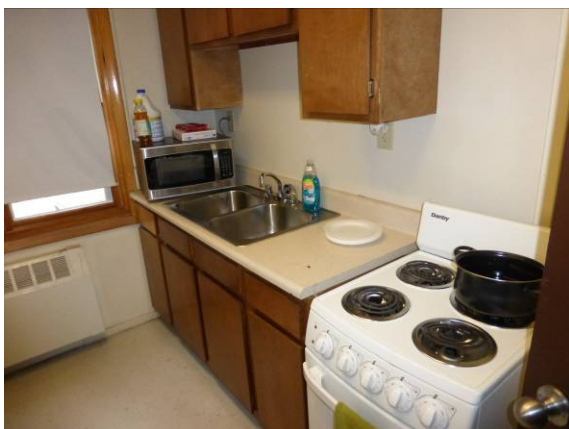
Photo #47: 3 story walk up kitchen

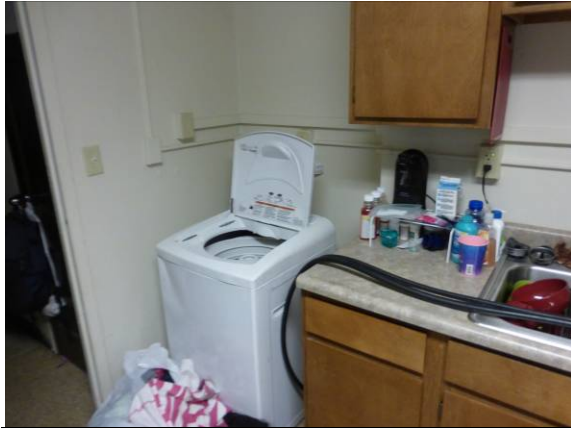
Photo #49: Tenant supplied washer

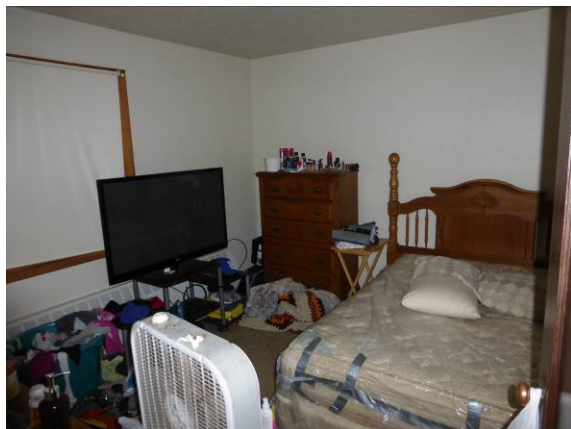
Photo #53: Tenant bedroom

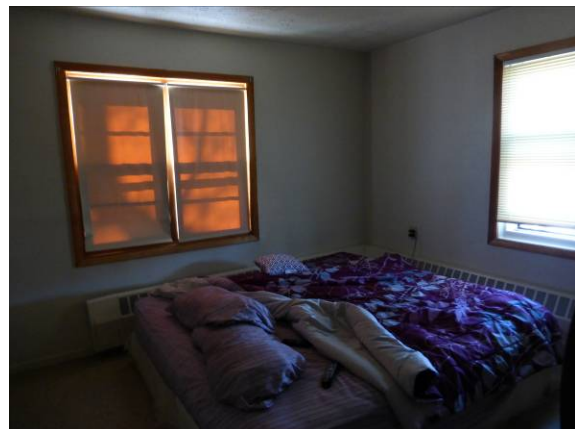
Photo #54: Tenant bedroom

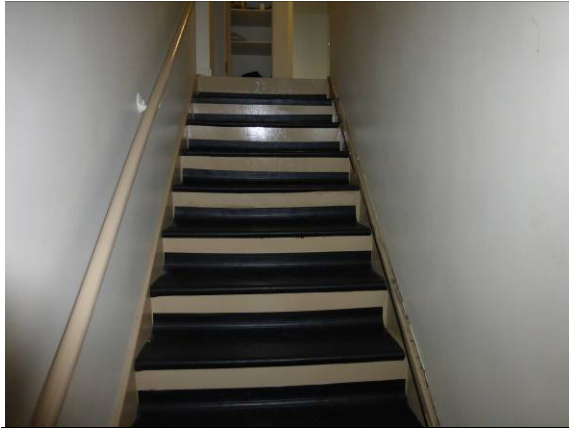
Photo #55:	Interior stairs
------------	-----------------

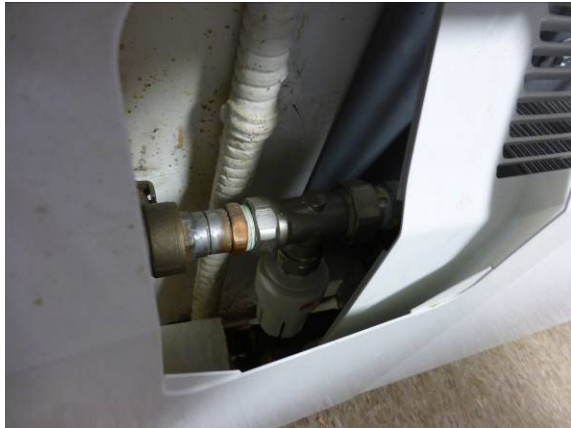
Photo #61: Radiator control

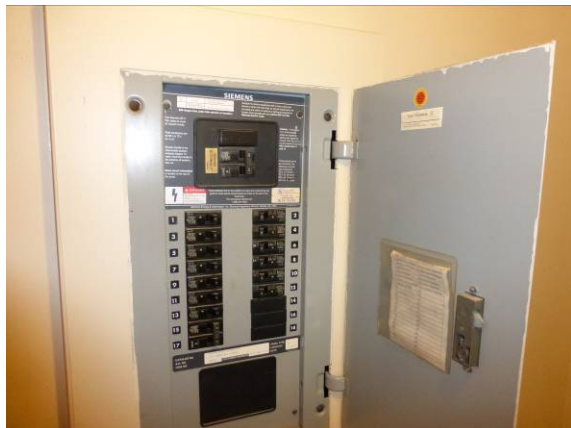
Photo #63: Electrical panel

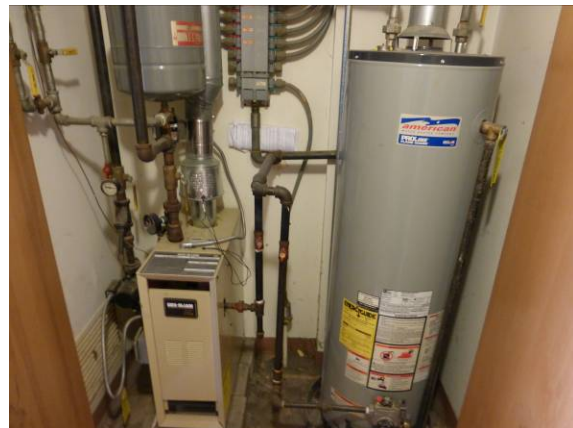
Photo #64: 3 story walk up unit – mechanical equipment

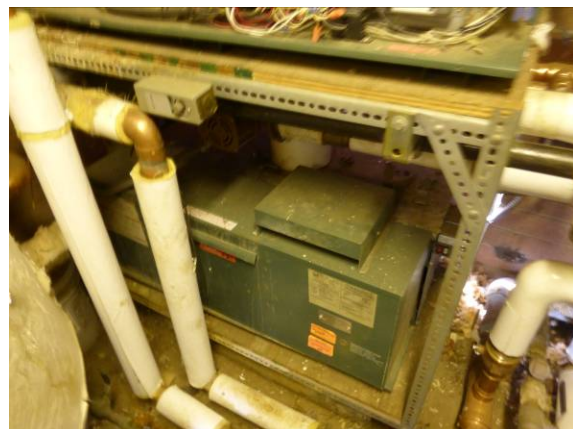
Photo #66: Central domestic water boiler

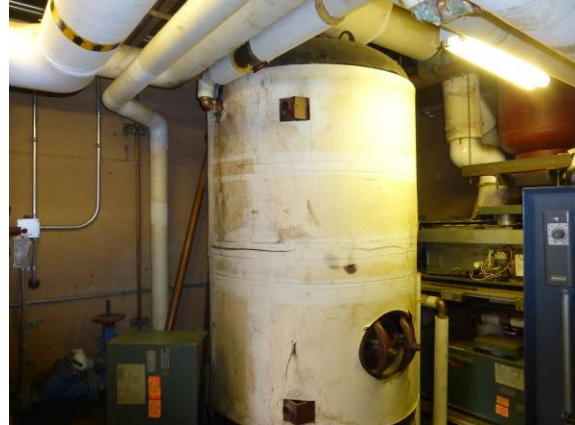
Photo #68:	Storage tank
------------	--------------

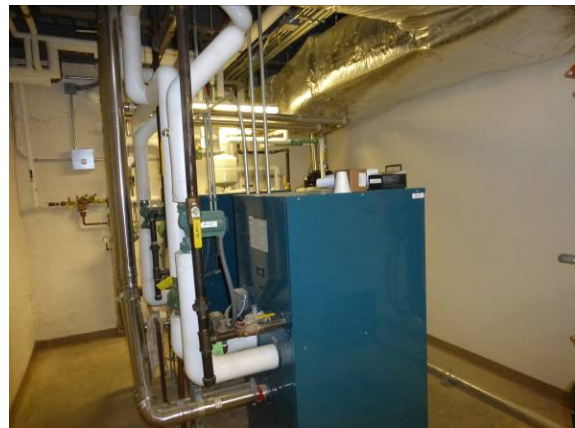
Photo #70:	Community Center - boilers
------------	----------------------------

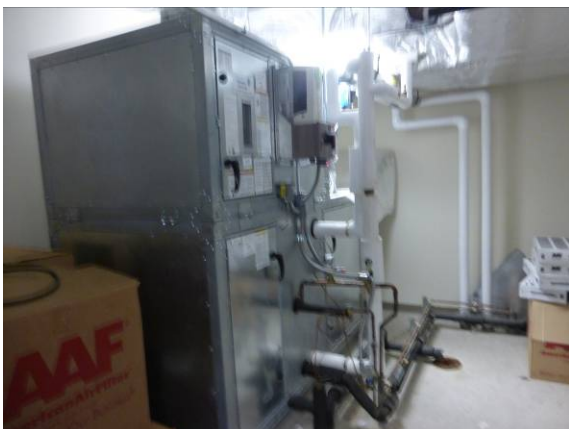
Photo #71:	Community center - air handler
------------	--------------------------------

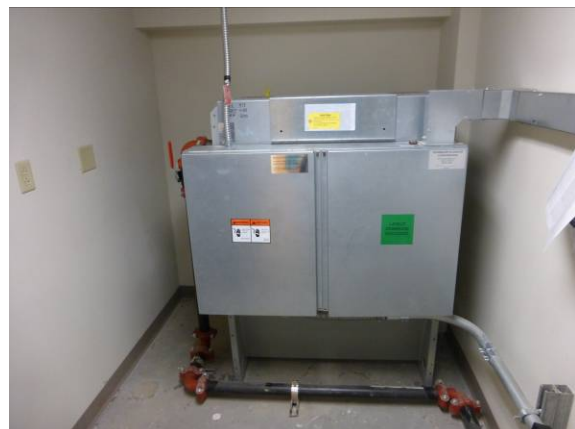
Photo #72:	Community center - hydraulic elevator equipment
------------	---

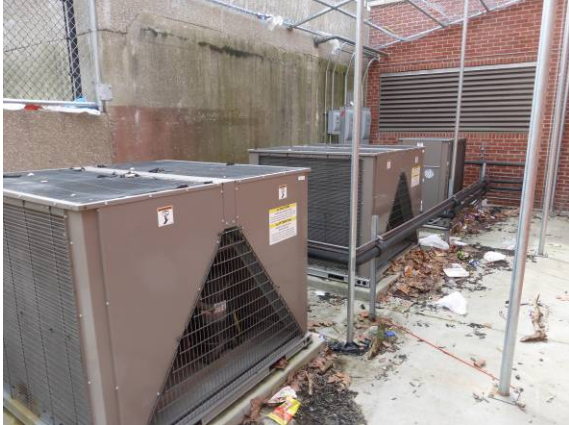
Photo #73: Community center – split system units

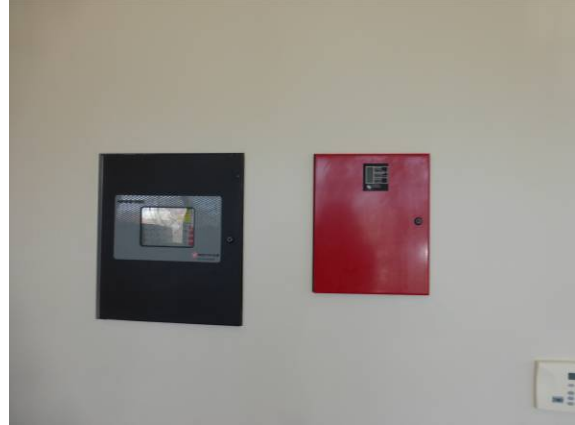
Photo #74: Community center – fire panels

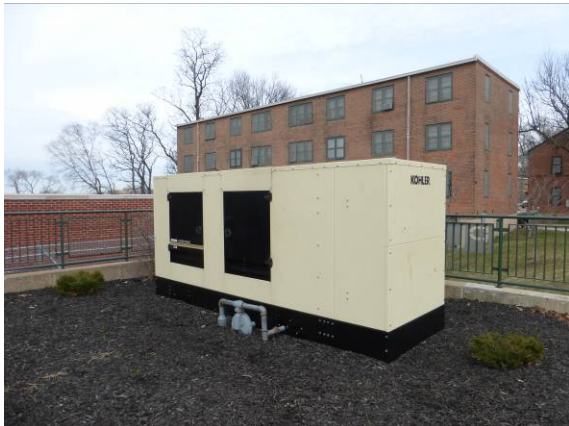
Photo #75: Community center – emergency generator

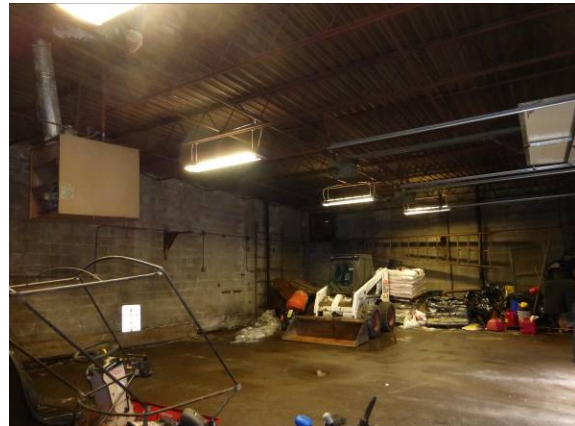
Photo #76: Interior of the maintenance storage garage

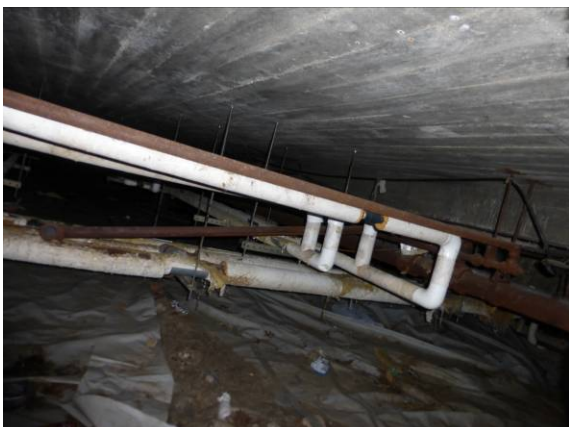
Photo #77: Row-home building crawl space
