CHAPTER IV

EXISTING CONDITIONS SURVEY

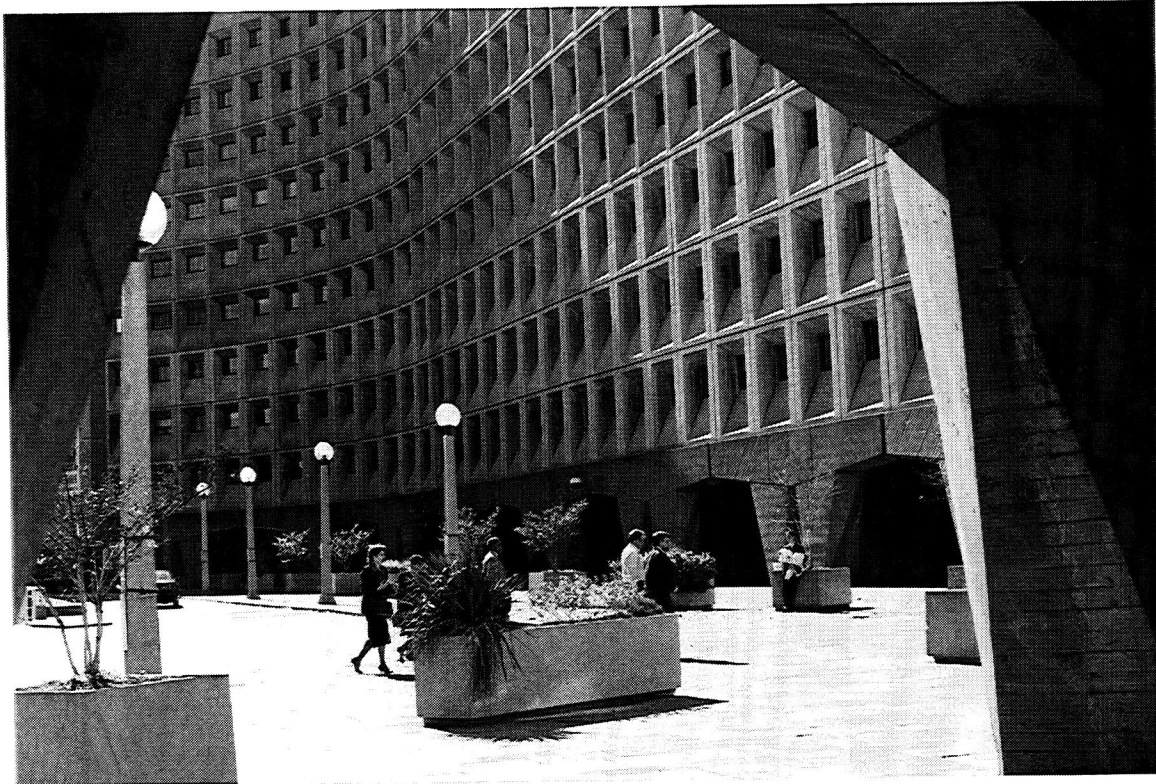
Illustration No. 4-3

Description: View looking south from beneath pilotis (see Illus. No. 3-48 for original view). Note stains on inside of pilotis and soiling on inside of precast concrete window units. Changes to the plaza include the addition of concrete landscaping planters which run the length of the plaza, spotlights mounted on the tree beams between the pilotis, and new clear glass globes replacing original light fixtures on the concrete standards. Signs have been added to the original light standards with metal bands which are rusting and staining the standards.

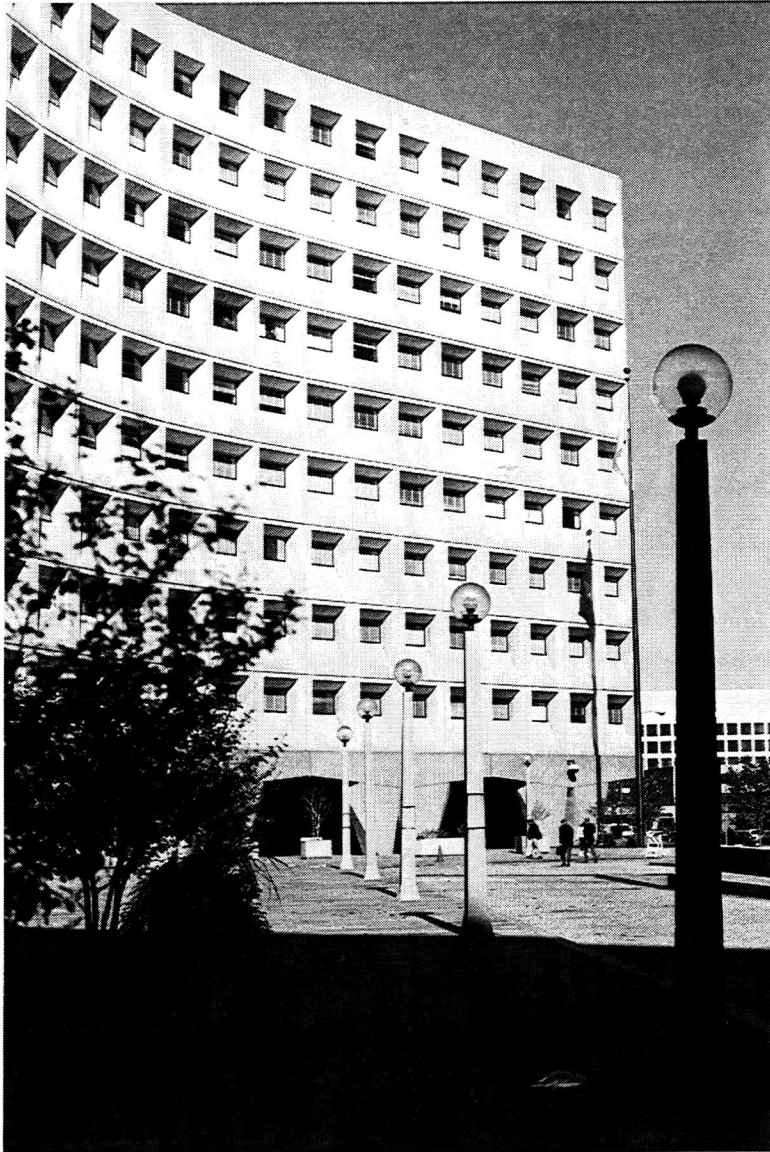
Illustration No. 4-4

Description: View looking north across plaza (see Illus. No. 3-47 for original view). Changes to the plaza include the removal of concrete stanchions and addition of plants set in concrete landscaping planters, removal of original light fixtures and replacement with clear glass globes set on original concrete standards, new spotlights mounted on the tree beams on the building, a concrete paved driveway area with a granite curb instead of the original bluestone which covered the entire plaza, and two new 80' flagpoles at the north and south ends.

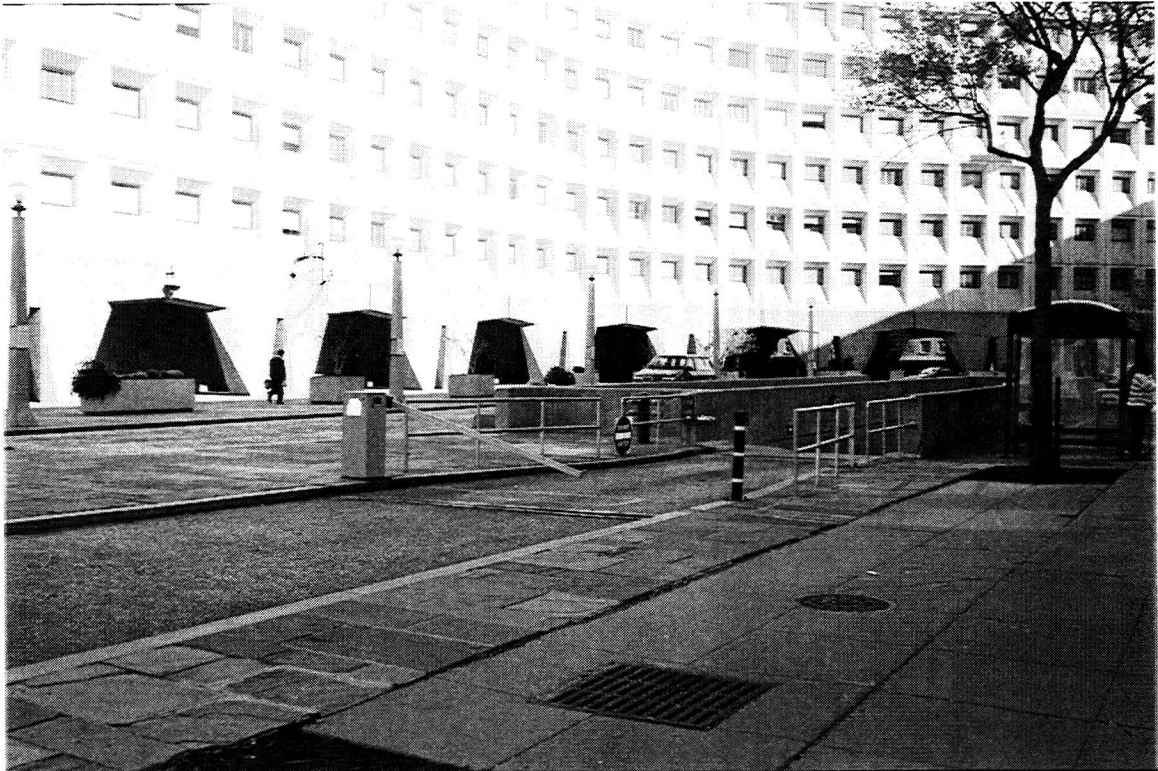
Illustration No. 4-6

Description: View looking towards south end of plaza, showing "banner" with 18 gauge stainless steel letters on the front. Note original brass finished steel guard plates on the front and back of the base. Note also the 80' black anodized aluminum flagpole (original flagpole was in this location and of the same material but was 40' tall) and two original concrete light posts, with non-original light globes. The standards have had signs attached with metal bands which are rusting and staining the standards.

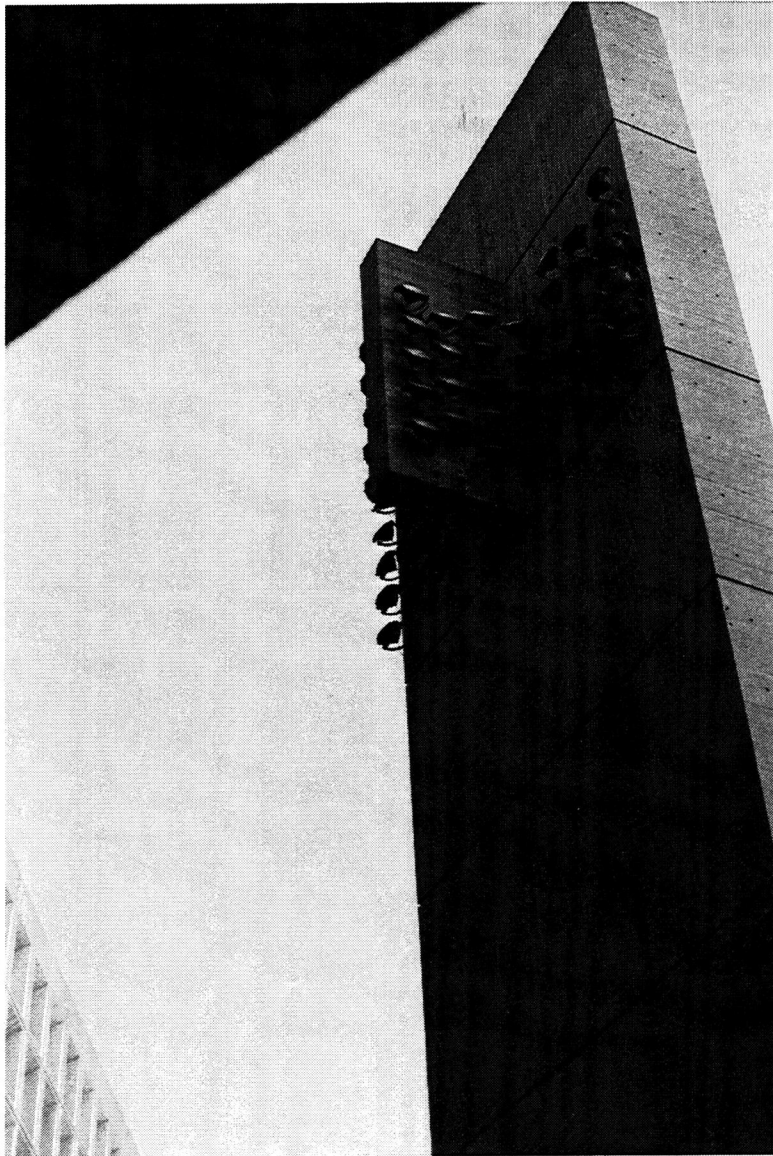
Illustration No. 4-9

Description: Backside of top portion of banner showing 64 original 1000-watt lights mounted on back of banner used to illuminate the building and its main entrance at night (compare with original photo, Illus. No. 3-50). The lights are in good condition.

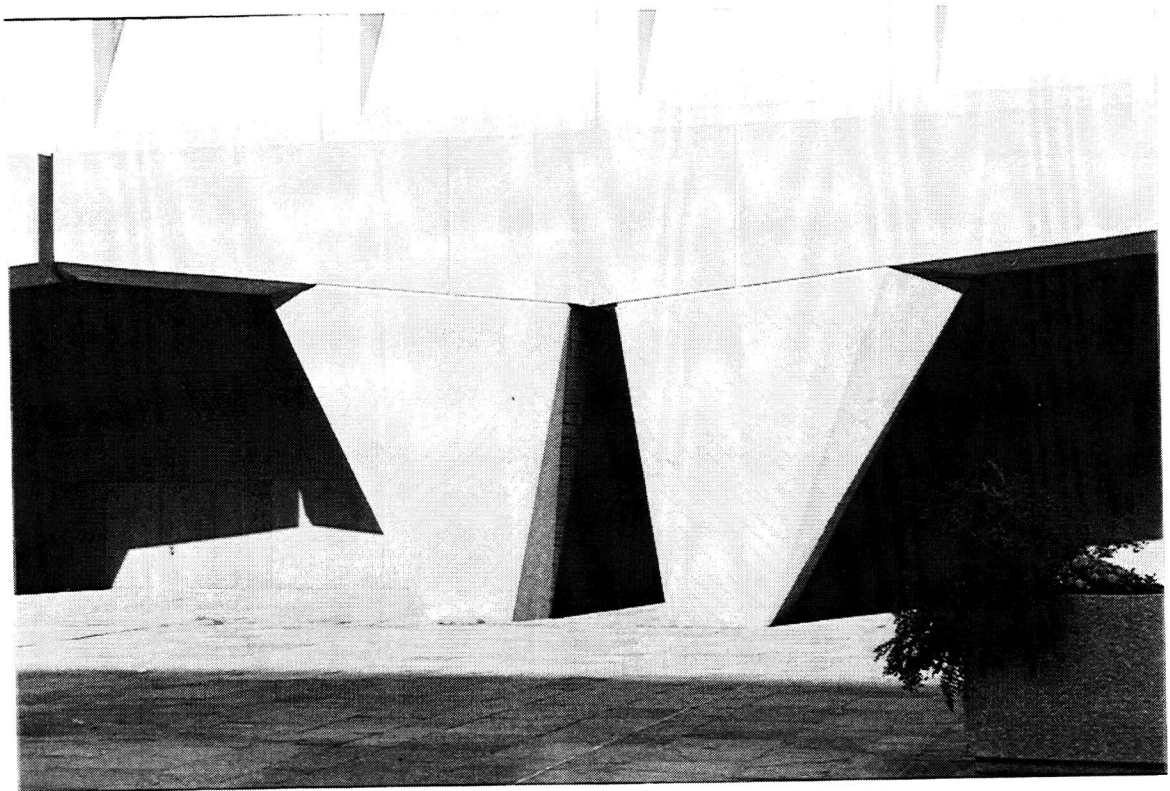
Illustration No. 4-11

Description: Detail of concrete tree column with granite facing on first floor underneath colonnade. The fronts of the pilotis, washed by rain, are clean and in good condition.

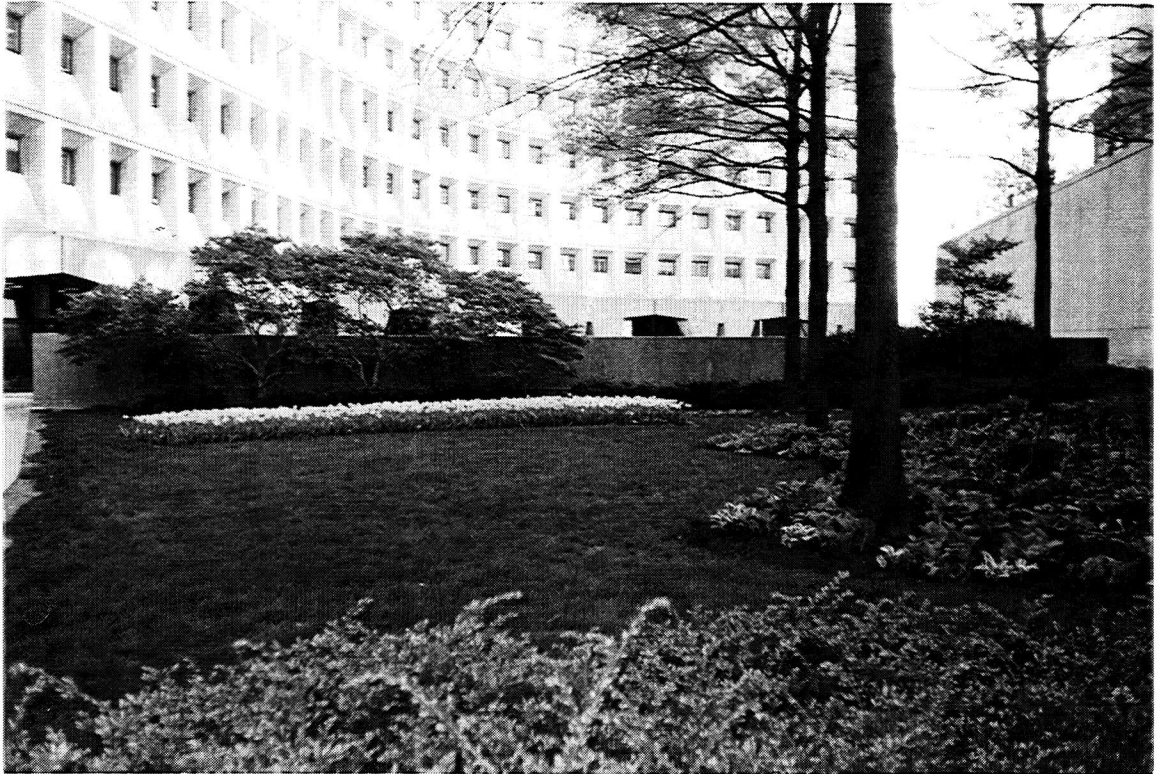
Illustration No. 4-19

Description: Landscaped area, looking south, which is similar to the original design intent, with grass covering the part closest to the building and willow oak trees staggered along the rear of the site next to the L'Enfant Plaza Building. Four of the trees had to be removed when the walkway to L'Enfant Plaza was added; three more were removed when the playground was installed. Small tulip magnolia trees along the retaining wall as well as additional shrubs and flowering plants have been added throughout as well as a sidewalk which bisects the area. The area is in excellent condition.

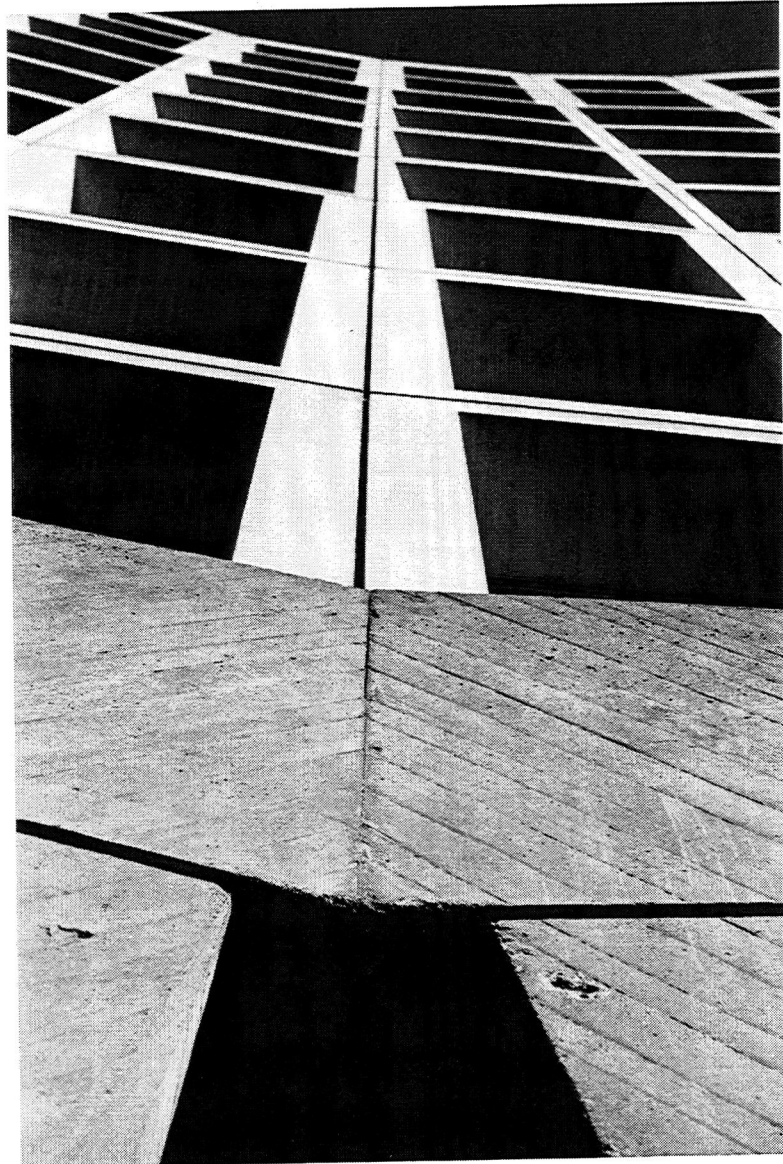
Illustration No. 4-23

Description: Facade detail looking up from top of pilotis on north end (see Illus. No. 3-52 for original photo). Note rust stains on face and underneath beams where pieces of metal in original formwork are rusting through. A small amount of honeycombing can be seen at the crotch of the pilotis.

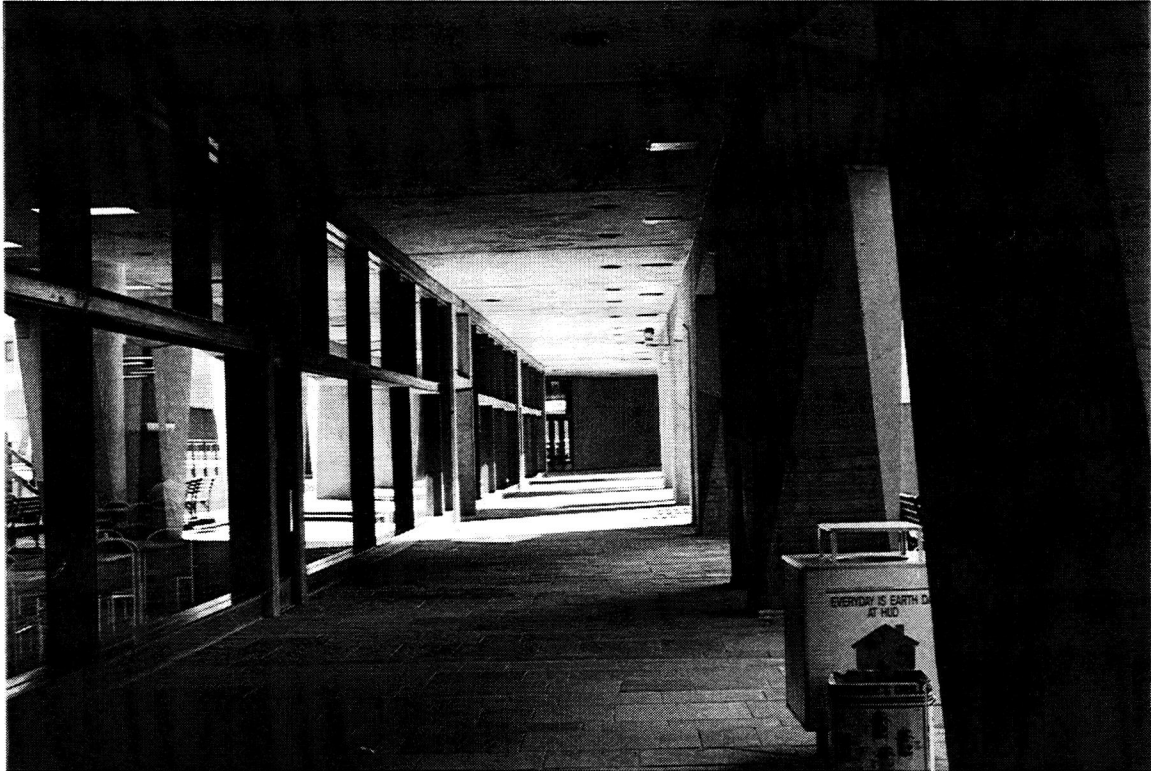
Illustration No. 4-25

Description: View looking south under colonnade with cafeteria on left and pilotis on right (compare with historic photo, Illus. No. 3-58). The three exterior entrances to the cafeteria can be seen, as well as the southwest entrance at the far end. All exterior doors are original, 1/4" clear flat polished glass set into black anodized finish aluminum frames with push bar panels with black anodized finish frames. The doors are in good condition but have been closed off. White cement plaster ceilings of the colonnade are soiled and stained, as are the insides of the concrete pilotis.

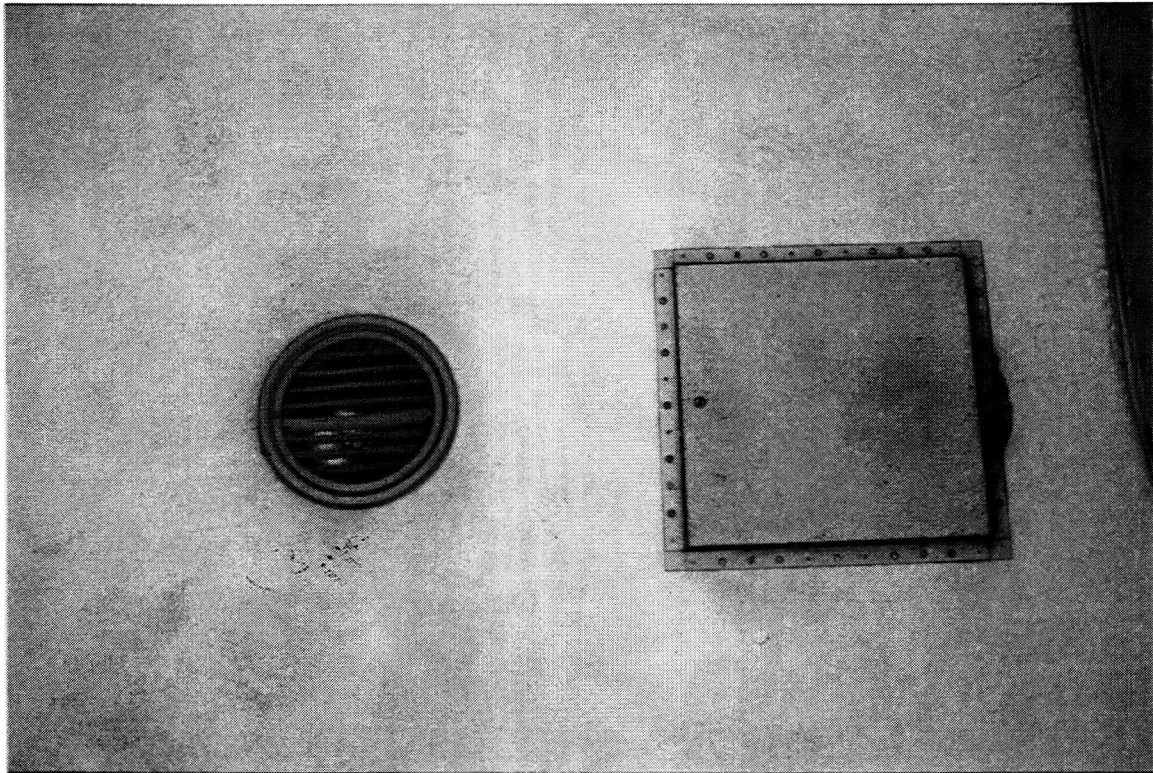
Illustration No. 4-26

Description: Detail of white cement plaster ceiling of first floor colonnade showing original light and access panel. Access panels are typically corroding; ceilings have stains and are soiled.

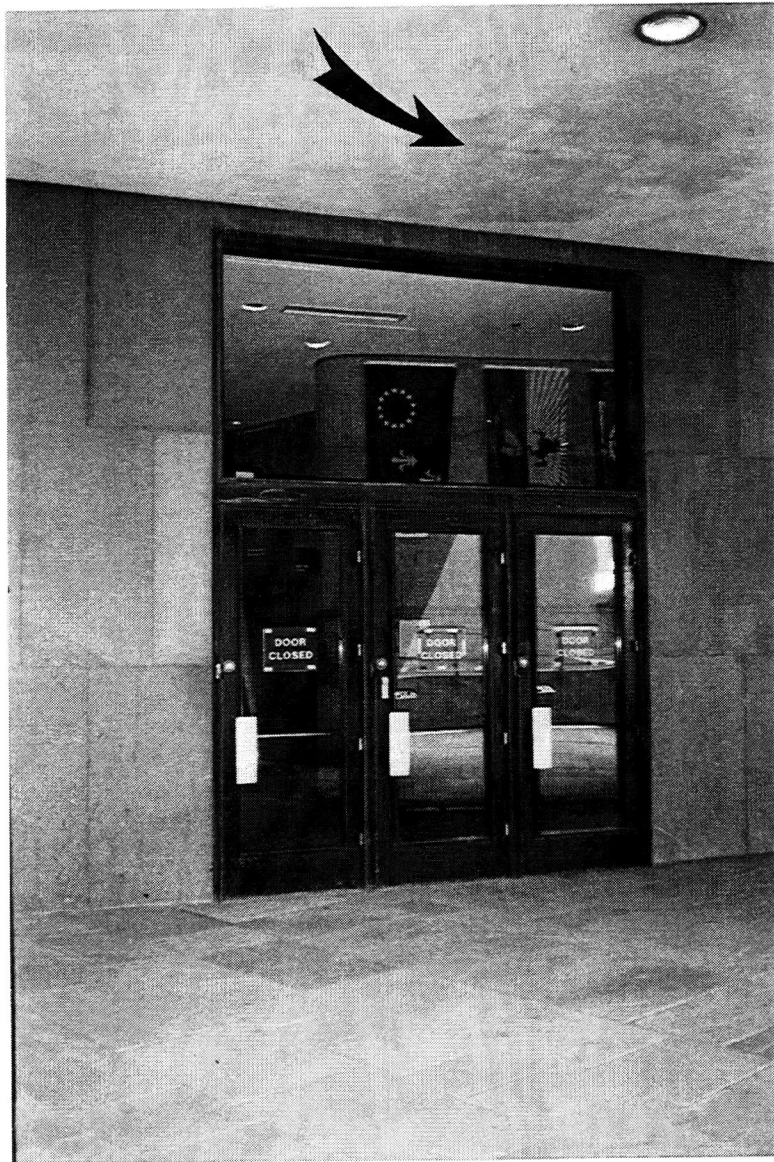
Illustration No. 4-27

Description: Southwest entrance, with three outswinging doors and glass transom above, which has been closed off. This entrance is the only one of the four main entrances into the building which has been unaltered, except for the "Door Closed" signs. Note staining on the white cement plaster ceiling above.

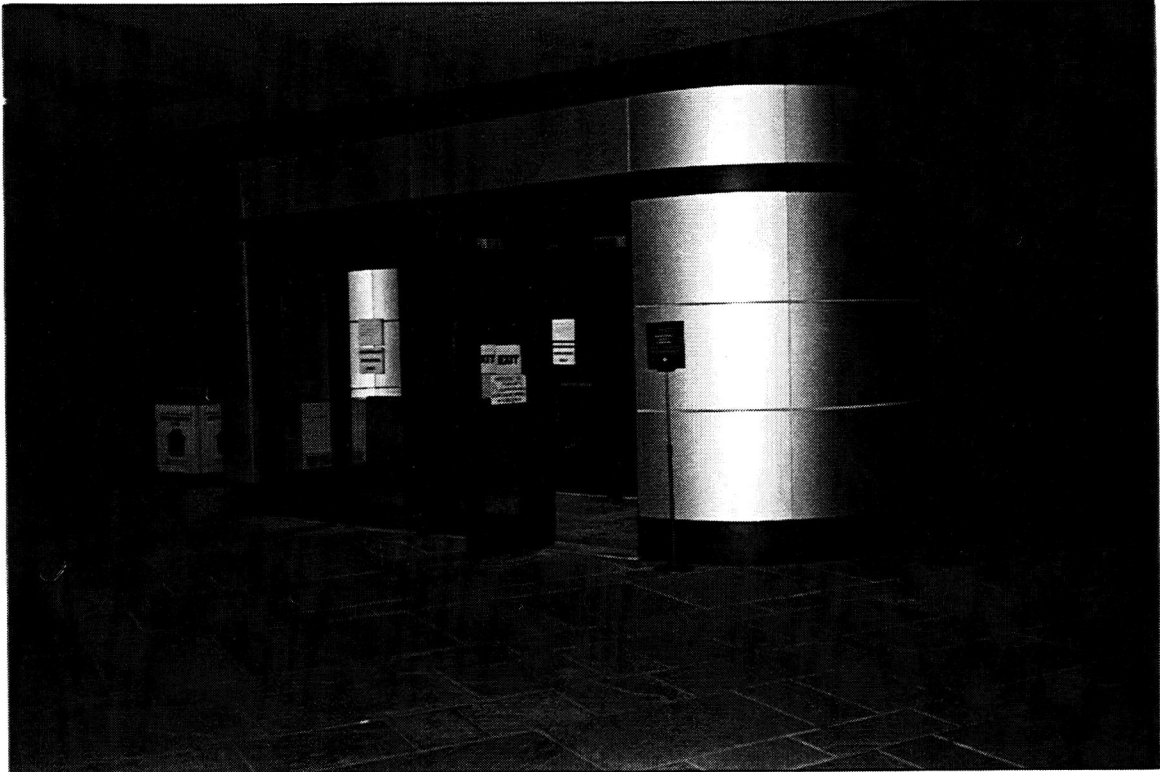
Illustration No. 4-28

Description: Northwest entrance, with recently added airlock vestibule. Original glass and black anodized aluminum doors on the inside have been removed and replaced with electric sliding doors; original glass transom above remains. The new vestibule, constructed of satin finish aluminum with a black base, includes glass side walls and oval shaped vestibule area with electric opening sliding doors.

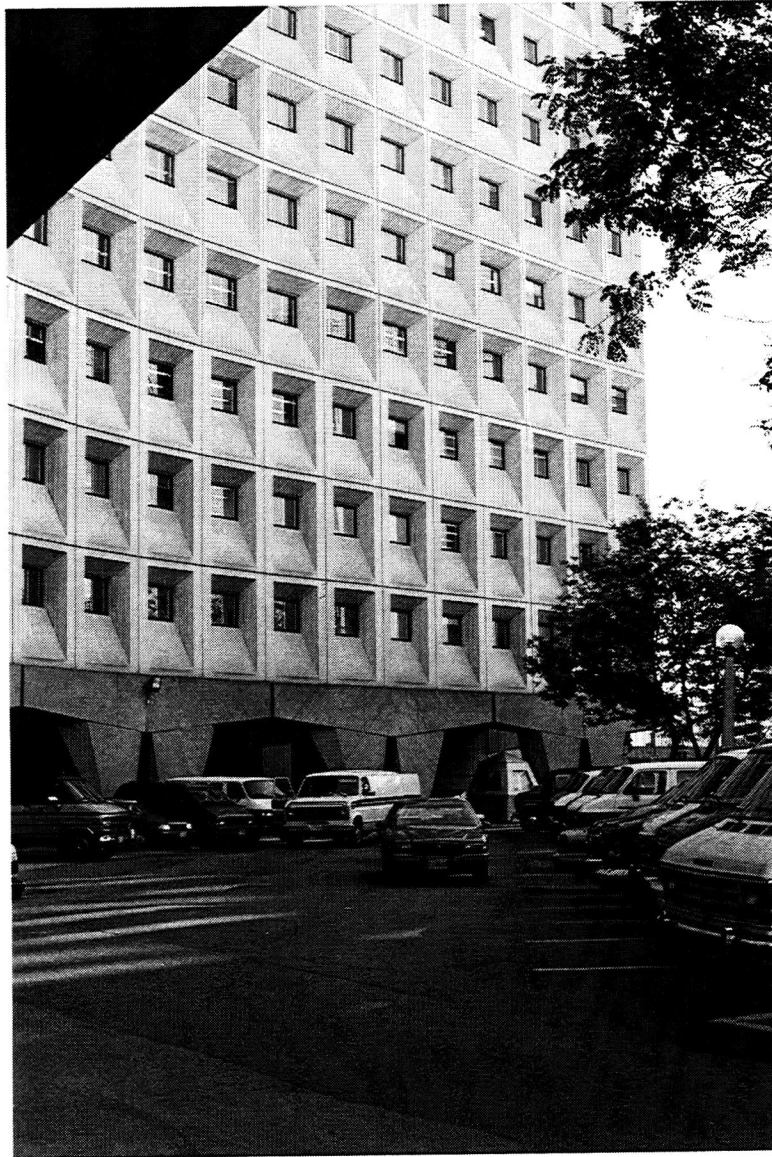
Illustration No. 4-30

Description: View looking west of parking area outside the building. Original concrete light standard remains in place, although light fixture has been replaced with clear glass globe. Spotlights have been added to the building on the beams above the pilotis. The parking attendant's booth, designed by Marcel Breuer and Associates, is of wood frame construction and is located under the pilotis on the west side of the elevation.

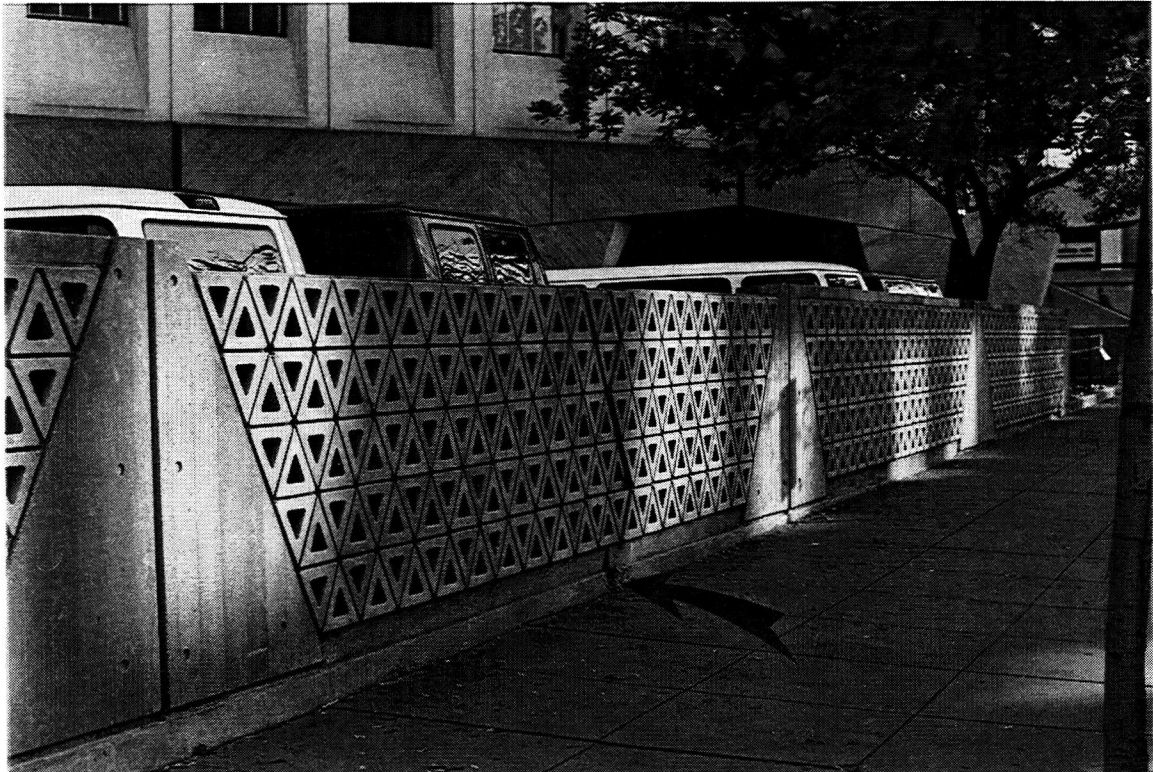
Illustration No. 4-31

Description: View of screen wall looking west. Note precast "bookend" walls on ends of walls, missing coping along top of wall, and the large crack which has developed on the base.

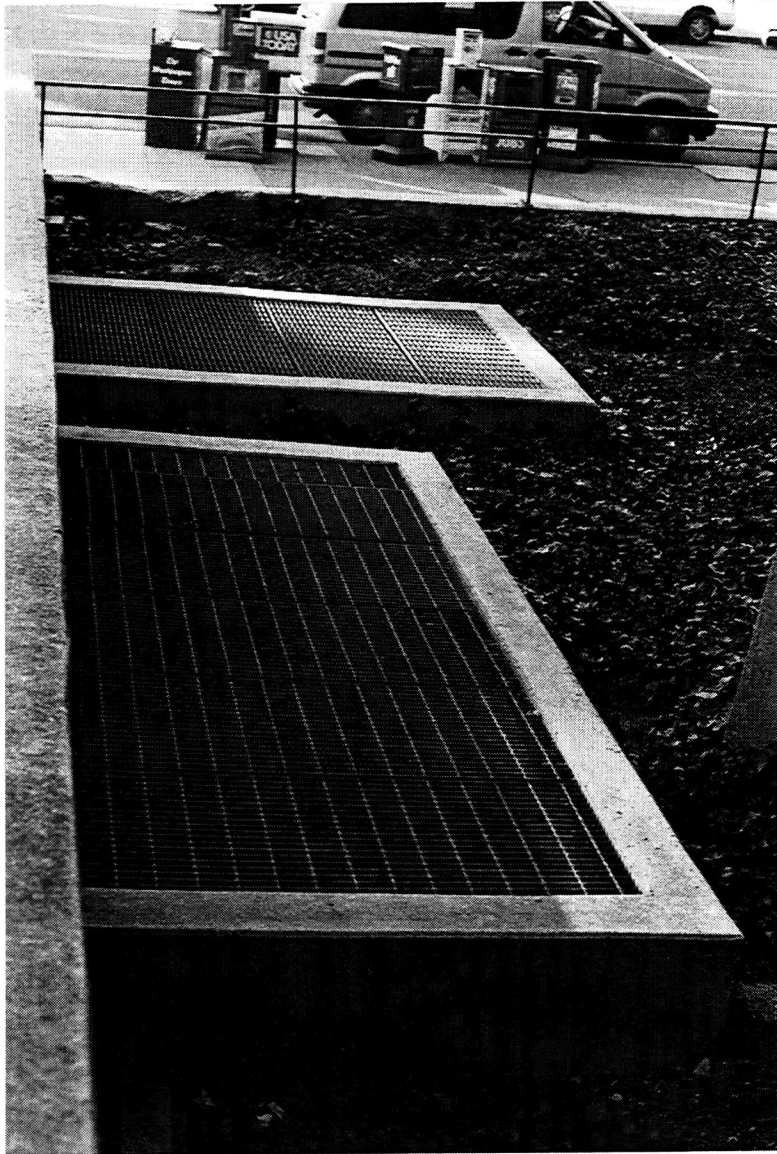
Illustration No. 4-32

Description: Building lighting pits under northwest corner of the stair tower. The vents on the pits are rusting and corroding.

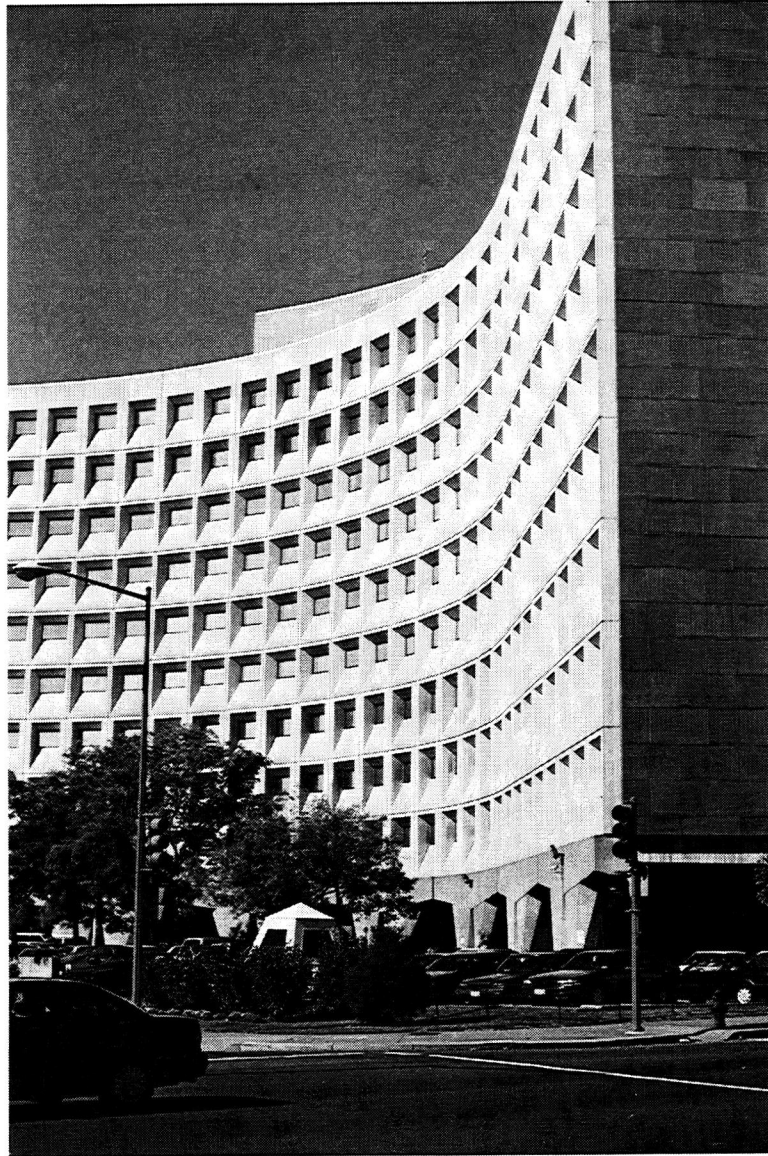
Illustration No. 4-35

Description: View looking west across Seventh Street with southeast granite faced end wall on right. Note staining below granite panels on end wall. The hexagonal shaped original parking attendant's booth, designed by Marcel Breuer and Associates, was replaced in 1988 and relocated in 1990, although it is believed the replacement booth was modeled on the original one in style and materials. Shrubs seen on the corner of the frontage road and Seventh Street were not in the original landscaping scheme. Non original light fixtures and signs have been mounted on the beams and pilotis of the building.

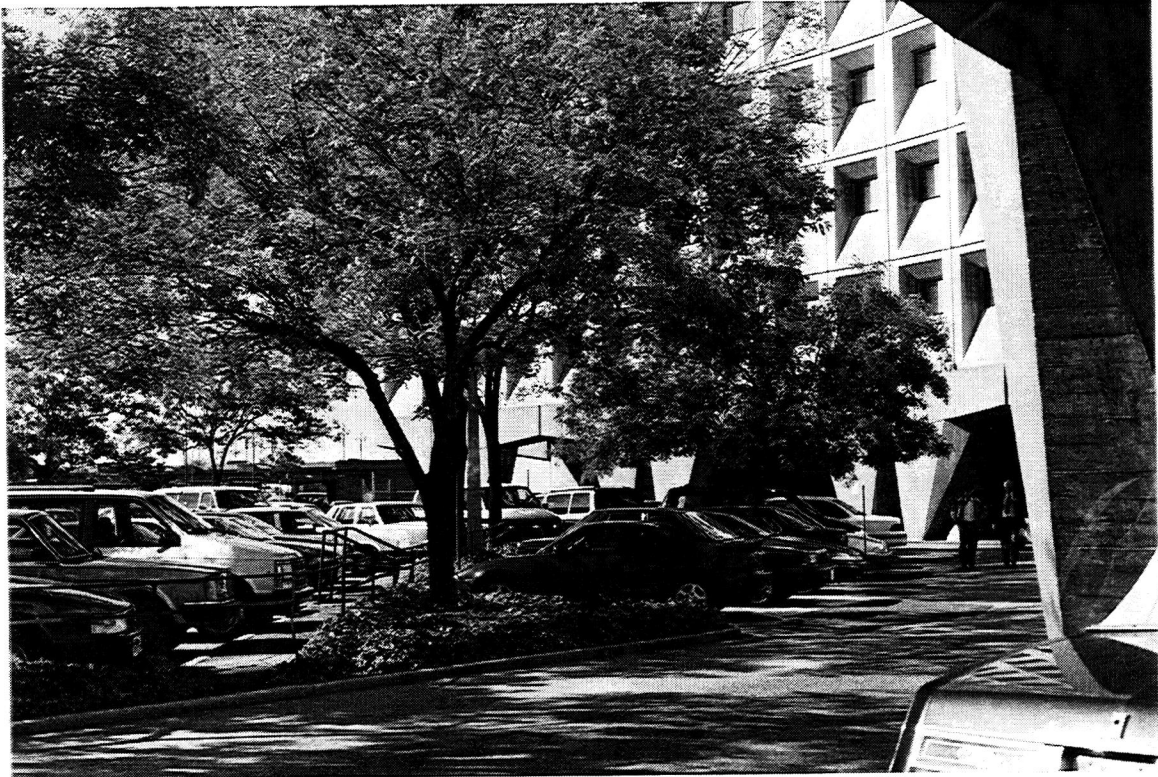
Illustration No. 4-36

Description: View looking west across parking area with five Japanese pagodas and English ivy on the central island. An original concrete light standard is in the center of the island with the original light fixture replaced by a clear glass globe. Metal railings have been added; these were not shown on the original drawings.

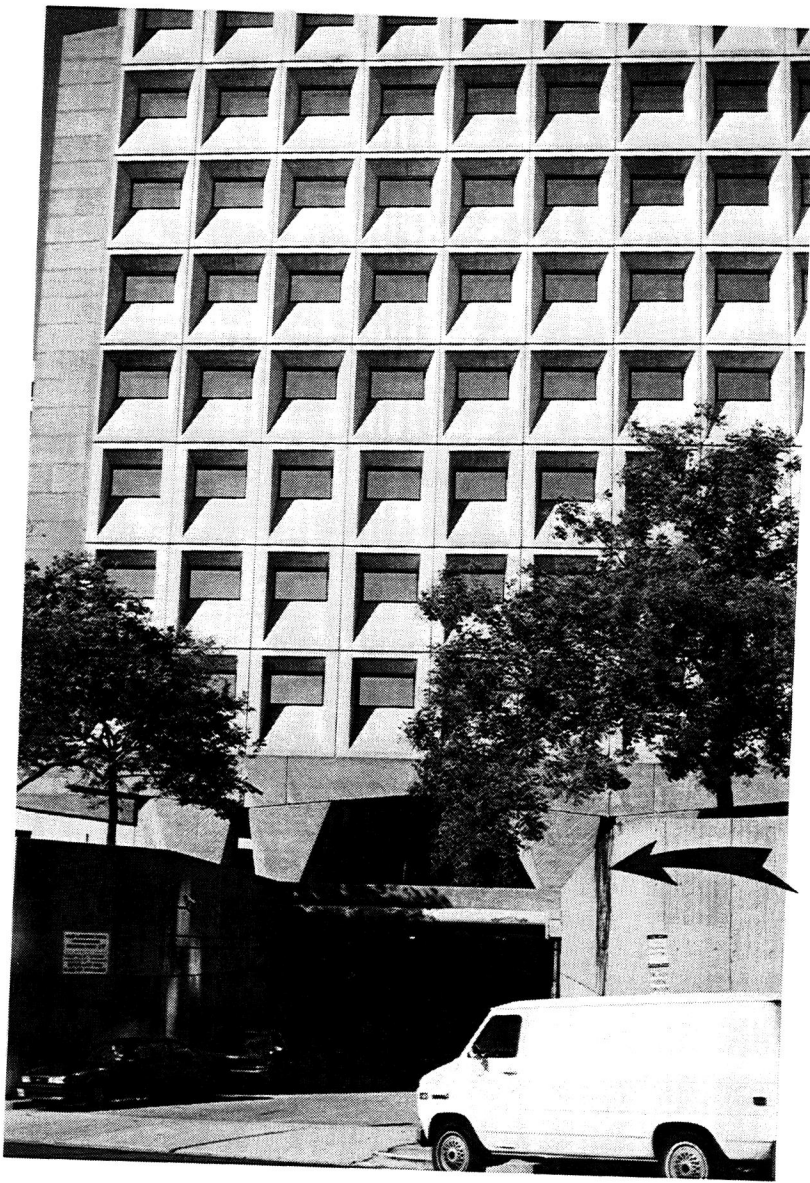
Illustration No. 4-39

Description: View looking north from frontage road along Southeast Freeway/I-395 at below grade loading dock entrance. The loading dock roll-up door was replaced in 1989. Note the large stain from a leak on the east wall and spotlights and conduit on the west wall.

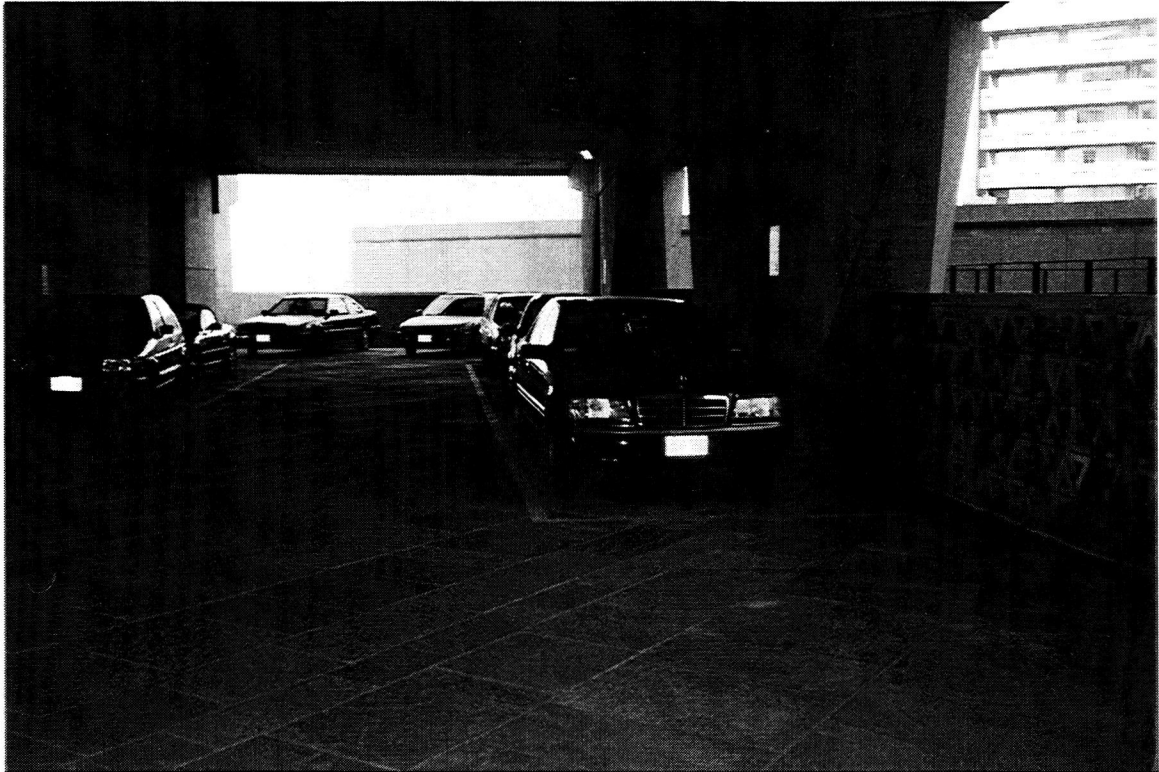
Illustration No. 4-40

Description: Southwest wing, under colonnade, showing parking area, new bluestone paving and original triangular concrete block screen wall, which is stained and dirty from automobile exhaust. Parking signs have been placed on the pilotis.

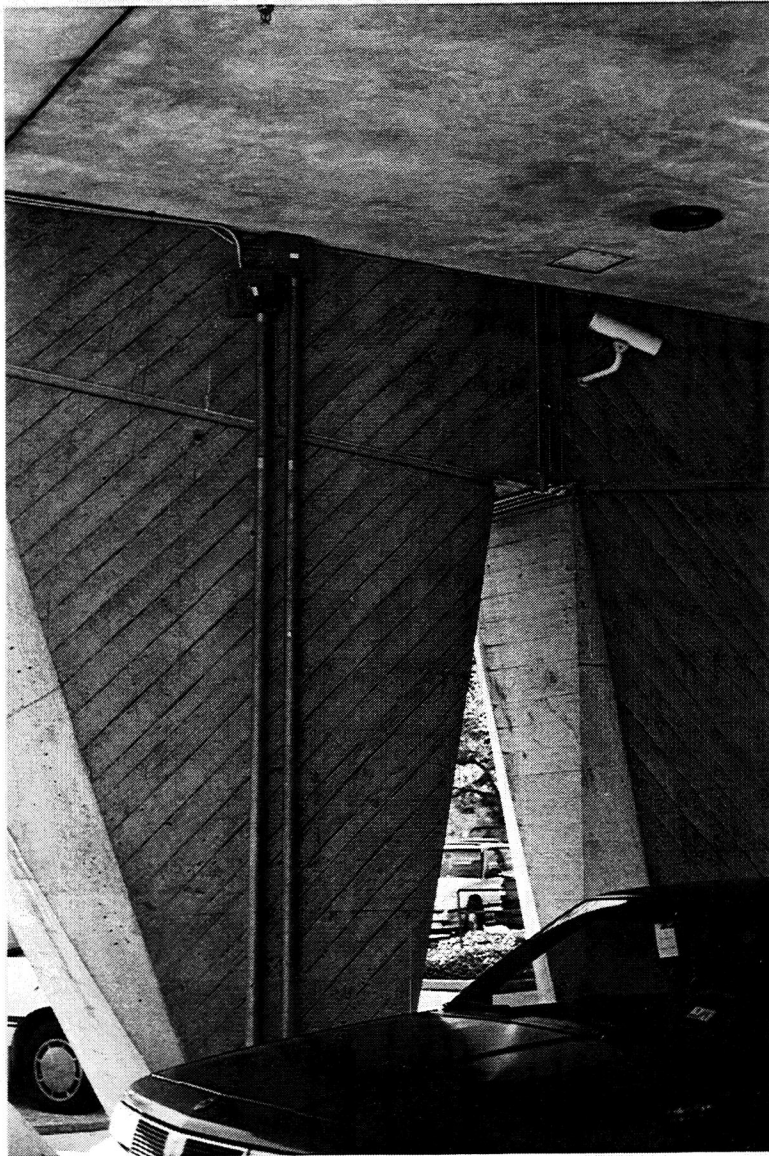
Illustration No. 4-41

Description: View under south end wall showing dirty white cement plaster ceilings, corroded access panel in ceiling, and conduit and light fixture added to inside of pilotis.

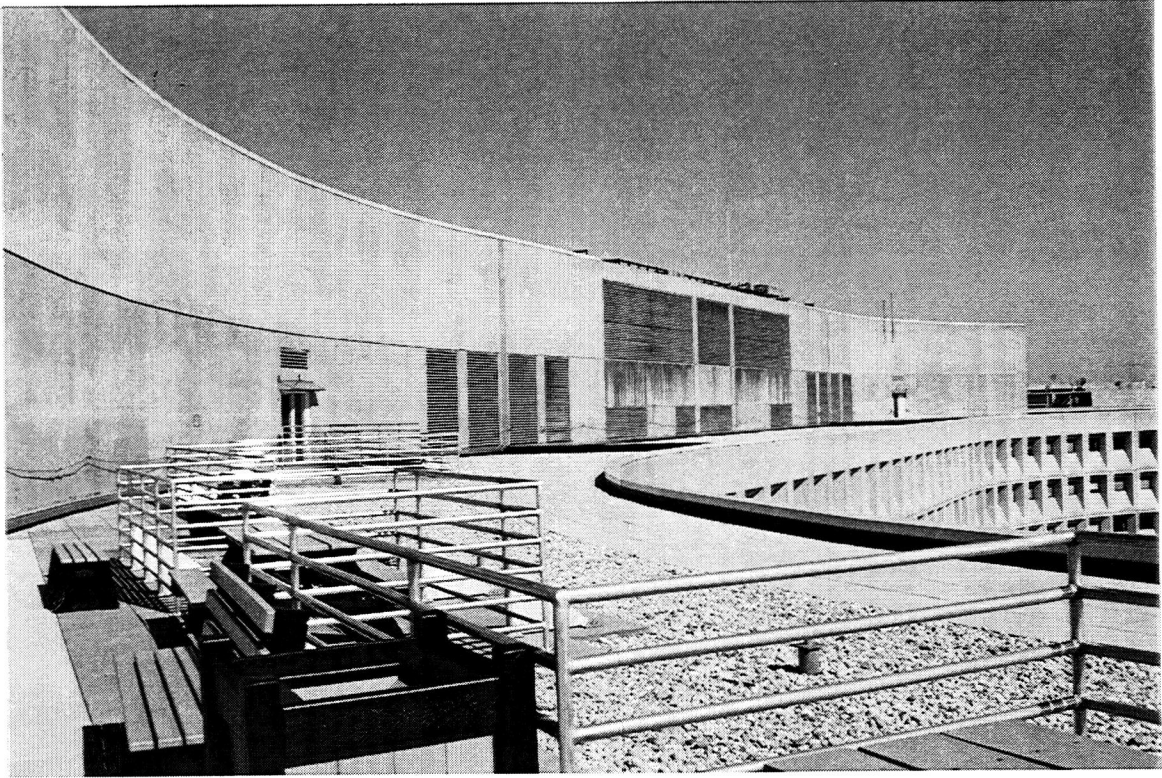
Illustration No. 4-42

Description: East side of penthouses, looking north from roof observation terrace. Note staining from exhaust below large aluminum mill louvers. The original roof terrace was built shortly after the building's completion in 1970 with redwood decking. It was removed and replaced in 1991 with 2'x2' concrete pavers.

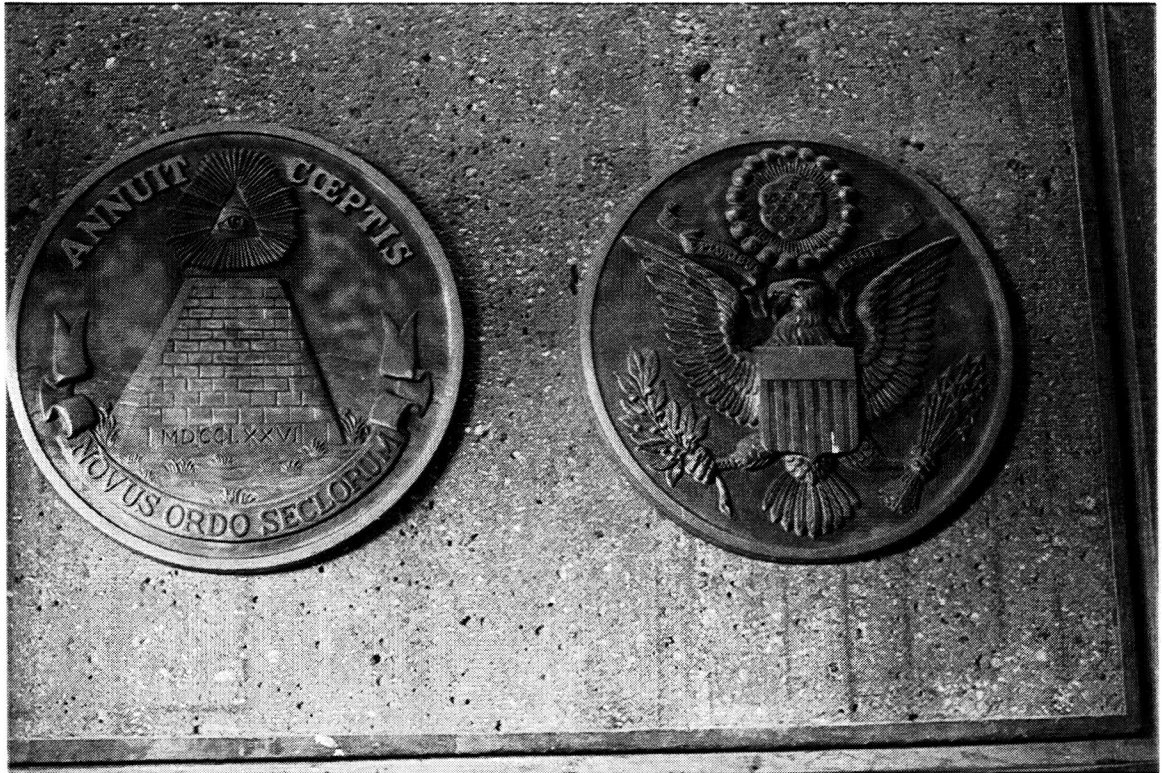
Illustration No. 4-46

Description: Original "Great Seals," constructed of natural anodized finish aluminum and located on the south wall of the vestibule of the main building entrance. The seals are in excellent condition.

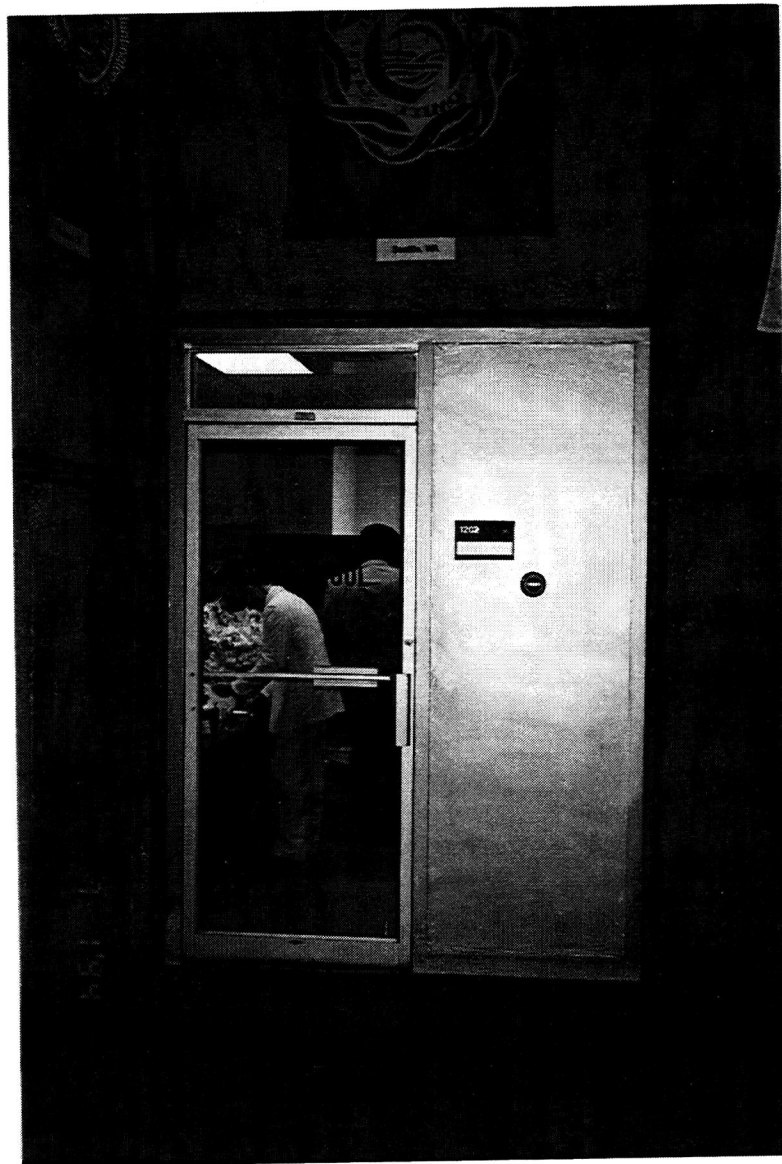
Illustration No. 4-48

Description: "HUD Motor Pool" entrance. According to original drawings, the original design intent was for the fixed panel to be a fixed glass and aluminum frame, however, during a construction, due to the location of a duct, a change was made to replace the glass panel with a fixed panel painted to match the surrounding frame.

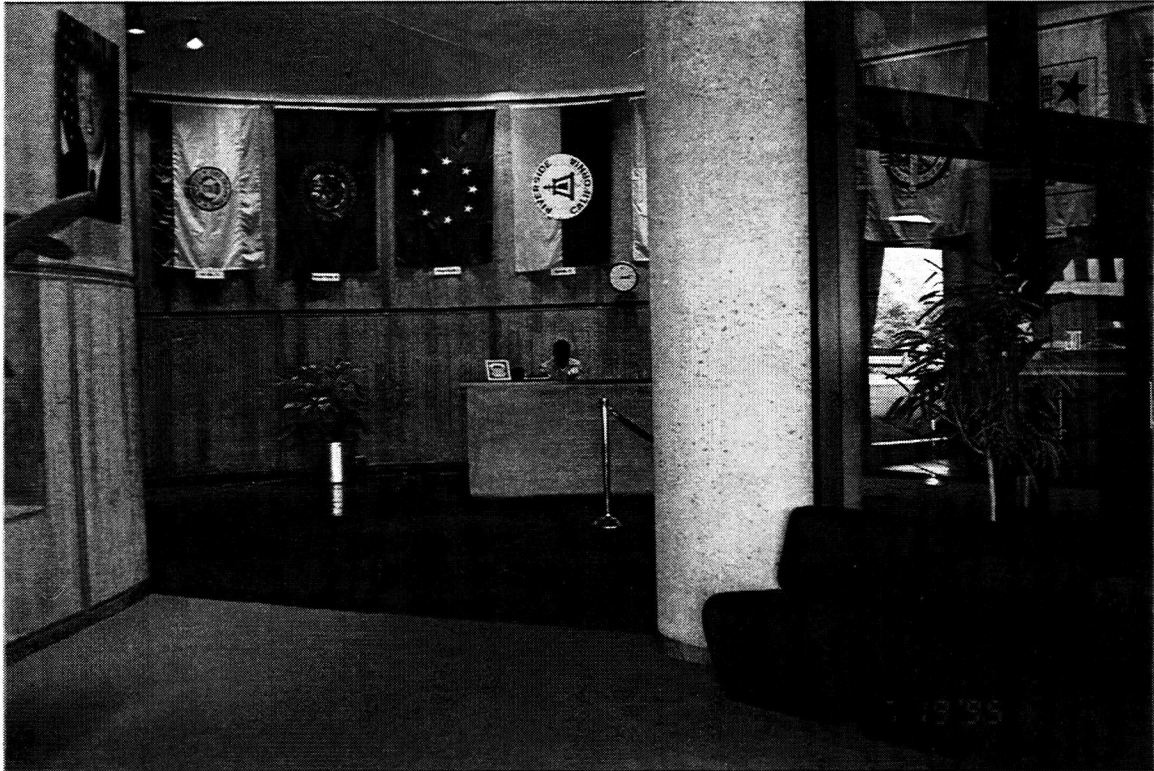
Illustration No. 4-50

Description: View looking north (compare with historic photo, Illus. No. 3-63). Bluestone paving has been coated with multiple coats of wax with wax splashed up onto recessed concrete wall bases; carpet runners have been added; bushhammered concrete walls are dirty; decorative flags have been hung from the ceiling; original white cement plaster original ceiling has been replaced with gypsum board.
