CHAPTER IV

EXISTING CONDITIONS SURVEY

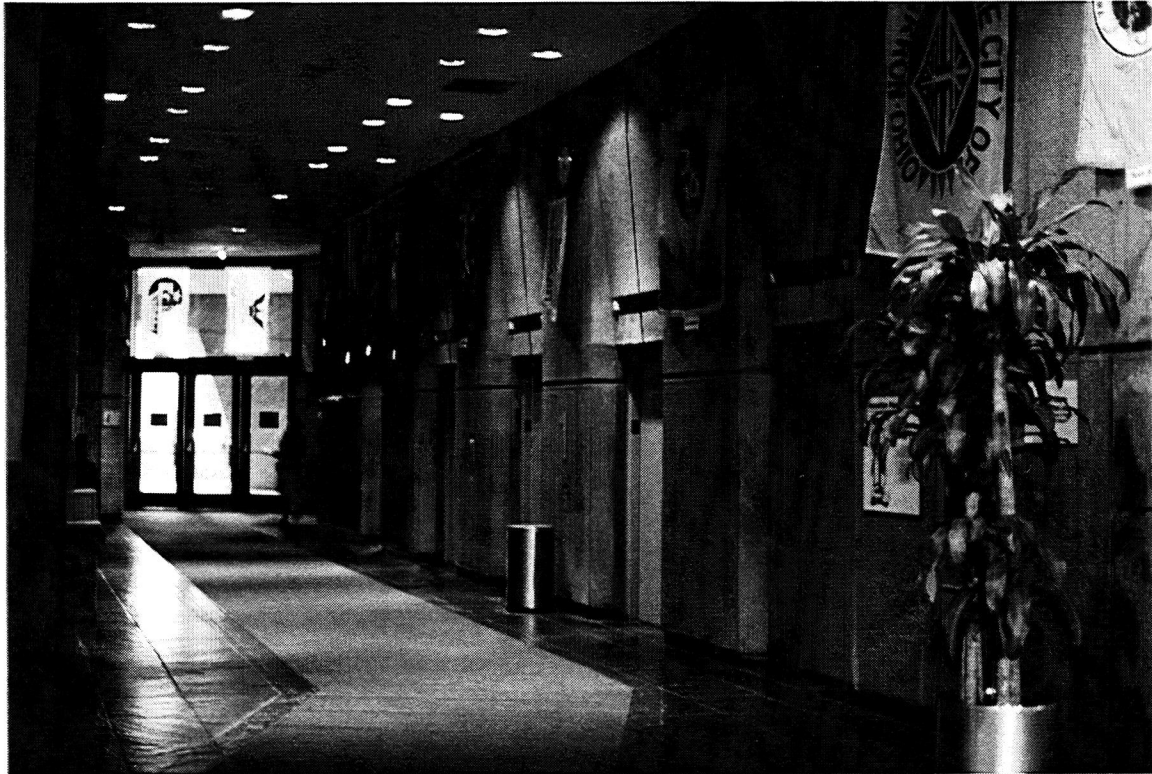
Illustration No. 4-51

Description: View looking west towards southwest entrance (compare with original photo, 3-57). Bluestone paving has been coated with multiple coats of wax with wax splashed up onto recessed concrete wall bases, carpet runners have been added, bushhammered concrete walls are dirty, original elevator "UP" and "DOWN" lights have been replaced with single UP/DOWN floor indicator signs, dark gray painted elevator doors and frames have been repainted light gray, decorative flags have been hung from the ceiling, original skeleton clock has been removed on south wall and receptacle covered with a flag, new clock has been added on north wall, original white cement plaster original ceiling has been replaced with gypsum board, wall hung ashtray has been removed and replaced with floor can, recycling bin has been added; and large silver numbers have been added to show the floor number ("1").

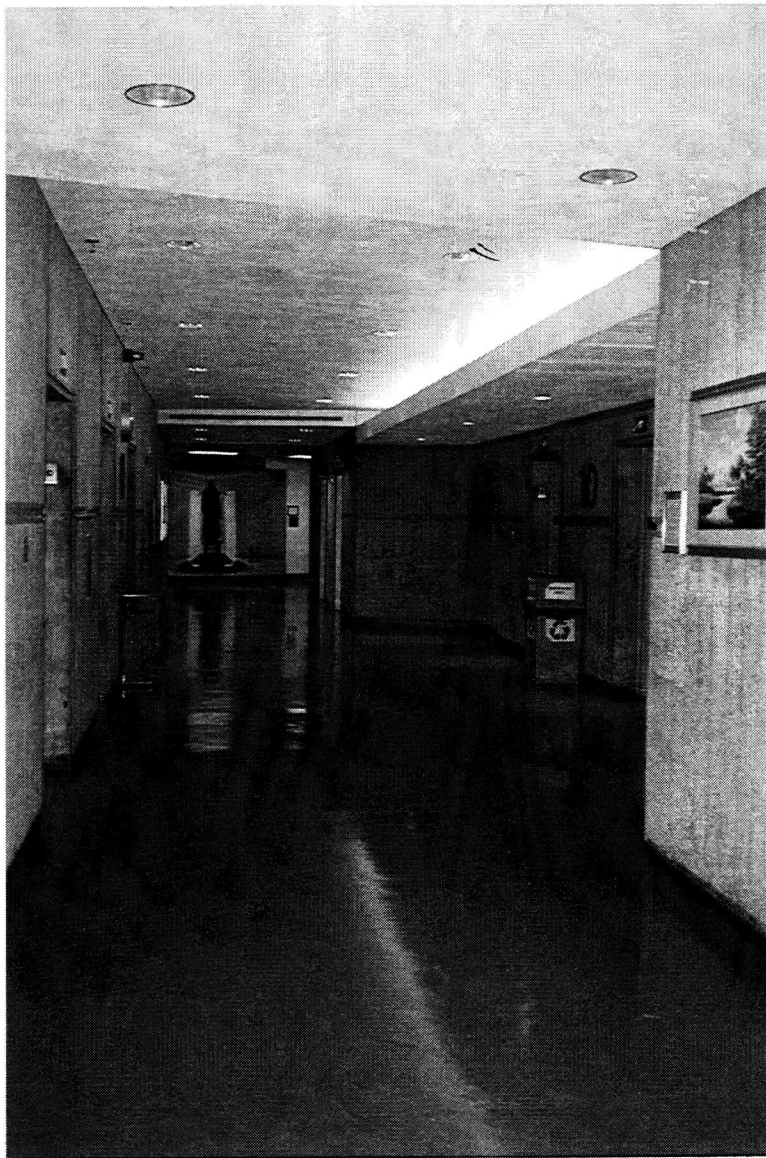
Illustration No. 4-55

Description: Typical upper floor elevator lobby looking west with original exposed concrete walls, 12" x 12" gray vinyl floor tile and photomural. Changes include replacement of plaster ceilings with lower gypsum wallboard ceilings during installation of a sprinkler system in 1991-1992, painting of exposed concrete soffit over north elevator bank, and addition of numbers to designate floor level. Concrete walls and recessed wall bases are soiled and stained. Recessed lights in gypsum board ceilings are new; recessed lights cast into the concrete soffit are original. New fluorescent lights have been installed above the concrete soffit to replace the originals.

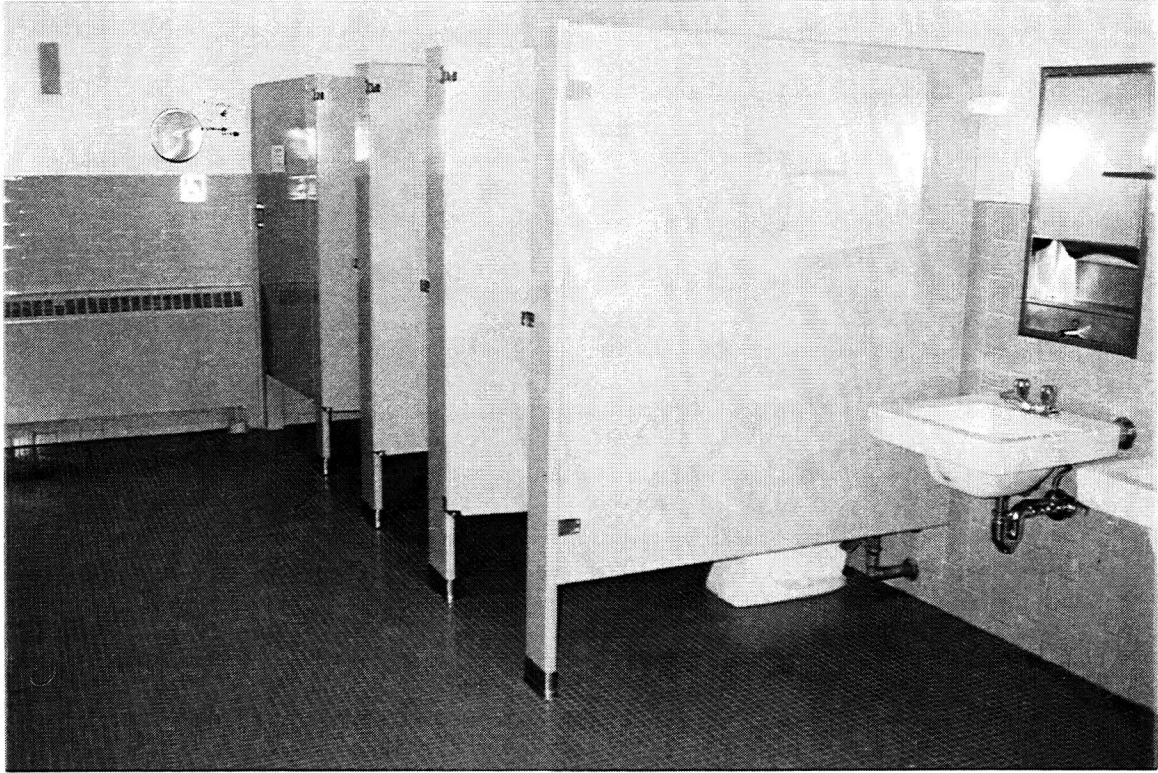
Illustration No. 4-56

Description: Typical first floor public toilet room with dark gray 1" x 1" unglazed ceramic tile floors with gray portland cement grout, 4-1/4" x 4-1/4" light gray ceramic tile walls set in a vertical ashlar pattern with white grout joints, steel enameled toilet partitions, white porcelain fixtures with wall hung sinks, and satin finish stainless steel accessories including mirror/paper towel/soap dispensers and in-wall trash receptacles, with last stall designed for handicapped access. Eggshell blue plaster walls were originally painted gray; toilet partitions were originally white.

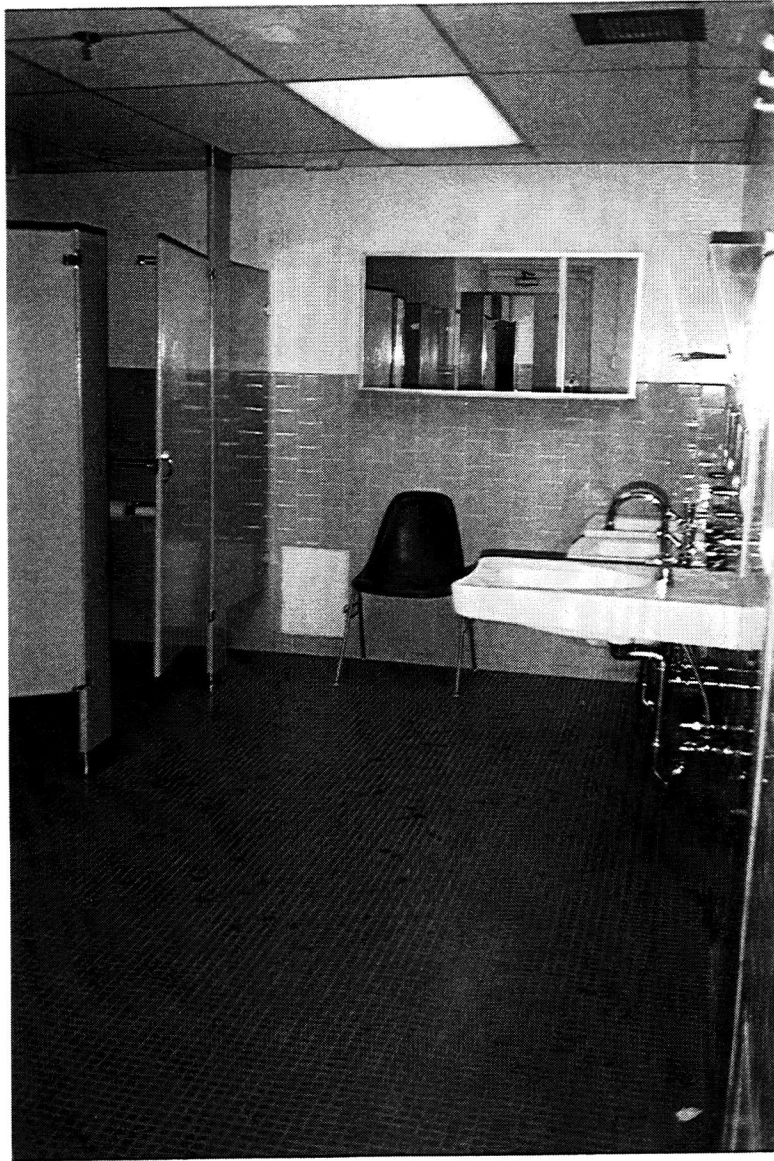
Illustration No. 4-57

Description: Typical public toilet room with original dark gray 1" x 1" unglazed ceramic mosaic tile floors, 4-1/4" x 4-1/4" light gray ceramic tile walls set in a vertical ashlar pattern, steel enameled toilet partitions, wall hung sinks, and stainless steel accessories. One pair of toilet rooms in each lobby have been made handicapped accessible: changes include removal of vestibule wall and modification of the last stall with rail bars and addition of a handicapped wall hung sink. Original plaster ceiling has been replaced with lay-in acoustical tile with recessed lights; eggshell blue plaster walls were originally painted gray; toilet partitions were originally white.

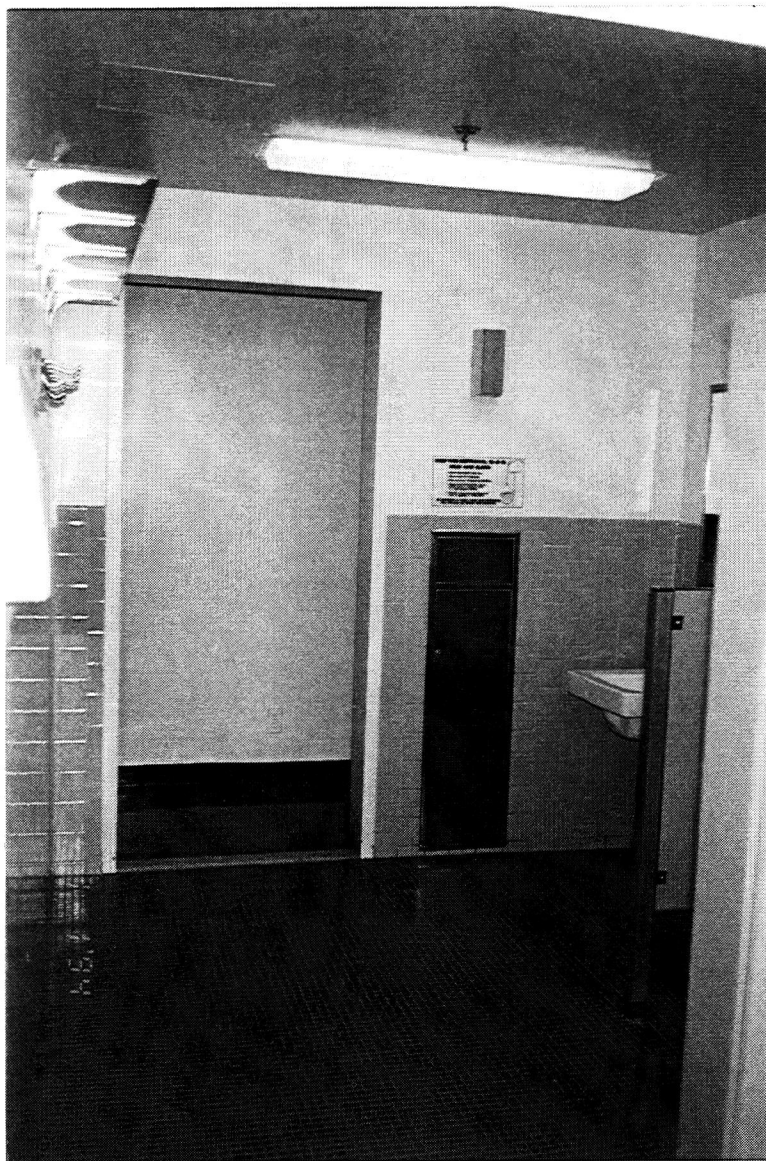
- Illustration No. 4-59
- Subject: Housing and Urban Development Building, Tenth Floor, South Elevator Lobby, Men's Toilet Room
- Date: July 1994
- Description: Typical men's public toilet room with gypsum board ceilings with original surface mounted light fixtures, vestibule wall, dark gray 1" x 1" unglazed ceramic mosaic tile floors, 4-1/4" x 4-1/4" light gray ceramic tile walls set in a vertical ashlar pattern, steel enameled toilet partitions, wall hung sinks and satin finish stainless steel accessories. This room has not been modified for handicapped access; it still has the vestibule with plaster wall leading into the toilet room. Changes to original fabric include the replacement of plaster ceilings with gypsum board during addition of sprinklers and changes in paint colors, from gray to white walls, and from white to blue toilet partitions.

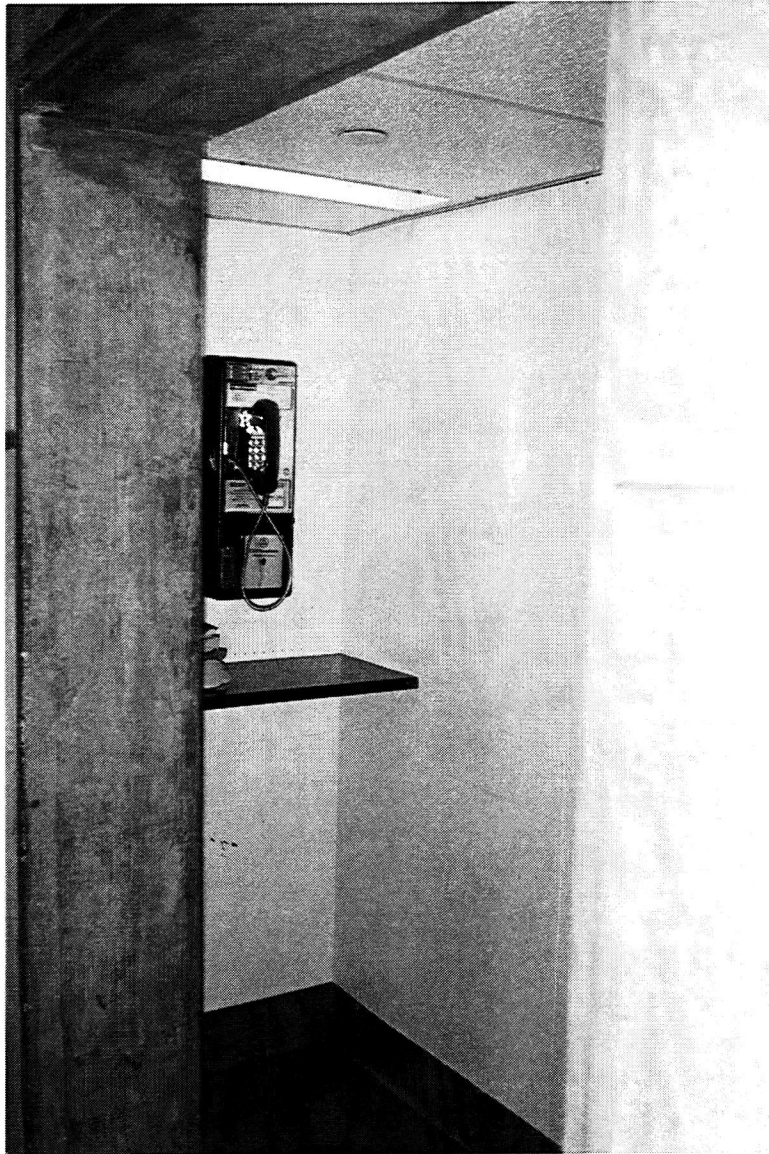
Illustration No. 4-60

Description: Typical telephone alcove with original pegboard walls, gray vinyl cove base and wooden formica shelf. Original plaster ceilings have been replaced with acoustical tile with recessed lights and shelves, originally specified to be "Oxford Gray," have been replaced.

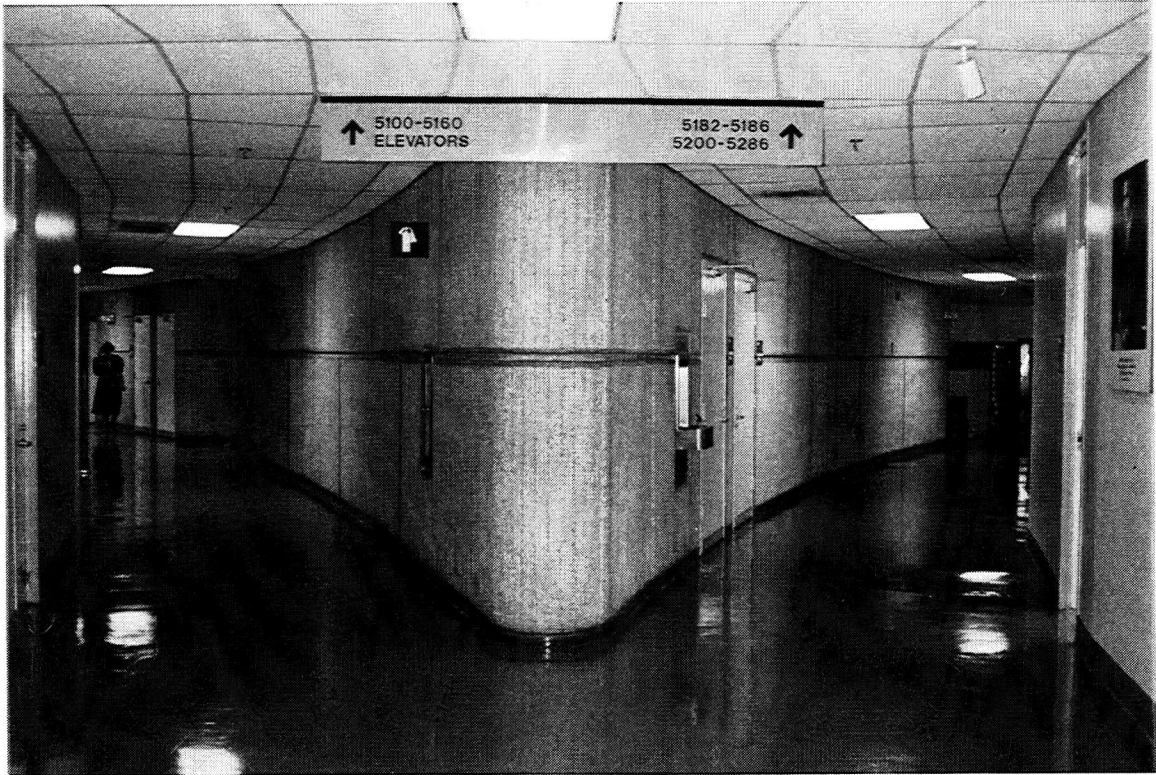
Illustration No. 4-61

Description: Typical office corridor looking south towards north core area showing original exposed concrete walls, original gray vinyl asbestos floor tile, service doors, drinking fountain and fire extinguisher. Changes include painting service doors silver, replacement of original splined acoustical tile ceiling with surface mounted fixtures with new acoustical tile ceiling with recessed light fixtures. Color coded wall hung room number signs have been added to orient visitors and employees, as well as signs marking telephone alcoves, fire extinguishers, etc.

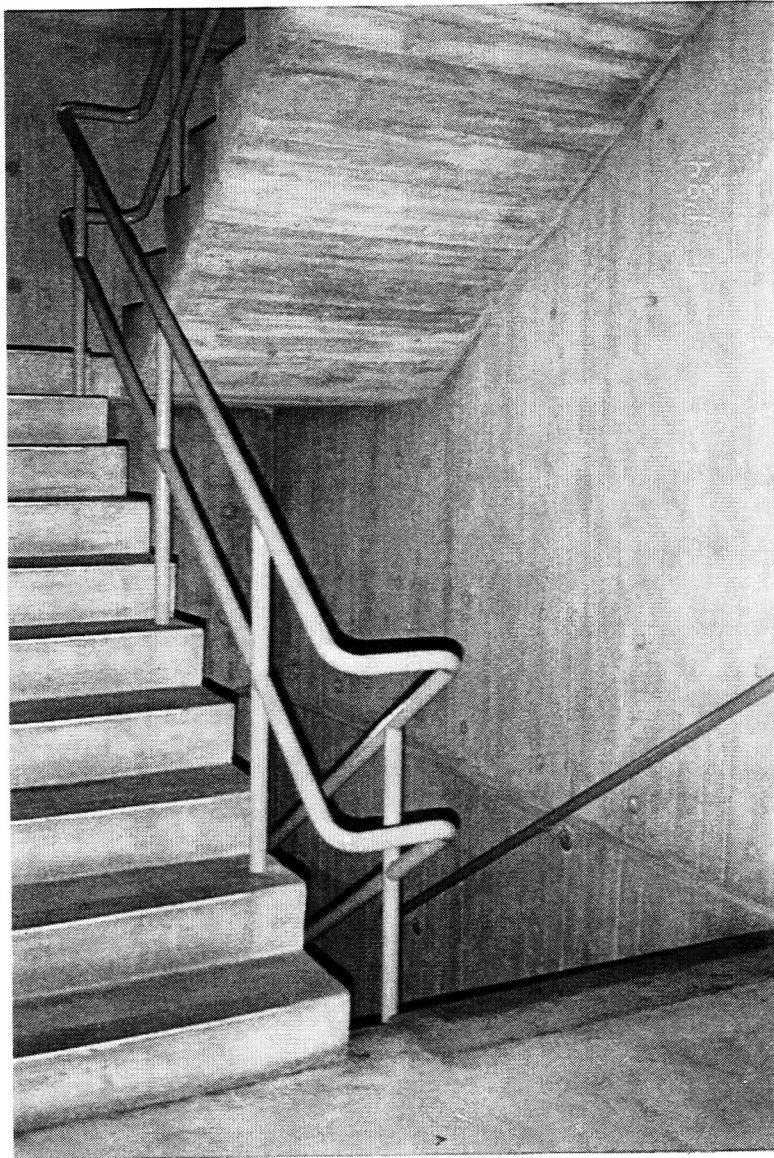
Illustration No. 4-64

Description: Typical end stairwell with exposed concrete walls with vertical formwork marks, concrete treads, risers and landings, painted metal piperails and balusters on the inside of the stairs and painted metal piperail supported by brackets on the outside walls. The stairwells are in good condition except that sealant from the floors has been splashed up onto the wall bases, treads and risers.

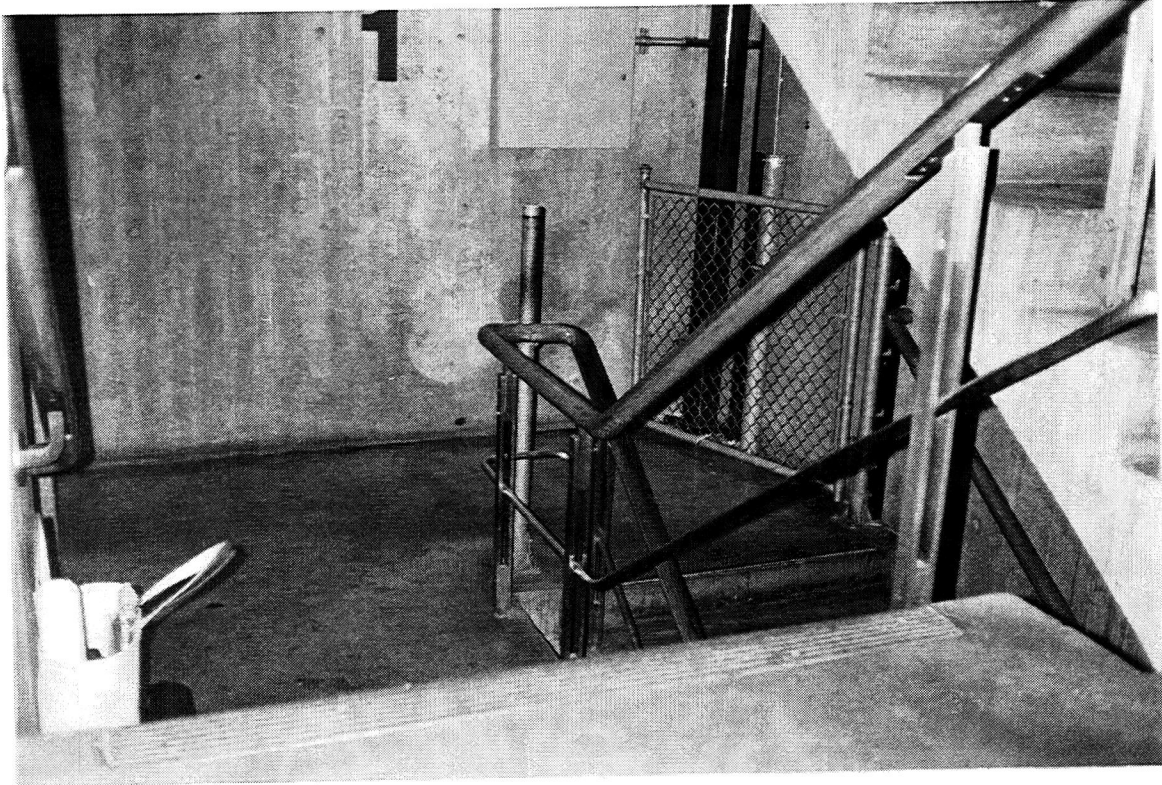
Illustration No. 4-65

Description: Typical core stairwell with concrete walls with vertical formwork marks, concrete treads, risers and landings and stainless steel railings with varnished white oak handrails. Numbers designating floor level have been added, as well as fencing and other mechanical/electrical devices. The stairwells are in good condition except that sealant from the floors has been splashed up onto the wall bases, treads and risers.

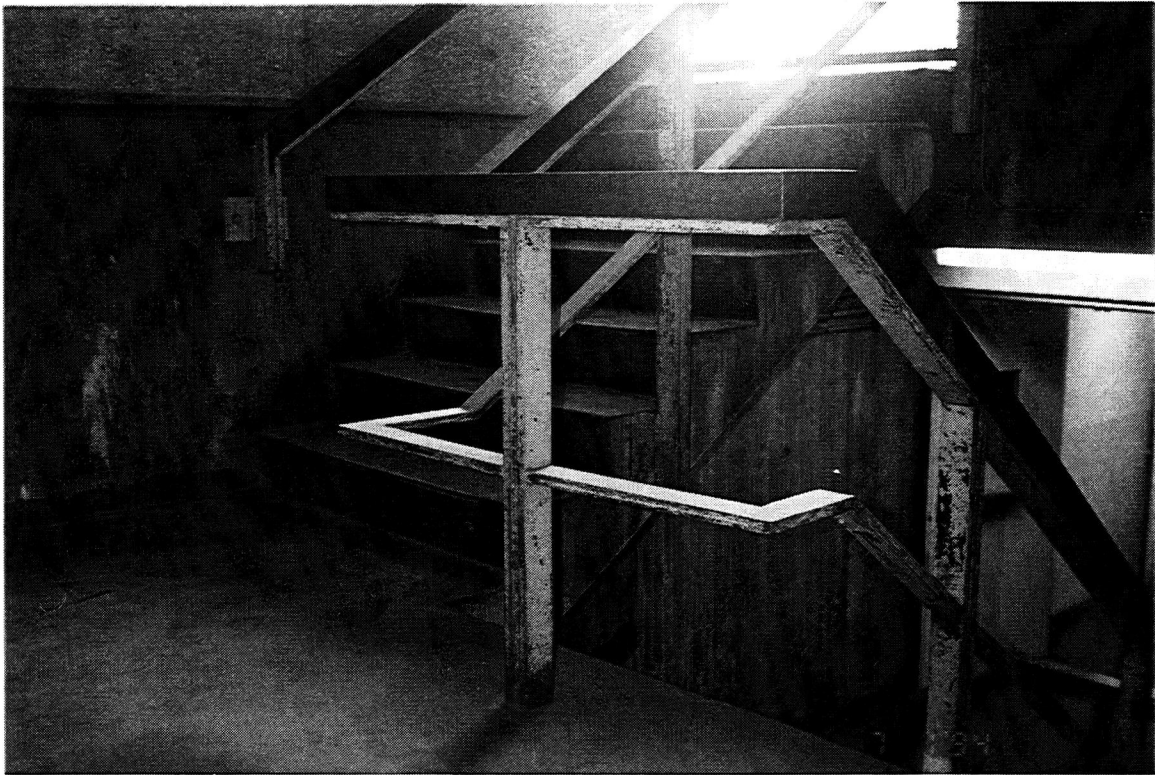
Illustration No. 4-66

Description: View looking up at plaza exit (locked) and down to basement level, leading from basement to garage at north end of building. Concrete walls are bushhammered at plaza level with vertical formwork marks below. Railings on both inside and outside are steel with a varnished square cherry handrail. The stairways are in poor condition: walls are stained and dirty, with sealant from floors splashed up. Steel railings are corroding and cherry handrails are dirty and have a worn finish.

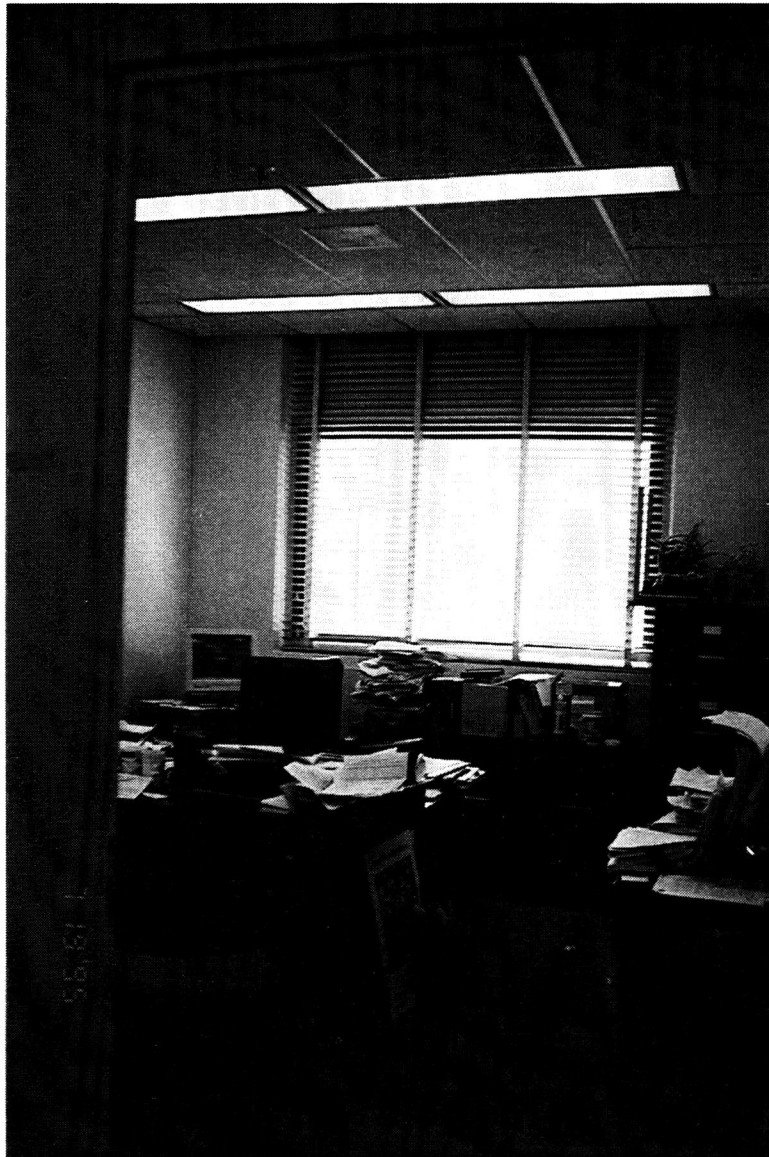
Illustration No. 4-67

Description: Typical office space. Floors have 12 inch carpet squares covering concrete floors with 4 inch high gray cove vinyl bases. Exterior walls are plaster with black anodized aluminum window frames and plate glass with original 2" wide gray Venetian blinds over window, and original metal wall panel with grill and access panel below window. Changes include new carpeting, replacement of gray Venetian blind tapes with white ones and replacement of original splined acoustical tile ceilings and 8 foot long fluorescent lights with 2' x 2' or 2' x 4' lay in acoustical tile ceiling with energy efficient fixtures.

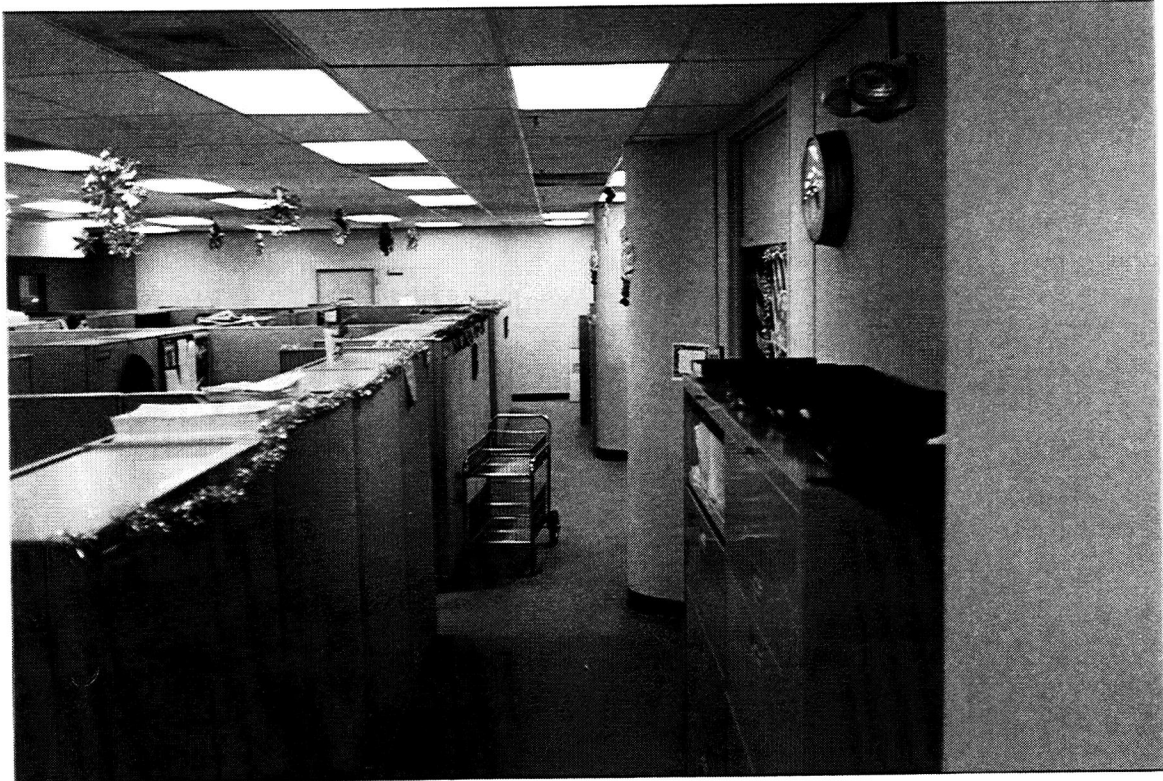
Illustration No. 4-68

Description: Original location of Staff Dining Room, which no longer exists and has been converted to general office space. Note plaster pilaster column covers similar in design to cafeteria dining room below, plaster walls and 4 inch gray cove base. The room originally had 12" x 12" gray vinyl asbestos tile, similar to the rest of the building. Changes to the space also include new carpeting and replacement of original splined acoustical tile ceilings and 8 foot long fluorescent lights with 2' x 2' or 2' x 4' lay in acoustical tile ceiling with energy efficient fixtures during sprinklering of the building.

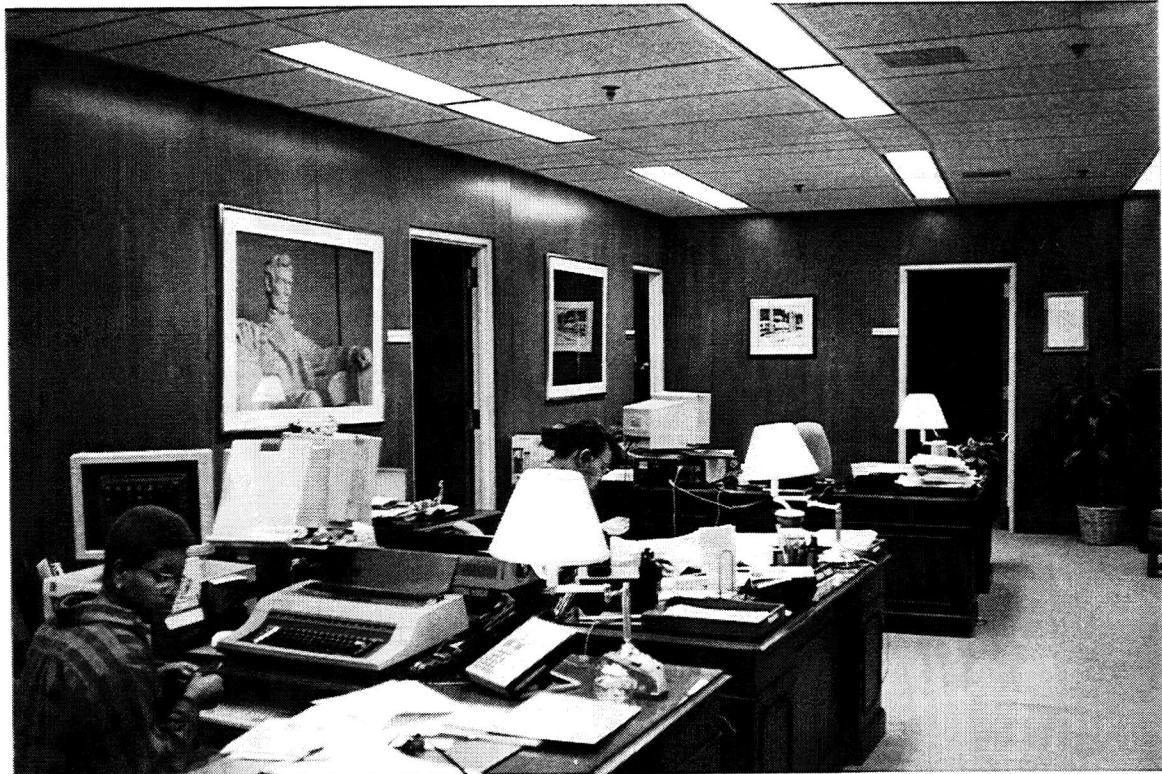
Illustration No. 4-70

Description: Reception/office area in typical Executive Office Suite (#4100-#9100), located behind south elevator lobby core area. Original American White Ash plywood paneling remains on the walls, as does original birch doors which were stained to match the ash paneling. New 12" x 12" rough finish acoustical tile ceilings have been installed, during sprinklering of the building as well as new roll carpeting.

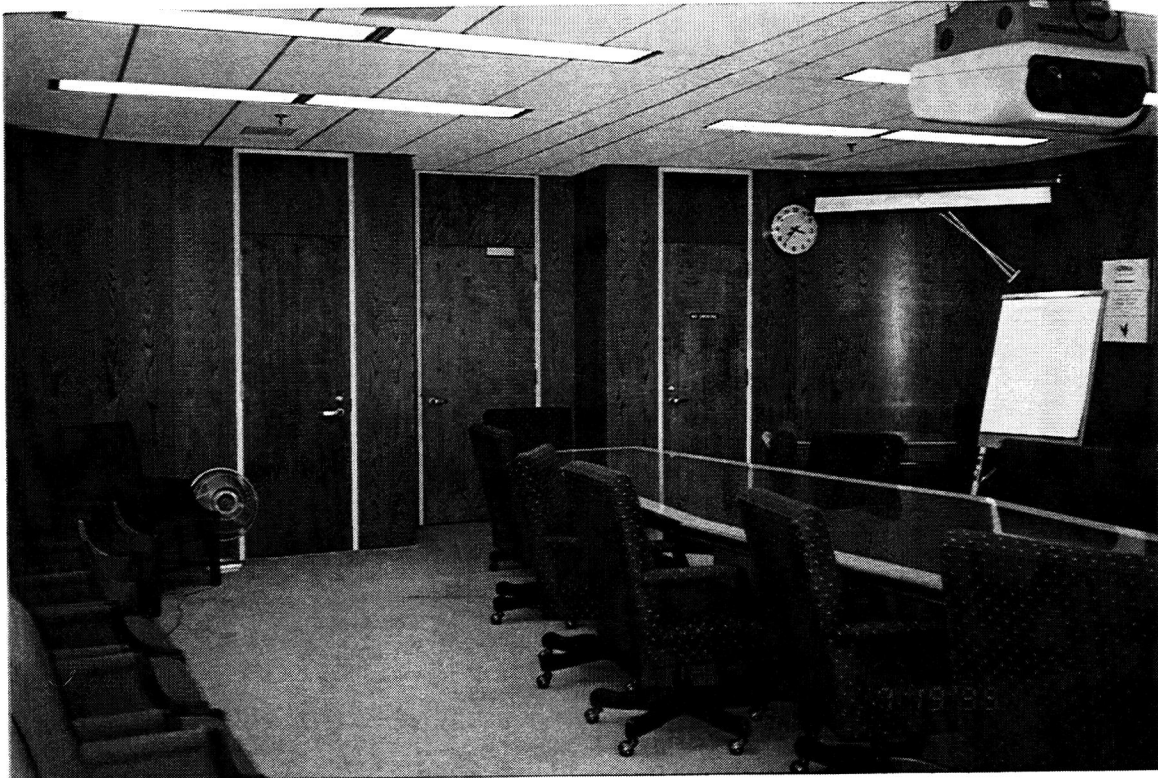
Illustration No. 4-72

Description: Large conference room in typical Executive Office Suite (#4200-#9200), located behind south elevator lobby core area, with entrance from executive office on east and from main corridor. Interior walls are paneled in American Ash plywood paneling with interior curved corners. Interior birch doors were originally stained to match the ash paneling. Original carpeting and drapes have been replaced, as has original rough finished splined acoustical tile ceiling. Exterior plaster walls include black anodized aluminum window frames with original 2 inch wide gray Venetian blinds over windows and original metal wall panel with grill and access panel below.

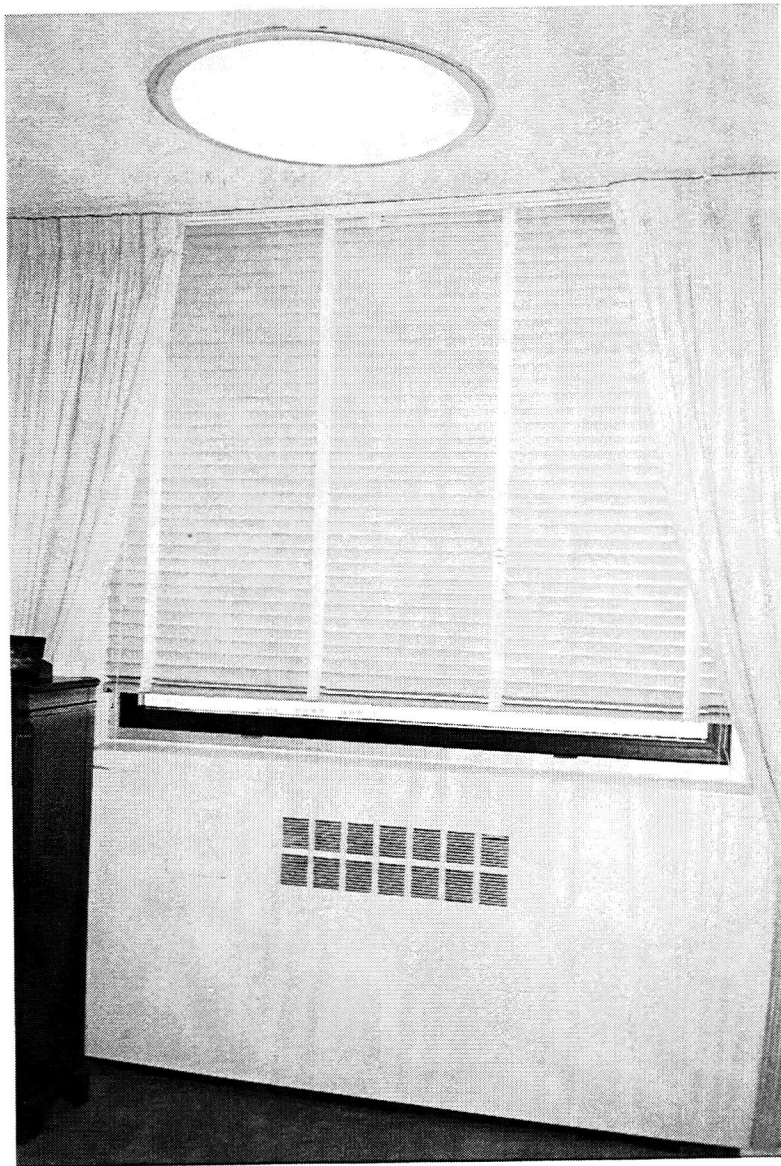
Illustration No. 4-73

Description: Exterior wall in typical Executive Office Suite with window with original 2" wide gray Venetian blind over window, original metal wall panel with grill and access panel, carpeted floor, and original recessed 30-3/8" diameter acrylic dish light fixture which had six 30-watt fluorescent lamps mounted above. Acoustical ceiling tiles were replaced during installation of a sprinkler system and gray tapes on the blinds have been replaced with white ones.

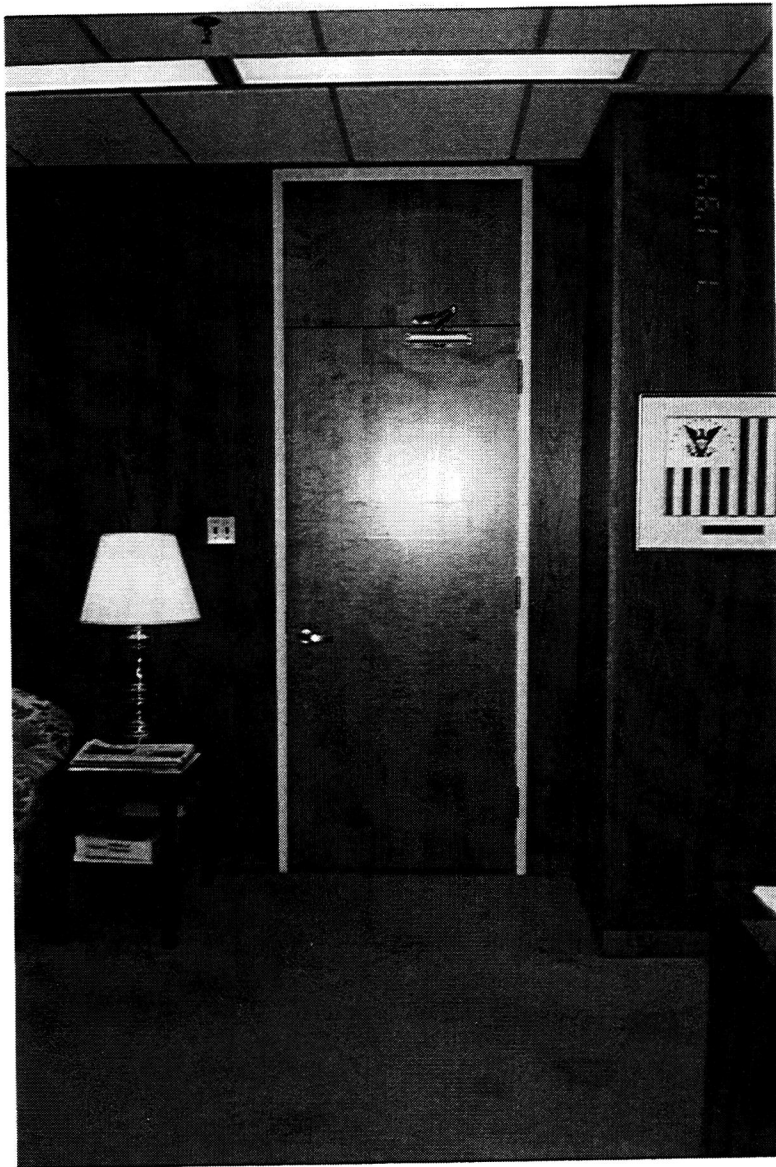
Illustration No. 4-75

Description: Reception area in typical Executive Office Suite. Original ash plywood paneling has been stained and darkened. The birch door and transom, which were originally intended by the architects to be painted white or black, were originally stained to match the ash plywood paneling. Original splined 12" x 12" acoustical ceiling tiles with surface mounted fluorescent light fixtures have been replaced with a lay-in 2' x 4' or 2' x 2' ceiling tiles with recessed light fixtures. Rooms were originally carpeted; carpeting has been replaced.

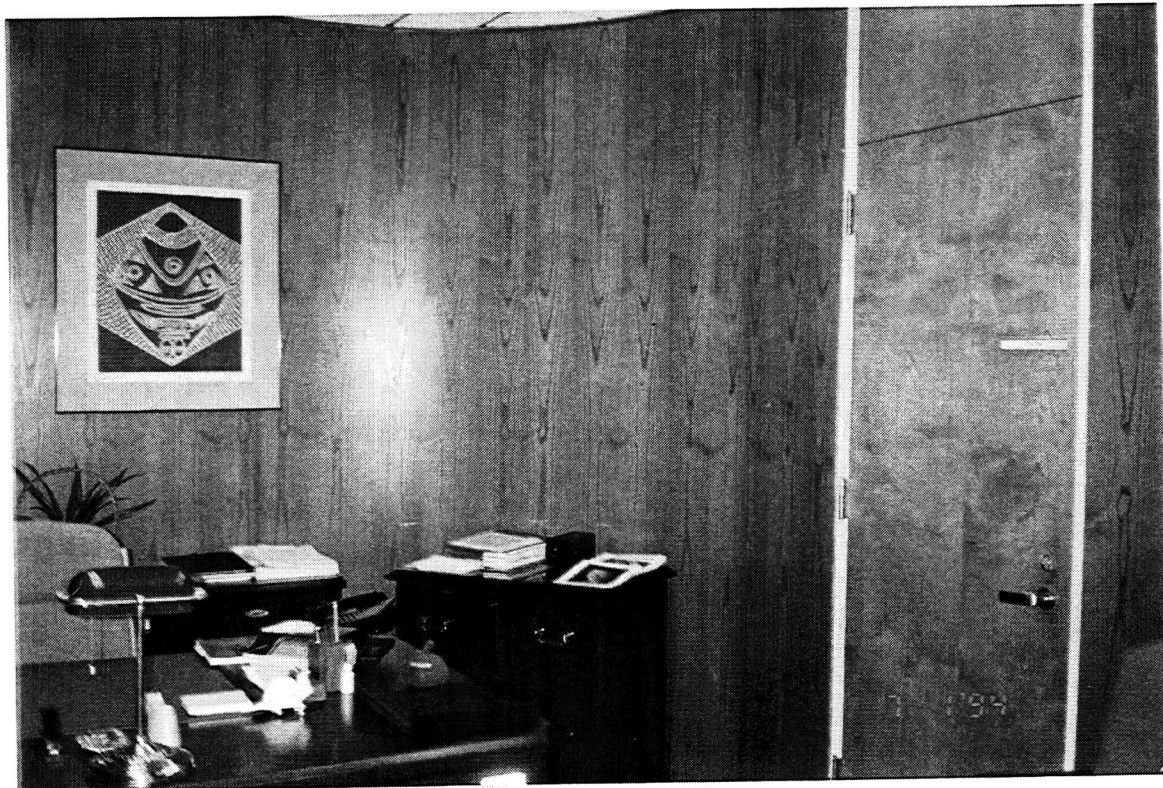
Illustration No. 4-76

Description: Original small conference room in typical Executive Office Suite with ash plywood paneling with four rounded corners. The birch door and transom, originally intended by the architects to be painted white or black, was instead originally stained to match the ash paneling. The conference rooms in the executive suites have all been converted to office space.

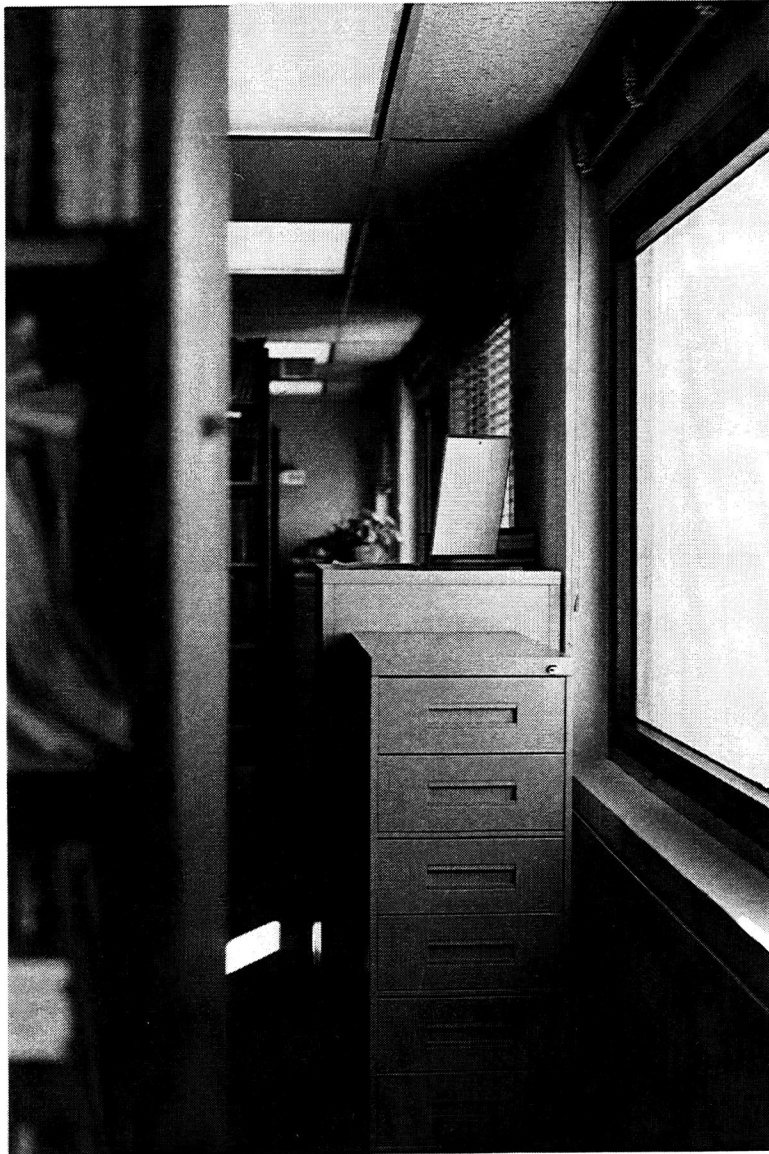
Illustration No. 4-78

Description: View looking south along outside wall. Original splined acoustical tile ceiling with surface mounted lights has been removed and replaced with lay-in acoustical tile ceiling with recessed fluorescent light fixtures.

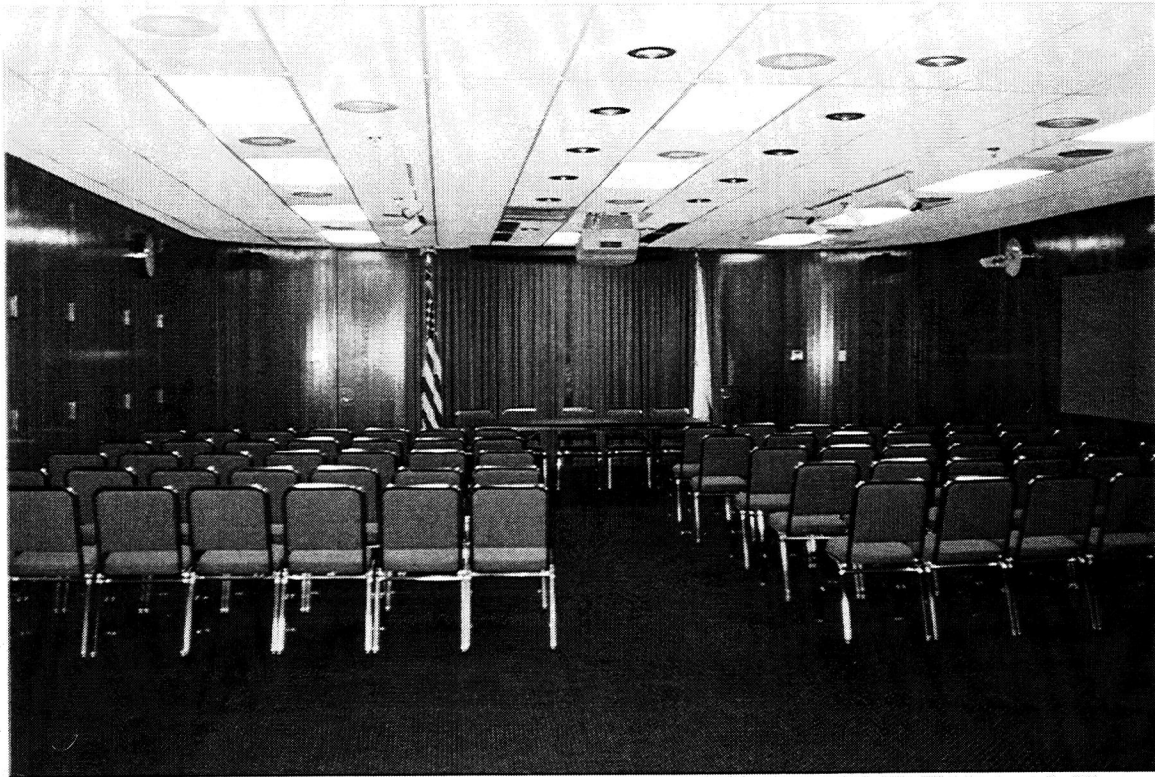
Illustration No. 4-80

Description: View looking north from foyer. Walls and doors are of 3/4" x 3" tongue and groove vertical American Cherry paneling which has had a glossy finish varnish applied. Five original corkboard panels on the east wall, two of them with a blackboard, have been covered with fabric. A new lay-in 2' x 4' acoustical tile ceiling with recessed fluorescent lights, security lights and surface mounted track lights has been installed to replace an original rough finished acoustical tile ceiling. A rear projection screen on the north end of the room has been replaced with a new screen and overhead projector mounted on the ceiling. Two skeleton dial clocks have been removed and have been replaced with new clocks. Original carpeting has been replaced.

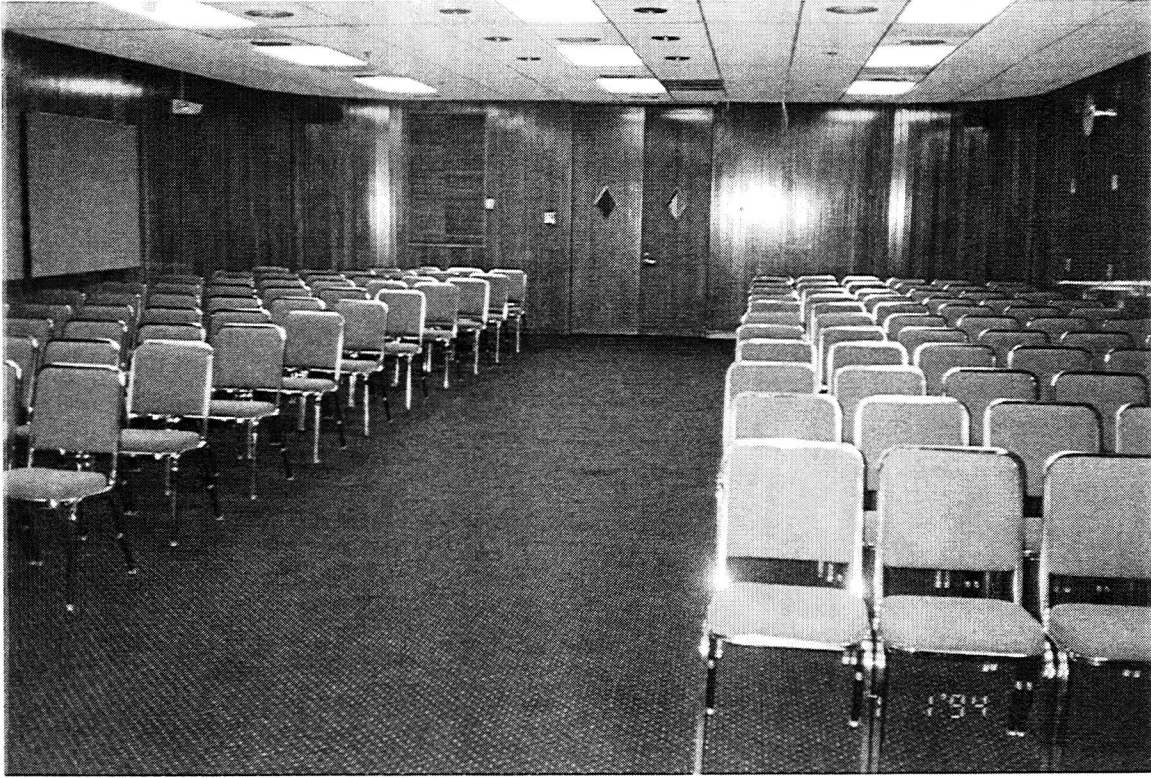
Illustration No. 4-81

Description: View looking south from front of room. Walls and doors are of 3/4" x 3" tongue and groove vertical American Cherry paneling which has had a glossy finish varnish applied. Speakers have been mounted on the four rounded corners of the walls. On the left (east) wall are five original panels on the east wall, two of them with a blackboard, which were originally of corkboard but have since been covered with fabric. A new lay-in acoustical tile ceiling with recessed fluorescent lights, sprinklers, surface mounted track lights and security lights have been installed to replace an original rough finished acoustical tile ceiling. On the east end of the foyer, a coat closet has been converted to mechanical space; the vent is visible to the left of the double entry doors. Hardware on the double doors is broken and the doors do not close properly. Carpeting has been replaced.

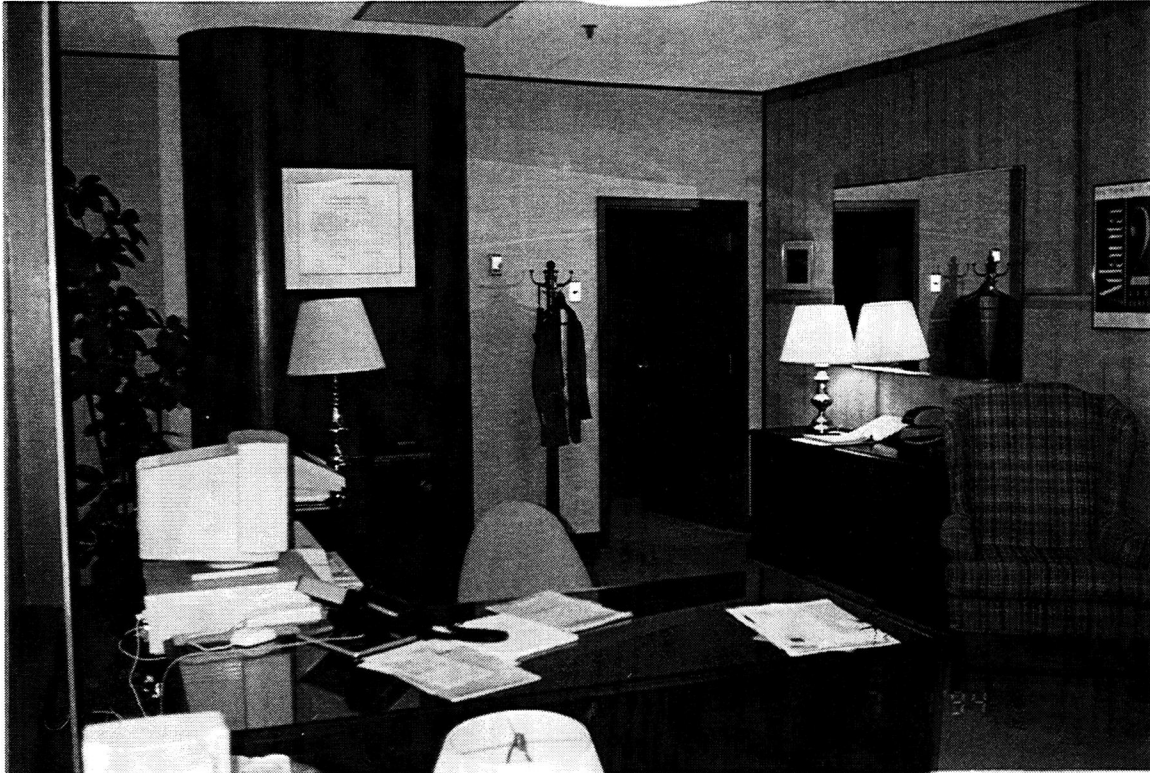
Illustration No. 4-87

Description: View of reception area looking west. Original 3/4" x 3" tongue and groove vertical American cherry paneling which has been varnished covers the concrete column. A new wall and door has been added behind the column to create additional office space. Floors were originally carpeted; carpeting has been replaced. Original rough finished 12" x 12" splined acoustical tile ceilings were replaced with new tile during sprinklering of the building which match the original.
