CHAPTER IV

EXISTING CONDITIONS SURVEY

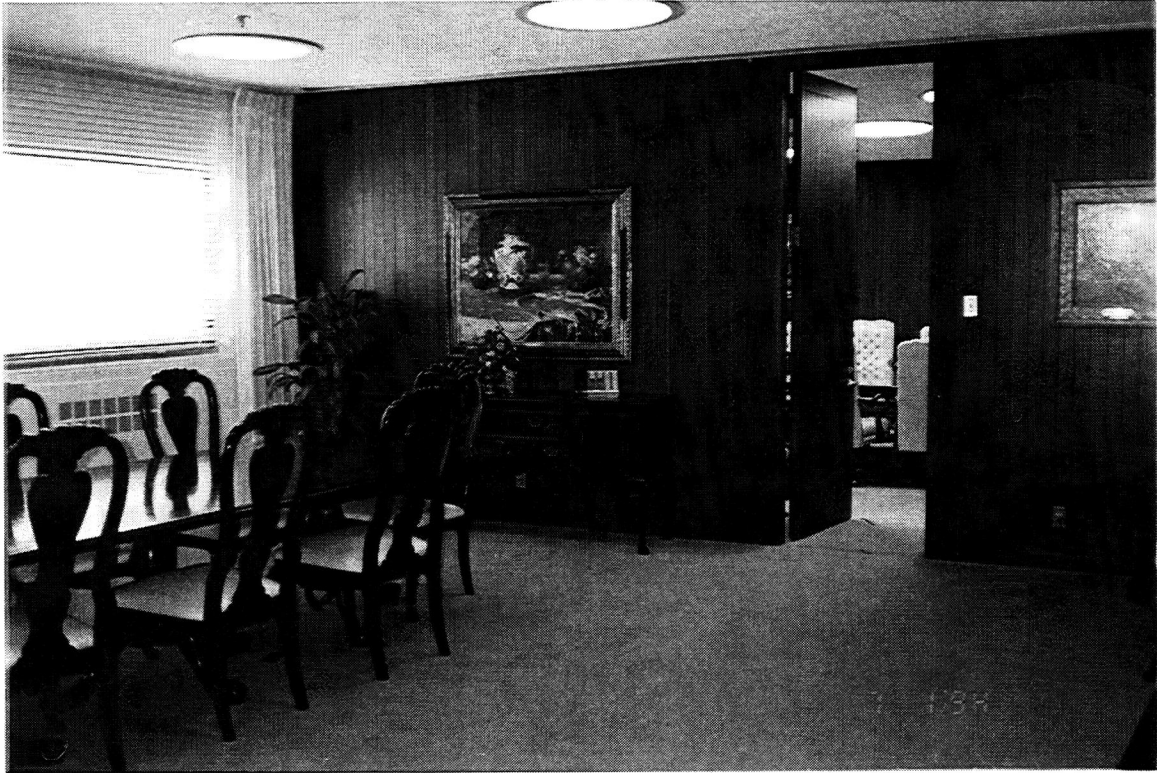
Illustration No. 4-90

Description: Dining room looking west into conference room with 3/4" x 3" vertical tongue and groove American Cherry paneled interior wall and door; the original matte finish has been varnished to a glossy finish. Original 12" x 12" splined acoustical tile ceiling was replaced during sprinklering of building with tile matching original; original light fixtures (listed as Type "G-1" on the Light Fixture Schedule, see Illus. No. 3-27) have been replaced with recessed 30-3/8" diameter ceiling light fixtures with six 30-watt fluorescent bulbs which match the adjacent Secretary's office, secretarial and reception area. Windows have original 2 inch wide gray Venetian blinds; drapes and carpeting have been replaced. The conference room, located through the open doorway, has identical finishes.

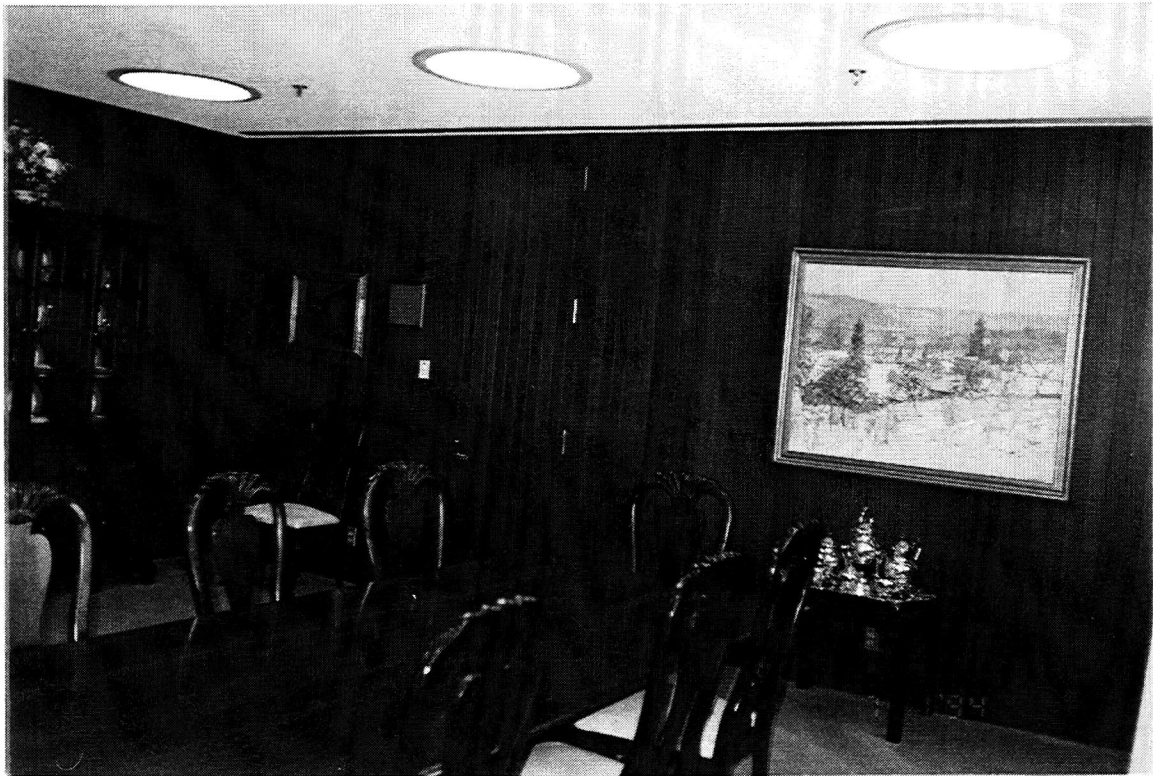
Illustration No. 4-91

Description: Dining room looking east towards secretarial area with original 3/4" x 3" tongue and groove American Cherry paneled walls and doors; the original matte finish has been varnished to a glossy finish. Original light fixtures (listed as Type "G-1" on the Light Fixture Schedule, see Illus. No. 3-27) have been replaced with recessed 30-3/8" diameter ceiling light fixtures with six 30-watt fluorescent bulbs which match the adjacent Secretary's office, secretarial and reception area. Original acoustical tile was replaced with new 12"x12" splined rough finished acoustical tile ceiling during sprinklering of the building; the tile matches the original. Original drapes and carpeting have been replaced.

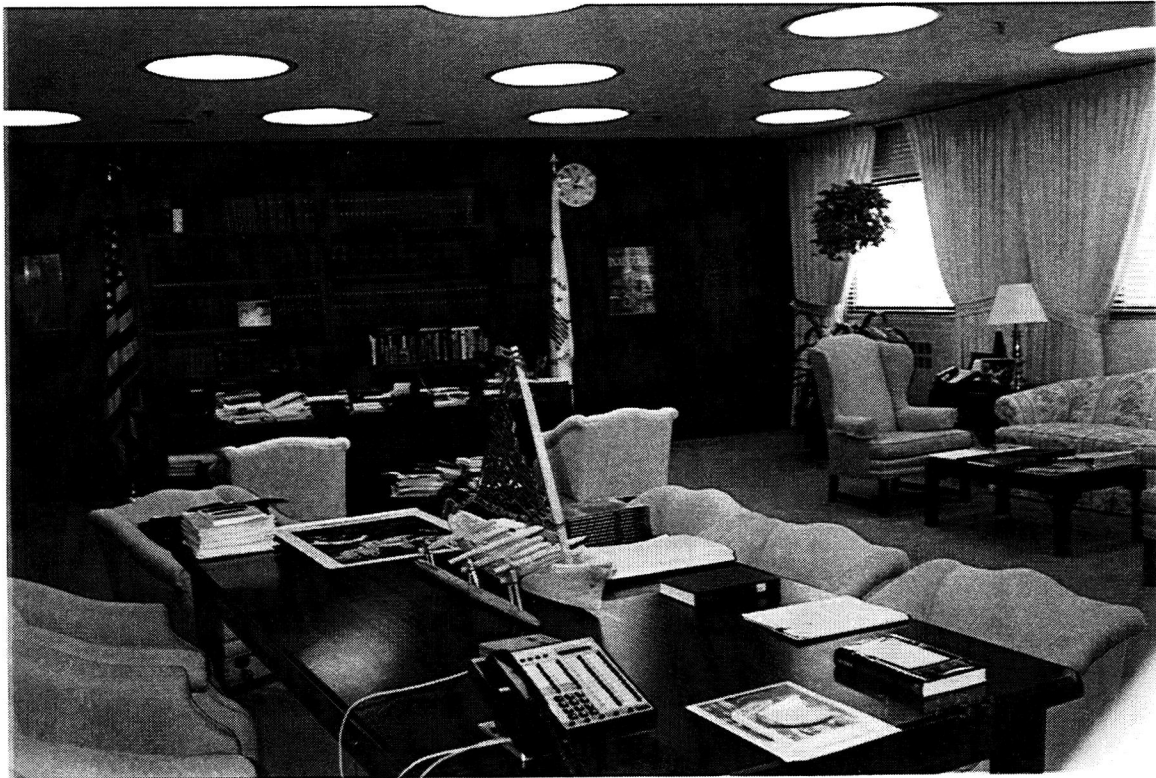
Illustration No. 4-92

Description: Secretary's office, with original 3/4" x 3" tongue and groove vertical American Cherry paneled walls, doors, and two adjustable built-in bookcases; original matte finishes have been varnished. Original recessed 30-3/8" diameter ceiling light fixtures with six 30-watt fluorescent bulbs remain; original 12" x 12" rough finish splined acoustical tile ceilings were replaced during installation of sprinkler system in 1991-1992 with tile matching the original. Windows have 2 inch gray Venetian blinds. New carpeting and drapes have been installed, as well as a new clock.

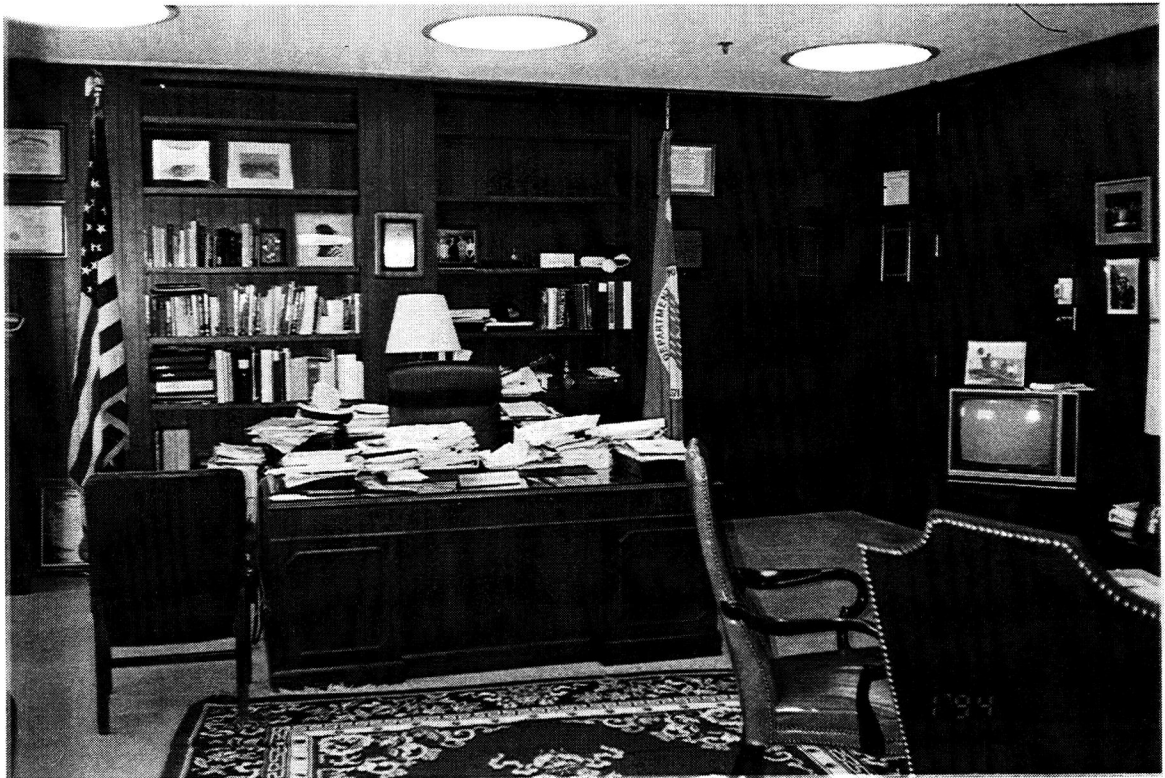
Illustration No. 4-94

Description: Deputy Secretary's office, with 3/4" x 3" tongue and groove vertical American Cherry paneled walls, doors, and two adjustable built-in bookcases; varnish has been applied to original matte finish on paneling. Original recessed 30-3/8" diameter ceiling light fixtures with six 30-watt fluorescent bulbs mounted above remain in new 12" x 12" rough finished splined acoustical tile ceilings, which was replacing during sprinklering of the building in 1991-1992. New ceiling tile matches the original. Carpeting and drapes have been replaced; windows also have 2" wide gray Venetian blinds. One door behind the desk leads to the Secretary's office; another leads to a private bath.

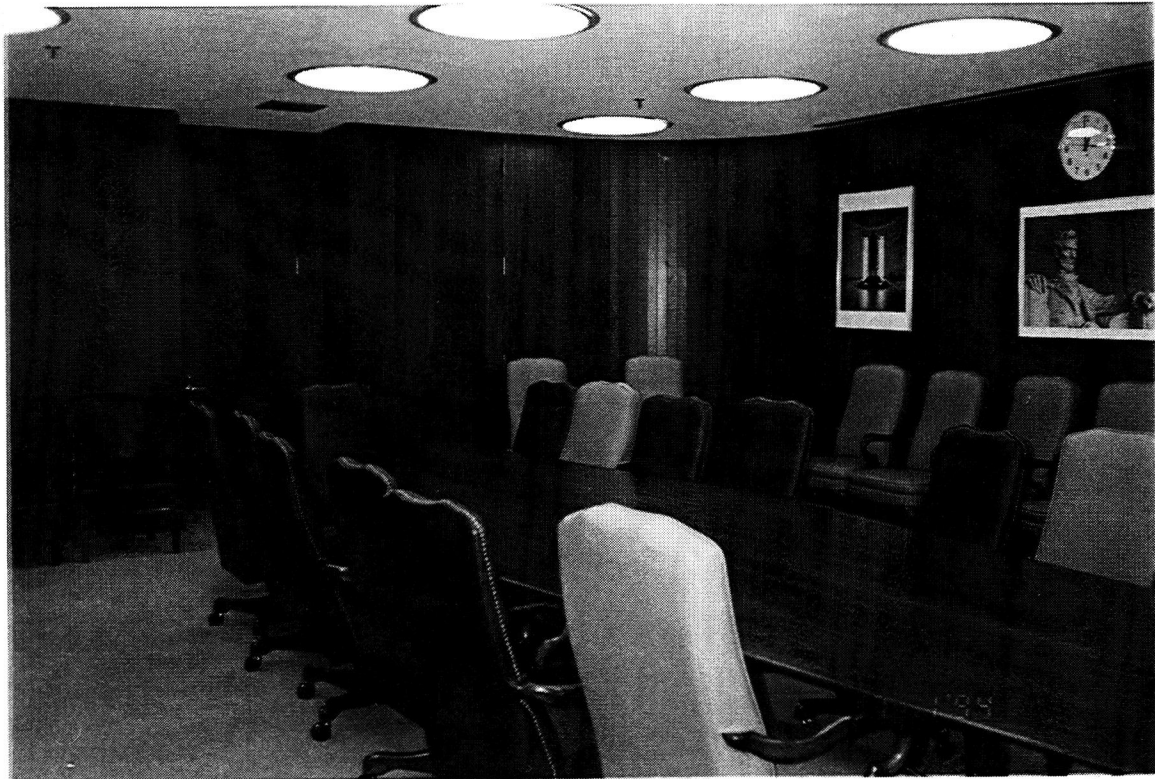
Illustration No. 4-95

Description: Conference Room, with 3/4" x 3" tongue and groove vertical American Cherry paneled walls and doors with curved corners on the inside walls; original recessed 30-3/8" diameter ceiling light fixtures with six 30-watt fluorescent bulbs mounted above set in new 12" x 12" rough finish splined acoustical tile which matches the original. The tile was replaced during sprinklering of the building in 1991-1992. Windows have 2 inch wide gray Venetian blinds; drapes have been replaced, as has carpeting. A new clock has been added, replacing the original skeleton dial clock. Two closets are located on either side of the door to the main corridor. The paneling, originally a flat finish, has been varnished with a glossy finish.
