FINAL REPORT OF THE MANAGEMENT SUPPORT CONTRACTOR  
FOR THE  
RESIDENTIAL SOLAR HEATING DEMONSTRATION

VOLUME III. HIGH TEMPERATURE EXPOSURE  
OF WOOD STRUCTURES IN SOLAR SYSTEMS

JUNE 1983

by  
BE&C Engineers, Inc.  
(A Boeing Subsidiary)

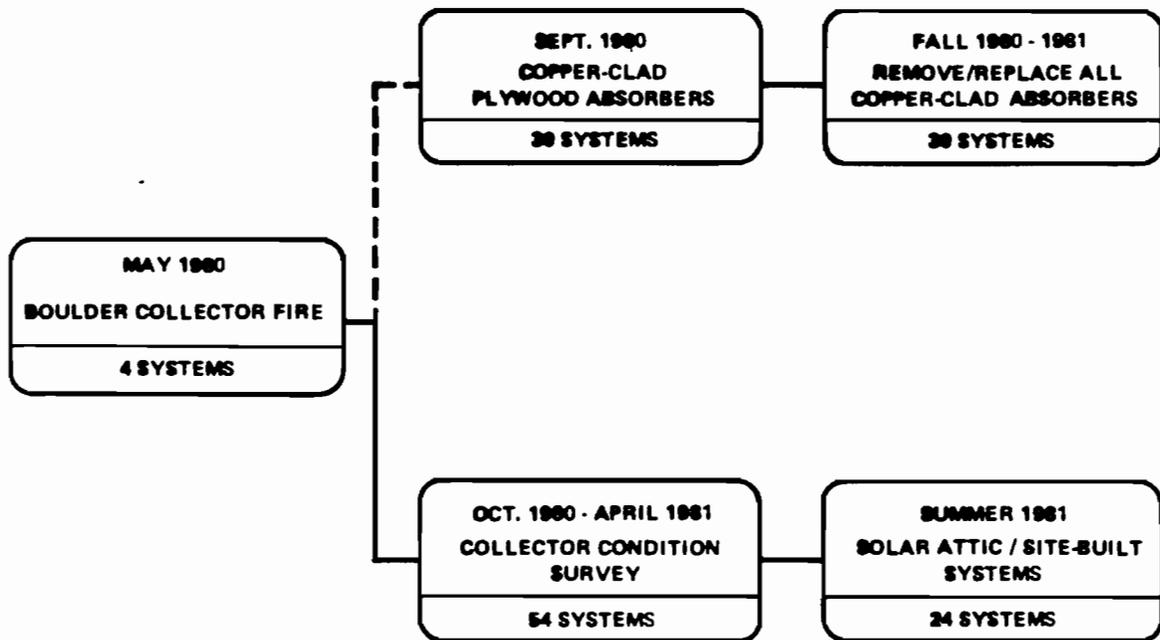
Figure 1-5. Investigation Chronology

After HUD completed its own investigation of the Boulder fire, it decided to investigate all HUD solar grant projects where the solar collection system contained materials that would degrade and possibly create a life-safety hazard if exposed to long-term stagnation conditions. Figure 1-5 is a chronological illustration of the fire incident and the resultant HUD investigations.

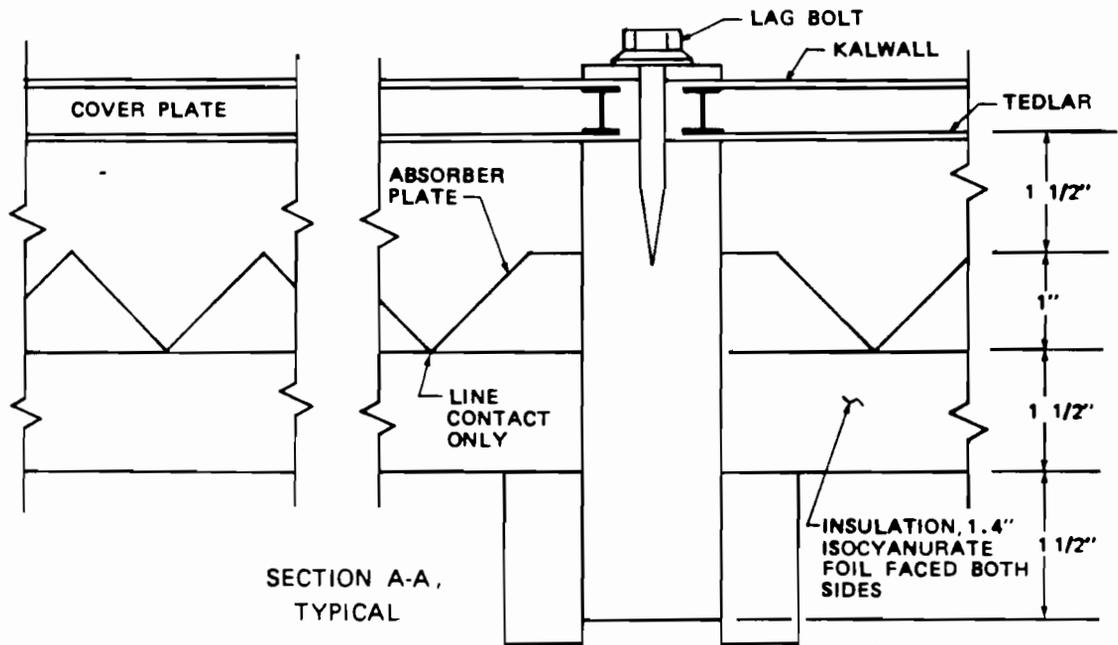
Figure 2-5. Site-Built Collector Cutaway (Air)

Sixteen site-built systems using air as the transport medium were investigated. Three showed heat-related material degradation. Figure 2-5 is a cutaway illustration of the typical collector construction. In one project with 12 systems, according to design data, foil-faced rigid isocyanurate insulation is in contact with aluminum absorber plates. Core samples of the insulating boards from four of those systems were discolored to a moderate degree, showing that excessive heat was conducted to the boards. Several others showed slight discoloration. Temperatures in these collectors were measured at 75°F at the inlet and 160° to 180°F at the outlets. See Chapter 3 for further investigations of these 12 systems.

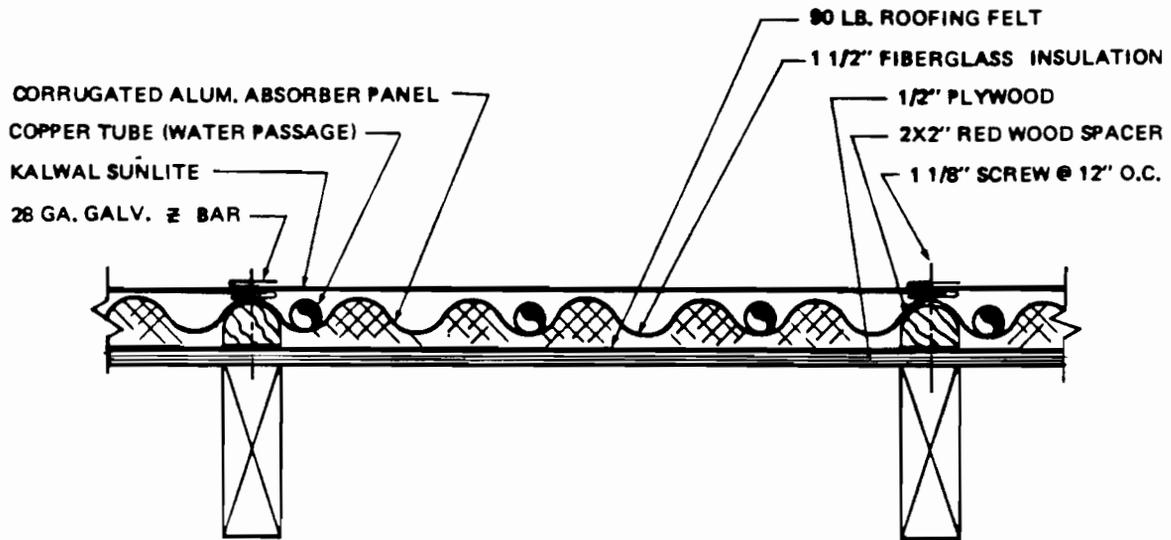
Figure 2-6. Site-Built Collector Cutaway (Liquid)

Four projects with five systems using liquid absorber panels in site-built enclosures were investigated. These included collectors with absorber plates mounted directly on wood products, insulation, or asphalt roofing paper. None of the collector materials showed any sign of degradation. Three systems were reported to have been operating without previous stagnation. A fourth system is drained during the summer months and the collectors allowed to stagnate in a dry condition. The insulation in contact with the absorber plate is fiberglass and is able to withstand the temperatures encountered. The wood spacer between the absorber and glazing did not appear to be affected by the temperatures reached during these stagnation periods. Figure 2-6 is a cutaway illustration of the collector construction.

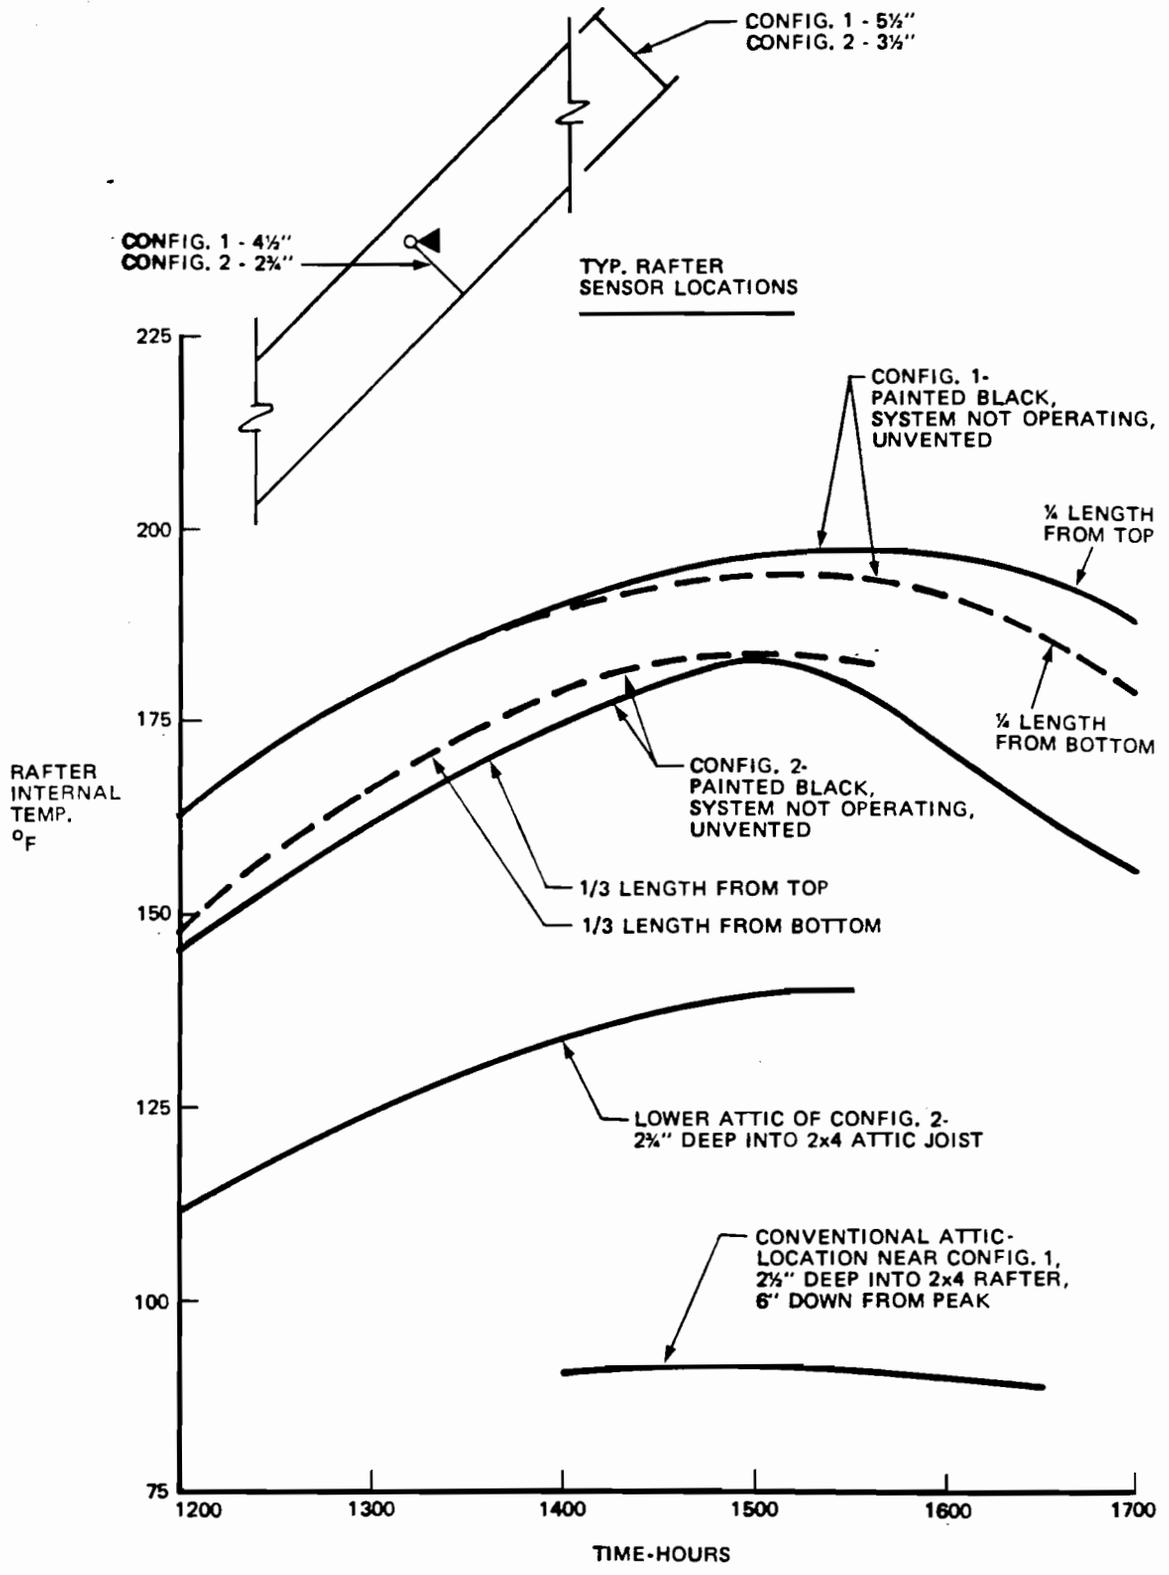
Figure 5-1. Maximum Rafter Temperatures, Solar Attics

As shown in Figures 5-1 and 5-4, measured temperatures are less than those considered to be potential fire hazards. Conversely, in all three configurations evaluated, wood temperatures exceeding 150°F were measured, substantiating the concern for degradation of wood structural members in solar systems. It was also verified that wood temperatures in solar systems exceed wood temperatures in conventional attics. Figure 5-1 compares maximum wood temperatures measured in Configuration 1 with those measured in a conventional attic in the same neighborhood during the same time period. Wood temperatures in the conventional attic were less than 100°F. A plot of maximum wood temperatures measured in the conventional lower attic of Configuration 2 shows that they are less than 150°F.

A maximum solar attic rafter temperature of 198°F was measured near the top. As shown in Figure 5-1, temperature variation between the top and bottom of the rafter is small. Figures 5-1 and 5-3 indicate that maximum solar attic temperatures (175°F) occur approximately one hour before maximum rafter temperatures.

A maximum solar attic rafter temperature of 183°F (Figure 5-1) was measured near the eaves. Again, Figure 5-1 indicates little temperature difference between the top and bottom of the rafter. A maximum solar attic temperature of 161°F (Figure 5-3) was recorded. As shown in Figure 5-2, solar insolation for this test condition was somewhat less than when temperature measurements were taken for other test conditions.

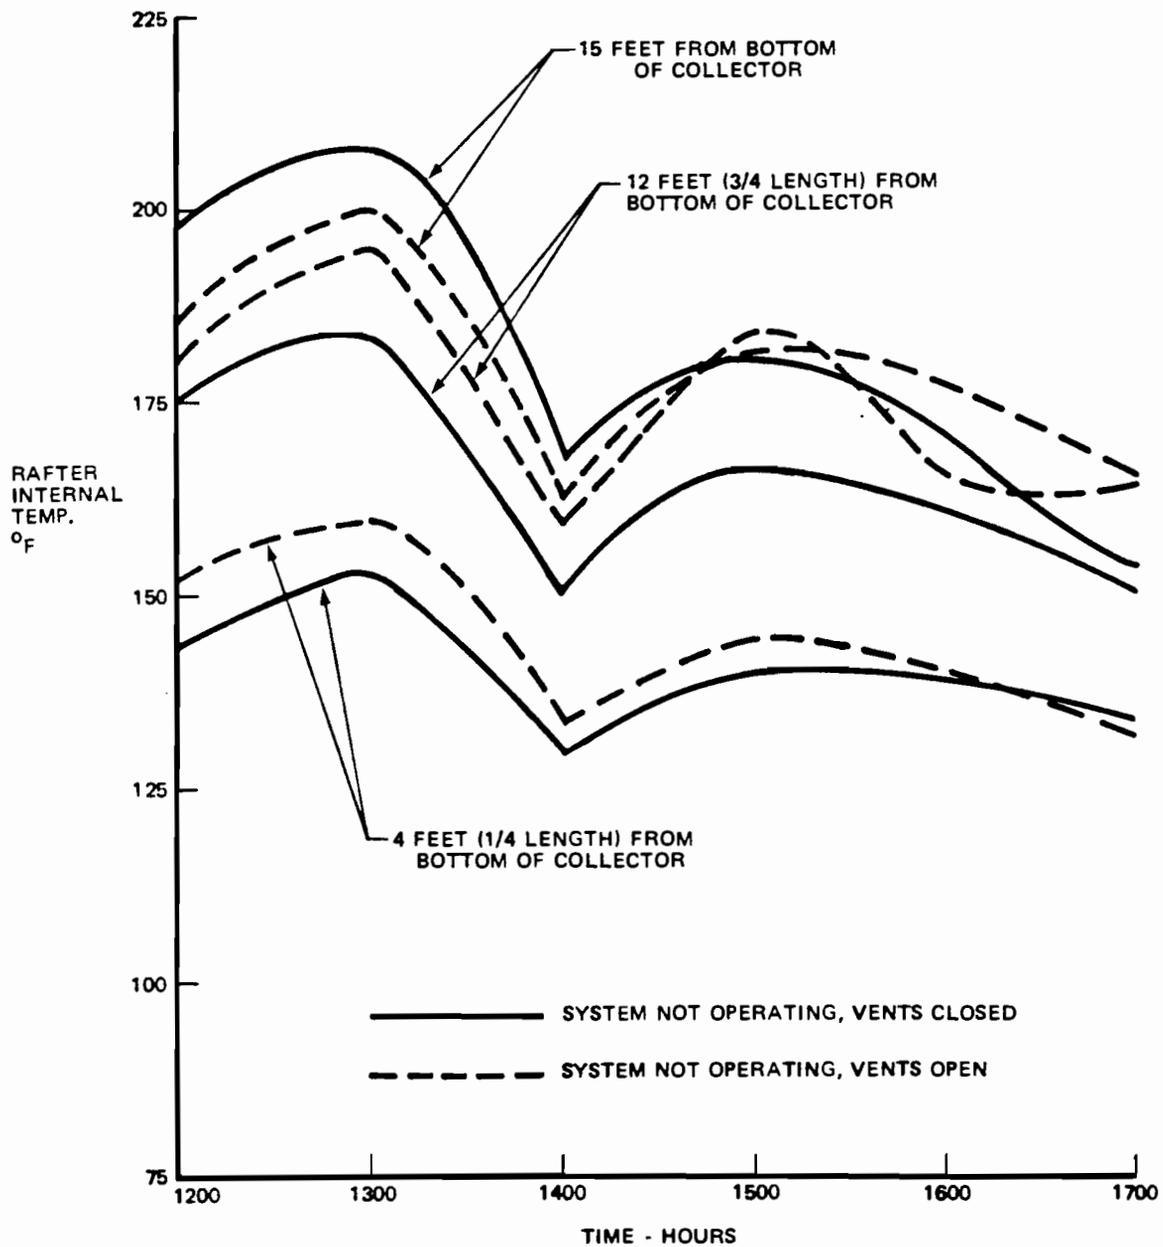
Figure 5-4. Maximum Rafter Temperatures, Site-Built Air Collector, Configuration 3

A maximum site-built collector rafter temperature of 208°F (Figure 5-4) was measured one foot from the top. Figure 5-4 shows rafter temperatures during a non-operating period when the vents were closed. Temperature profiles are plotted for rafter locations 4 feet, 12 feet, and 15 feet from the bottom of the 16-foot collector. Figure 5-5 shows solar insolation for the day data were obtained. Figure 5-6 includes plots of collector air temperature and the ambient air temperature in the attic. It is interesting to note that a period of low solar insolation occurred during the day that reported site-built collector data were recorded. This day was selected because periods of very high solar insolation also occurred. Figures 5-4, 5-5, and 5-6 show that for site-built collectors, changes in the temperature of the rafter, collector air, and attic ambient air followed very closely the changes in solar insolation.

The effects of natural ventilation on rafter temperatures with site-built collectors were shown in Figure 5-4. Maximum rafter temperatures, when the system was not operating, were compared for the vents-open and vents-closed conditions. Maximum temperatures occur at the top end of the rafter when vents are closed; however, from the three-quarter point down, rafter temperatures are higher when the vents are open.

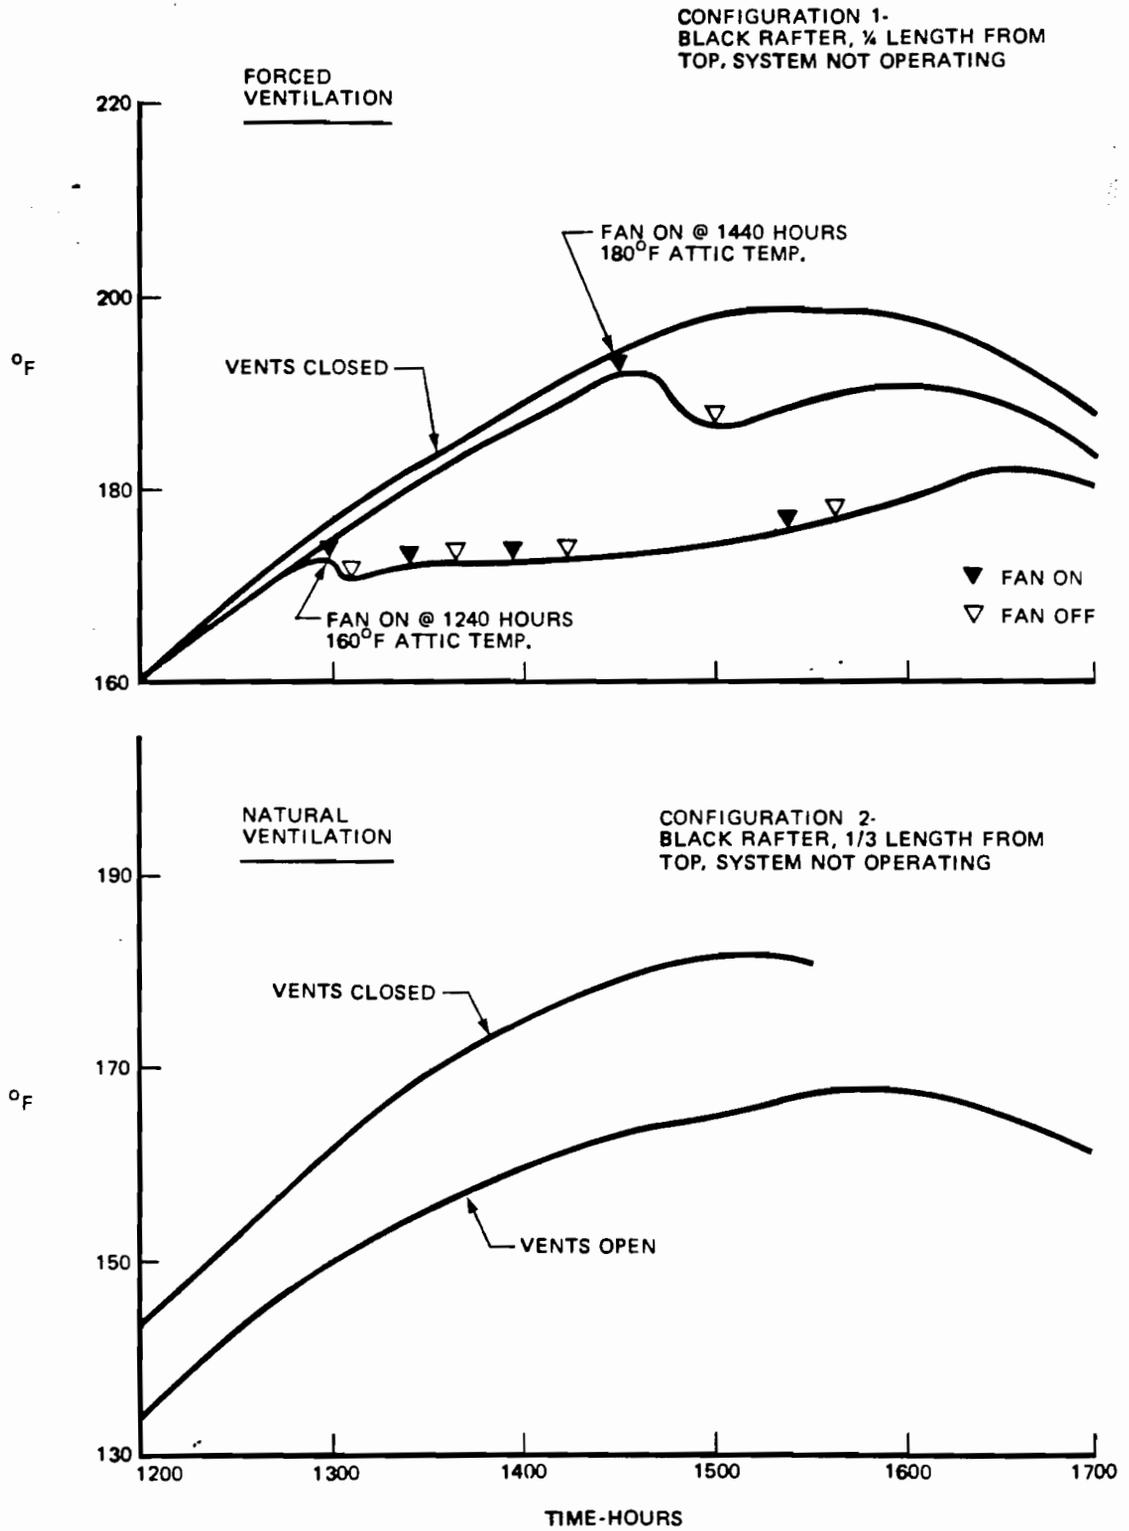
**Figure 5-7.** Rafter Internal Temperatures, Solar Attics, Forced and Natural Ventilation

The effects of forced ventilation were evaluated in Configuration 1. Figure 5-7 compares the effect on maximum rafter temperature of ventilation fans actuated at 160°F and 180°F. Comparing the attic ambient temperature when the fan is initially actuated at 160°F (Figure 5-8) with the effect on maximum rafter temperature (Figure 5-7), the following was observed: Attic ambient temperature dropped to below 150°F and could be maintained at that level with the fan on; maximum rafter temperature initially dropped and then remained approximately constant when the fan was on. The reduction in maximum rafter temperature can also be observed in the plot for fan-on at 180°F (Figure 5-7).

The effects of natural ventilation using eave and ridge vents were evaluated in Configuration 2. Figure 5-7 compares maximum rafter temperatures for two conditions, attic vents open and attic vents closed. As shown in Figure 5-8, ambient attic temperature was less than 150°F when attic vents were open. It should be noted that the air vents previously installed and replaced in gabled

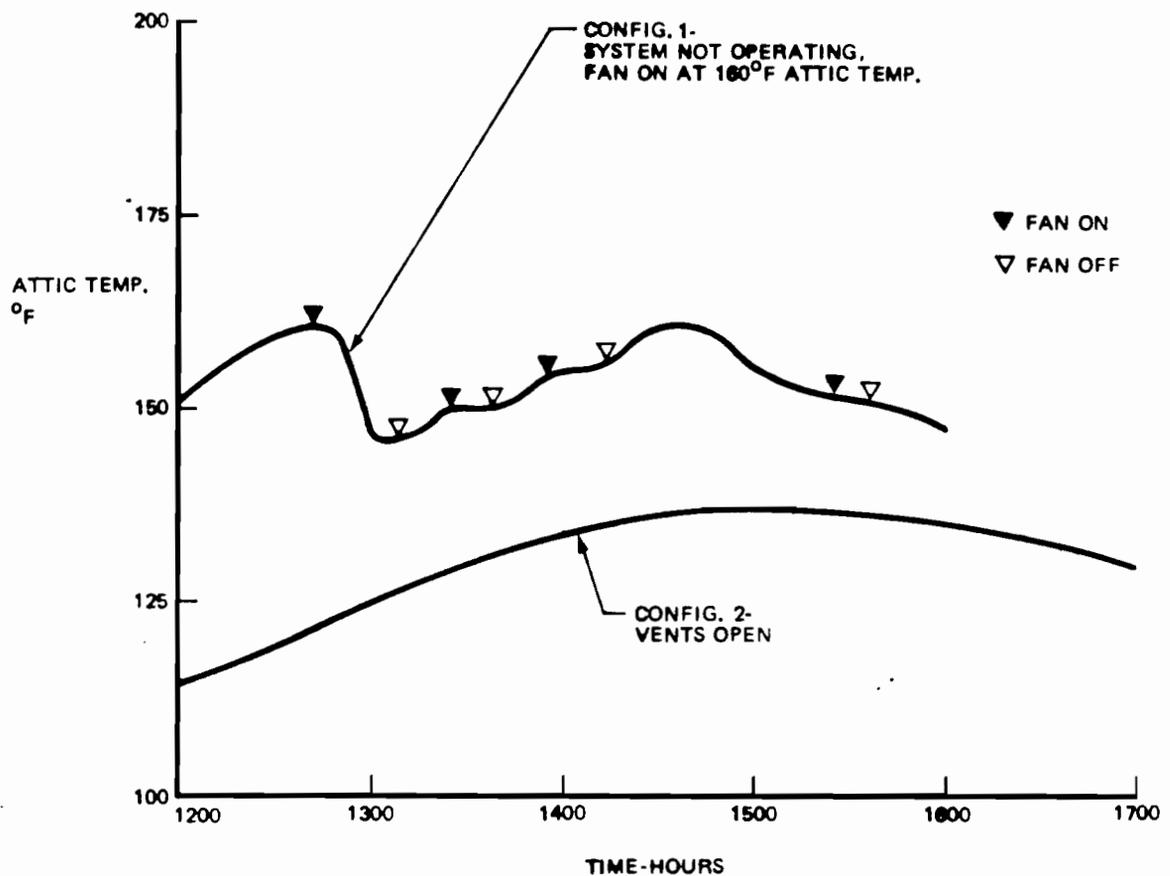
Figure 5-8. Maximum Solar Attic Ambient Temperatures, Forced and Natural Ventilation

walls had minimal effect in reducing attic air temperatures (as shown, ridge vents were more effective).

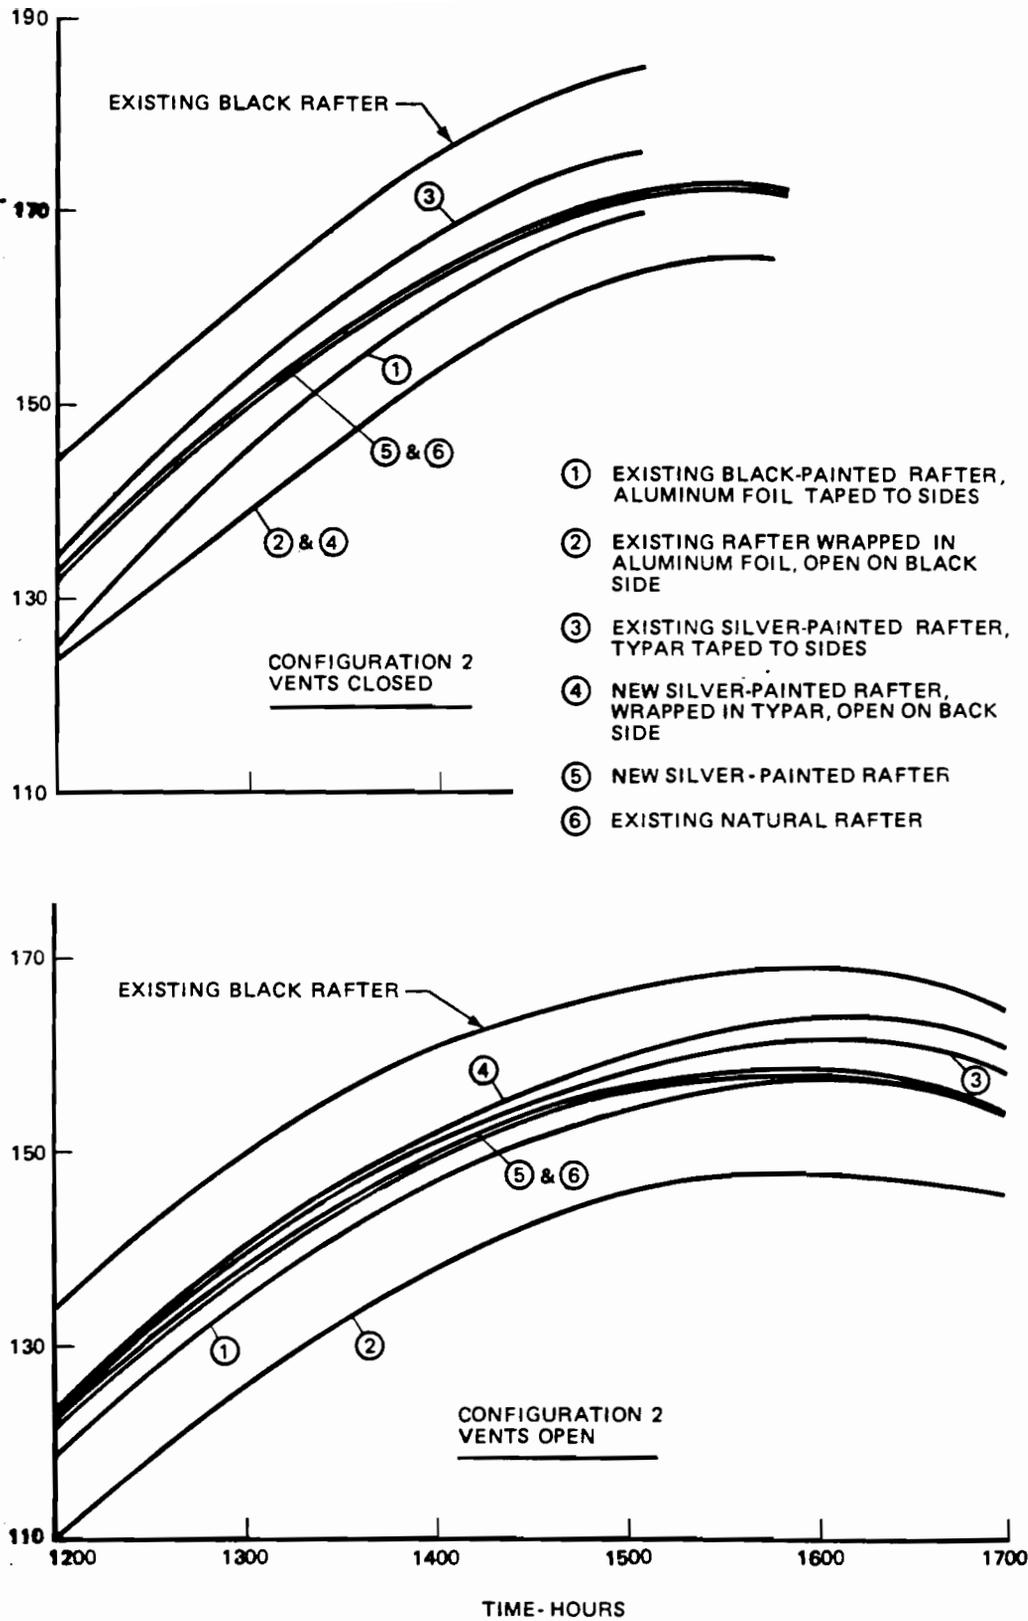
Figure 5-9. Effect of Reflective Surfaces on Rafter Internal Temperatures

The effects of reflective coating on maximum rafter temperatures for both solar attics and site-built collectors were evaluated using Configuration 2. Figure 5-9 compares various coatings during both vents-open and vents-closed conditions. The reduction in maximum rafter temperature by type of reflective surface appears to have the order shown in Table 5-1. Minimal difference was observed between the vents-open and vents-closed conditions.

that rafter temperatures remained constant when ventilation maintained attic temperature at 150°F. As seen in Figures 5-1 and 5-3, Configuration 1, an attic temperature of 150°F at 1200 hours relates to a maximum rafter temperature of 163°F. Figure 5-9 indicated that further reductions of 14 to 20°F can be expected with appropriate rafter surfaces.
