## NBS BUILDING SCIENCE SERIES 72

### Fire Endurance of Gypsum Board Walls and Chases Containing Plastic and Metallic Drain, Waste and Vent Plumbing Systems

W. J. Parker, M. Paabo, J. T. Scott

Center for Fire Research  
Institute for Applied Technology  
National Bureau of Standards  
Washington, D.C. 20234

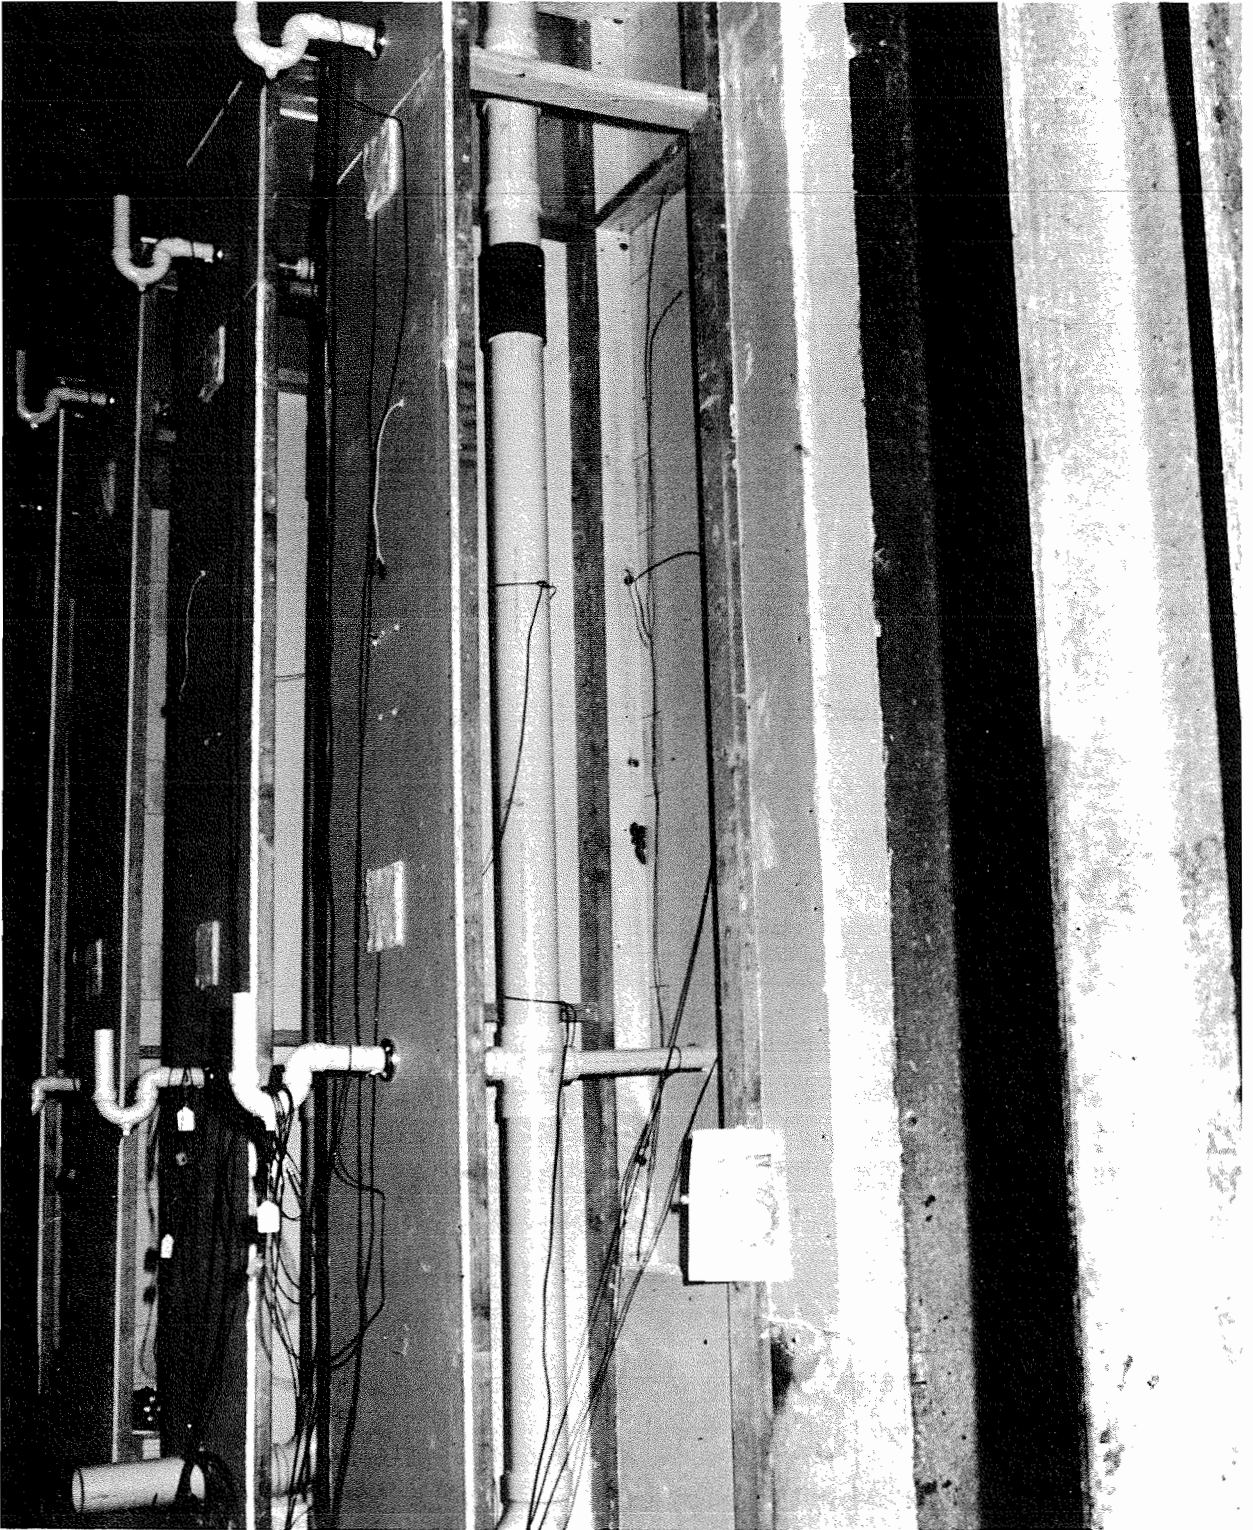
Figure 8. Photograph of chase 5  
with side removed.

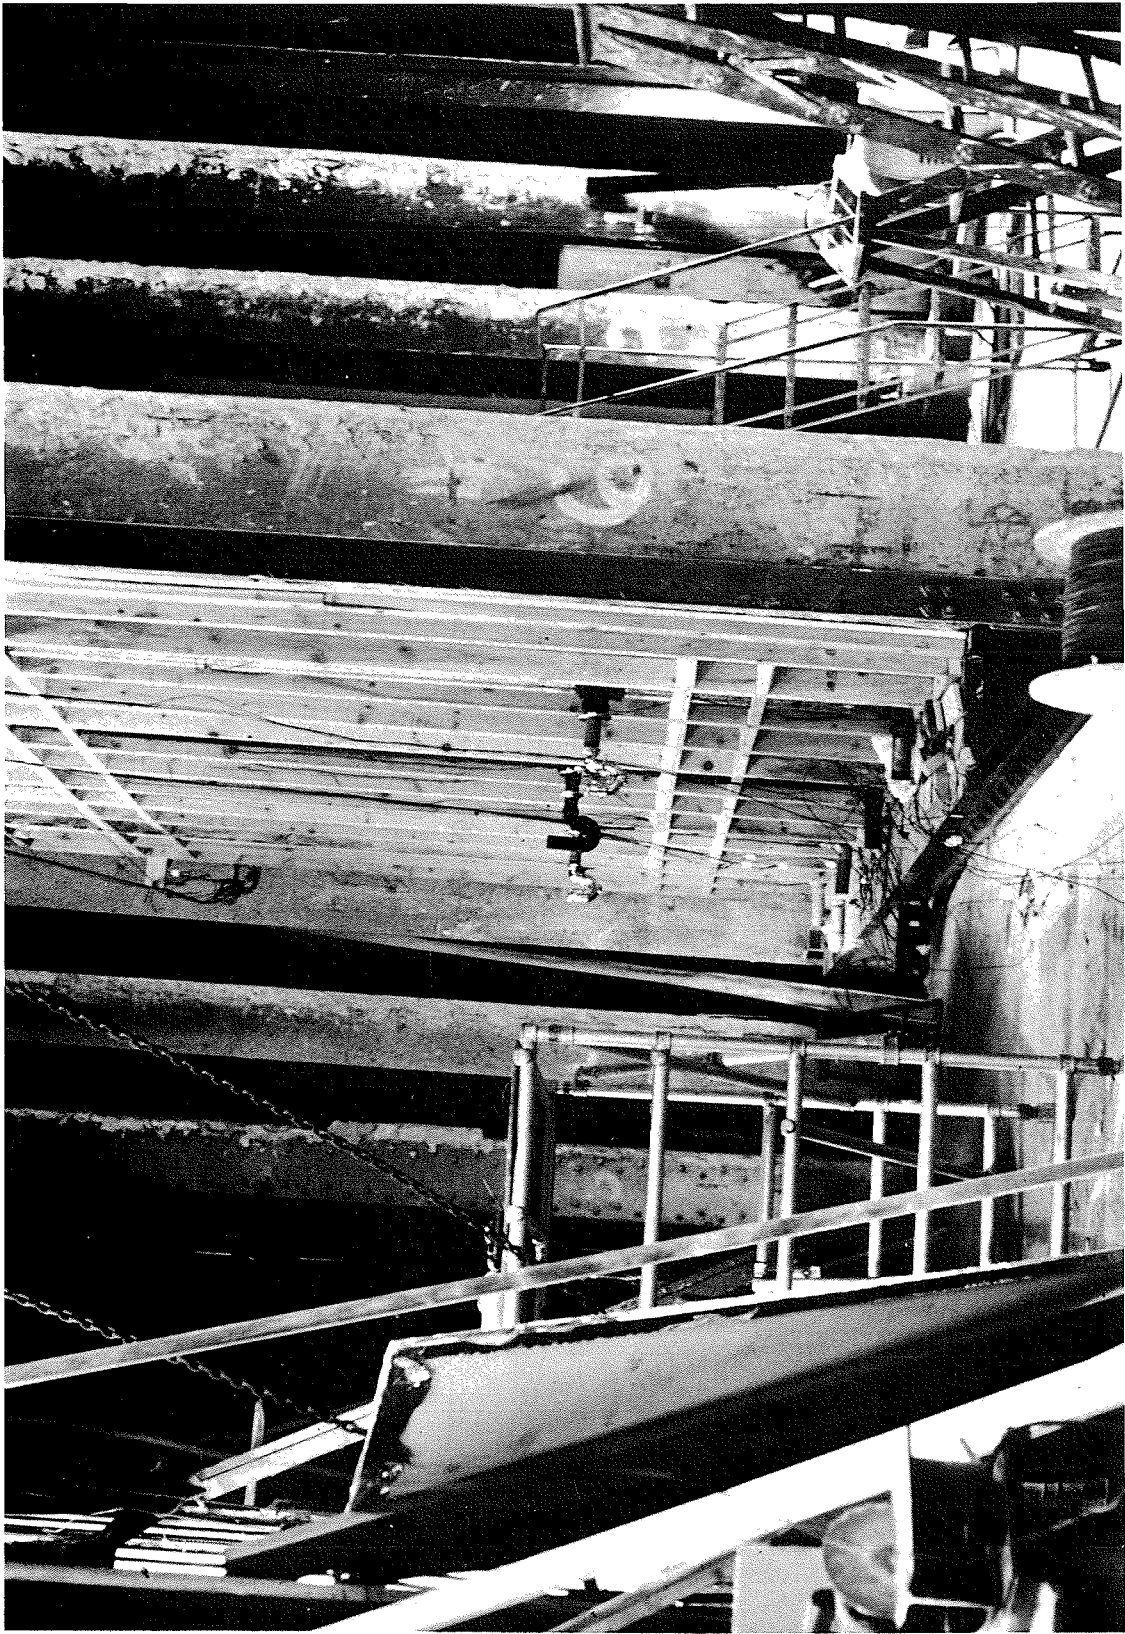
Figure 14. Photograph of wall construction in test 3.

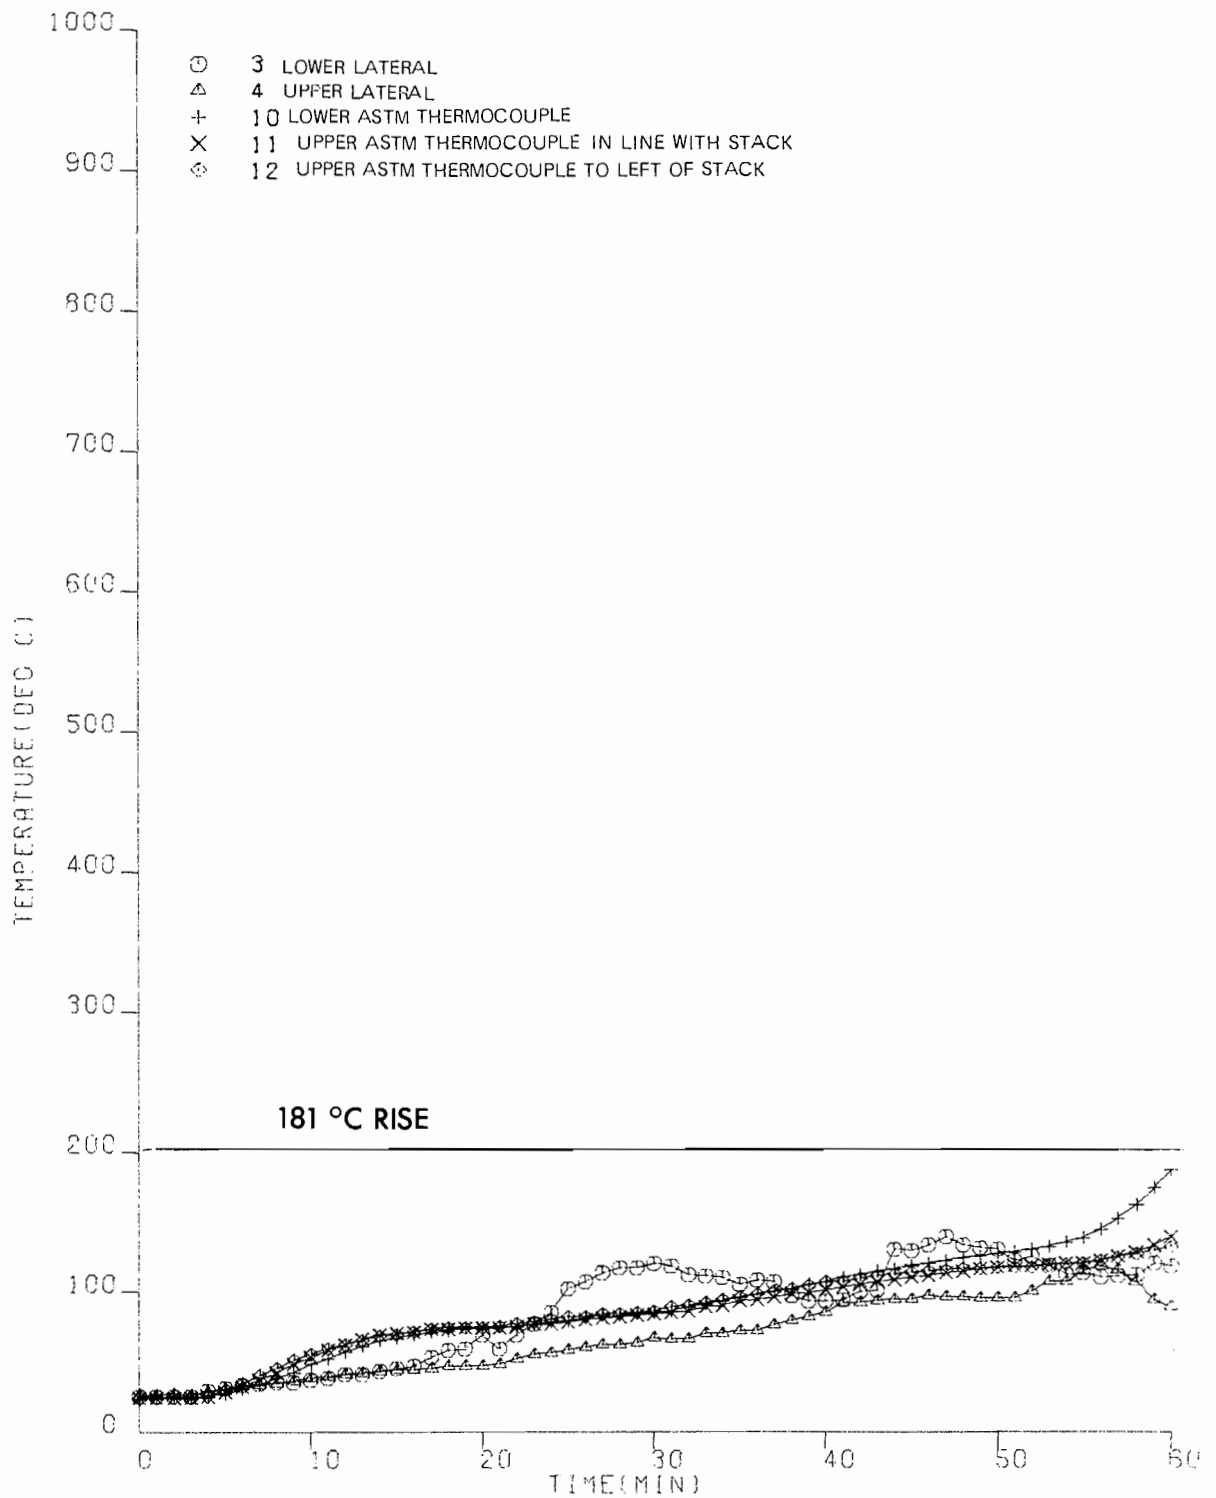
Figure 26. Unexposed lateral and ASTM surface temperatures in PVC installation (cavity 7) in test 4.

Figures 22 through 53 provide a record of the temperature data for Tests 3 through 10. Thermocouples Nos. 3 and 4 recorded the temperatures on the lower and upper laterals at the point where they come through the unexposed surface of the chase walls. The horizontal lines indicate the allowable temperature rise (181 °C or 325 °F) for a thermocouple on the unexposed surface of a rated fire wall and indicate when the temperature exceeded one of the criteria.
