WINDOW FRAMES & REPLACEMENT UNITS

ESSENTIAL KNOWLEDGE

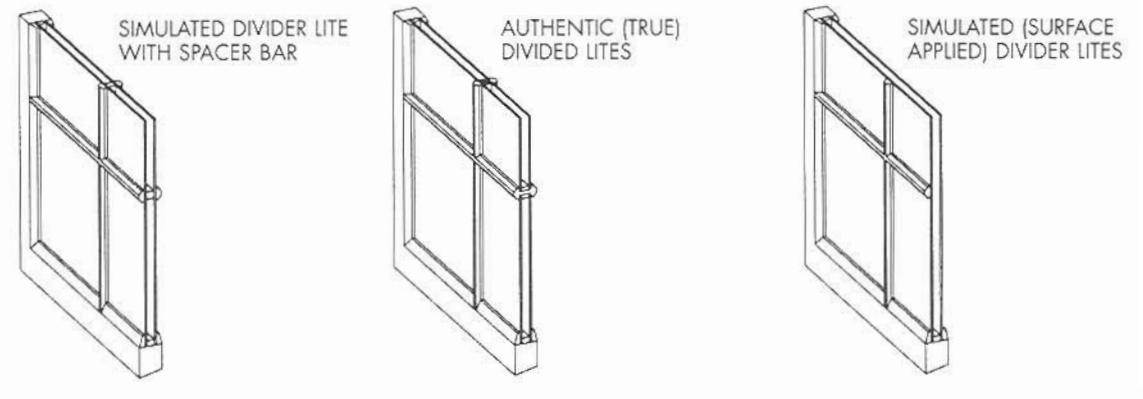
FIGURE 1

MUNTIN TYPES

The method of assembly is also an important consideration in overall window performance. Historically, glass was only available in small panes and a window frame joined several panes to form the desired opening. This grid of frame material is referred to as a muntin. As glass technology evolved, windows increased the size of the grid, ultimately only being restricted by the operable weight of the sash. With no structural requirement for muntins and the advent of insulating glass the grid was preserved solely for aesthetic reasons (sense of enclosure, ability to define expanse of view, existing architecture). Today there are several options available dependent upon the degree of authenticity desired relative to convenience or performance. A window sash with individual lites (panes) is inherently more expensive and less efficient because of the increased length of the glazing perimeter. These window muntins are described as true or authentic divided lites as they serve their original structural purpose. The width of these true muntins, however, is typically larger to accommodate the insulating glass. Multiple individually sealed glazing units also increase the likelihood of seam failure.

Alternate methods have been developed to simulate the appearance of true divided lites and provide the ease of cleaning a single pane and/or to minimize the cost of fabrication. Simulated divided lites are muntins (grilles) adhered to the surface of the glazing and often available with an optional air space grille (spacer bar) simulate the appearance of true divided lites at lower cost and without significantly compromising energy performance. Single-lite insulating glass reduces the likelihood of seam failure. Another type, referred to by some manufacturers as "snap in" grilles, can be removed for cleaning but are considered to be the least convincing because of their thin profiles. They are also subject to damage with repeated use. A third option offers a combined strategy: a true divided lite sash with a single full size panel, which is set into the sash like an integral storm unit. This provides a single surface to clean from the interior while maintaining a historically authentic appearance with good thermal performance.

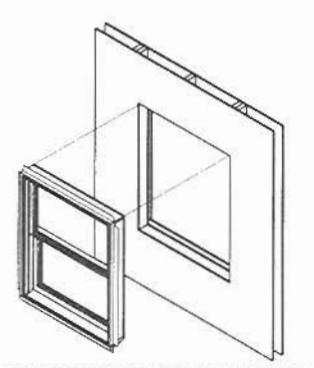
FIGURE 2

REPLACING EXISTING WINDOW UNIT

The benefits provided by new materials may be retained by the use of a variety of partial replacement methods (Fig. 2). The primary benefit of partial window replacement is the preservation of the original materials including surrounding trim and surfaces, which can save labor and material costs. The preserved material's potential useful life and ability to be replicated are often the driving criteria.

Replacement of existing window units with an entirely new unit will provide the best available performance and the opportunity to assure proper installation of the unit. Sources of damage to the unit being replaced may be corrected with the removal of the original window.

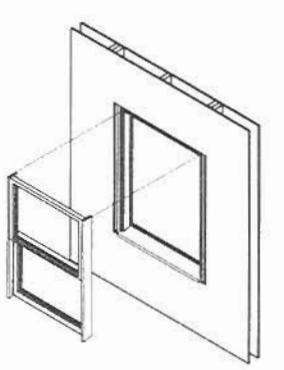
SECONDARY FRAME REPLACEMENT UNIT

The most popular form of replacement windows are vinyl units that fit within the existing window frame, although wood window units for this purpose are also available from Pella, and others. The secondary window unit is perceived as a unit within a unit, providing the sash and track with a pre-assembled narrow frame. These units are available in a wide variety of stock sizes or may be custom fabricated with a choice of glazing.

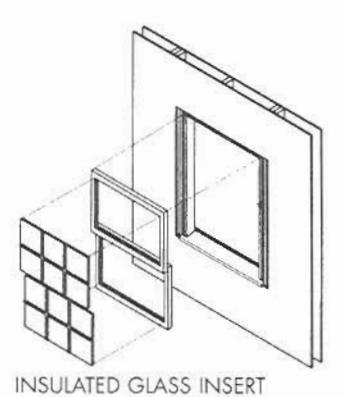
SASH REPLACEMENT UNIT

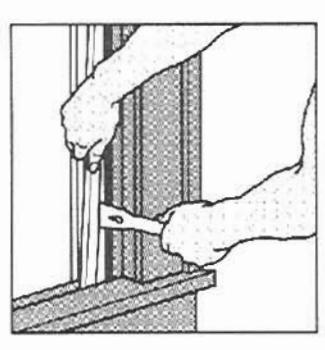
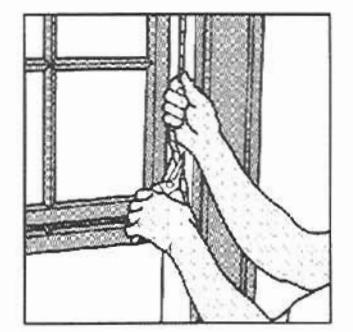
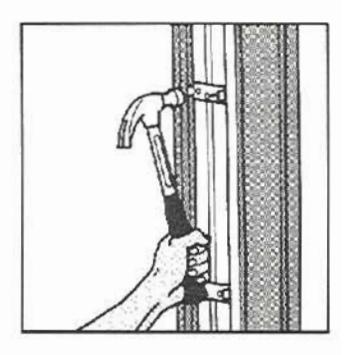
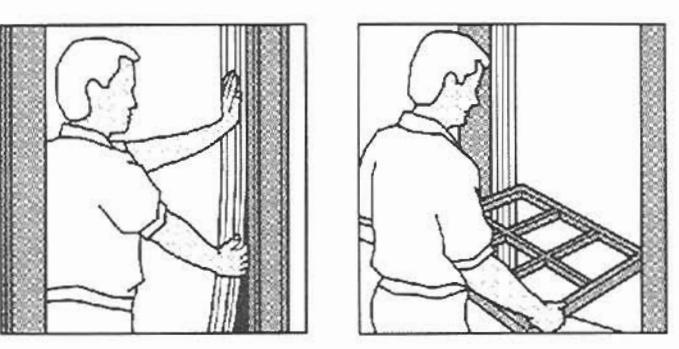
FIGURE 3

TYPICAL INSTALLATION OF A SASH REPLACEMENT WINDOW UNIT

Replacement sash units are a very popular choice for partial window replacement (Fig. 3) and are now produced by the majority of window manufacturers, including Caradco, Marvin, and Weather Shield, among others. These inserts come in a kit, which includes the sash and track (jamb liners) with a counterbalance mechanism and hardware. The units are available in a wide variety of stock sizes or can be custom fabricated with a choice of glazing.

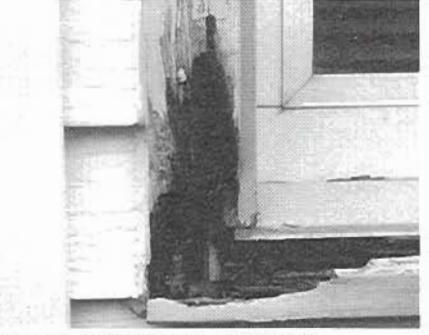
FIGURE 4

ROTTED WINDOW FRAME CLEANED

Rotted or damaged wood frames can often be repaired with epoxy products. There are essentially two types of epoxy repairs: consolidants for use where the wood is intact; and a putty-like filler material for areas that are missing or require removal because they are beyond repair (Fig. 4). Epoxy consolidants will penetrate and bind with the wood fibers while preventing further deterioration. Consolidants, which are either poured or brushed on the surface in liquid form, bond with the wood fibers to create a surface with greater strength than wood and water resistant. The material cures in a matter of minutes or hours (depending on the amount used) and may then be worked as wood. Consolidants may be used as a primer for the application of an epoxy filler material, to fill voids or achieve intricate profiles that would otherwise be difficult and expensive to replicate in wood on a small scale. The increased strength of the epoxy material is suitable for structural elements such as an operable window frame when applied as per manufacturer's instructions. Consolidants are available from numerous sources (manufacturers and distributors) including Abatron, Conservation Services, Gougeon Bros. Inc., and Repair Care Systems USA, among others.

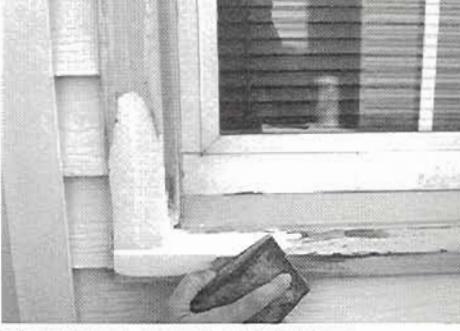
EPOXY FILLER APPLIED AND SANDED

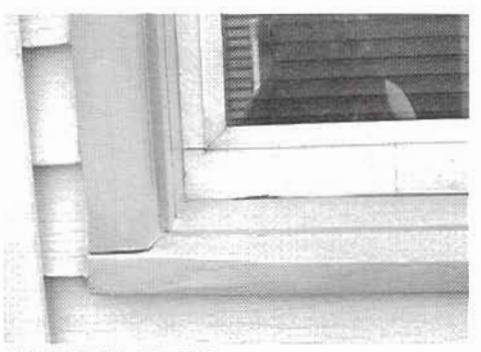
EPOXY FILLER PAINTED
