NBSIR 73-165

Fire Endurance Test on a Steel Tubular Column Protected with Gypsum Board

April 1973

Final Report

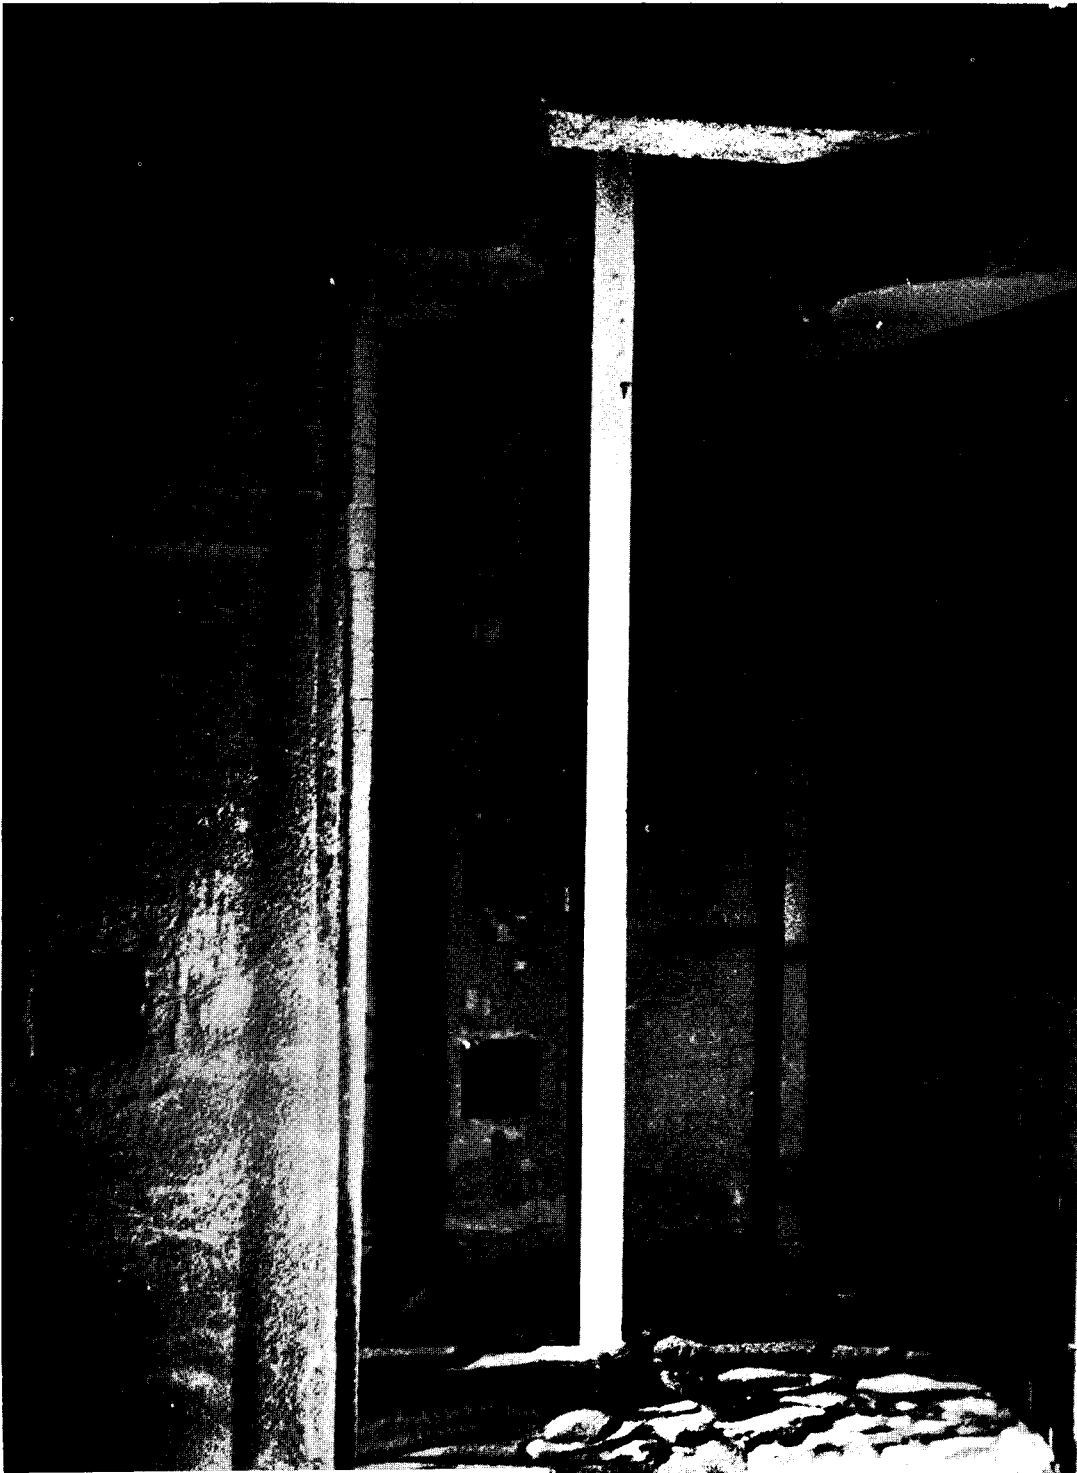
Figure 1. The column assembly in place
prior to fire test.

Figure 1 shows the column assembly in place prior to the fire test. The column assembly was made up of a 3 in. x 2 in. x 3/16 in. hot rolled rectangular structural (ASTM Grade A-36) steel tube protected by two layers of gypsum board. The underlayer was 3/8 in. regular gypsum board and the face (fire-exposed) layer 1/2 in. type C. The fire-exposed face was plastered with 1/8 in. thick joint compound. At the top and the bottom of the column assembly a 6 in. x 9 in. x 3/16 in. thick bearing plate was attached with a continuous fillet weld around all sides of the column leaving an overall column length of 10 ft. 8 in. (including the 3/16 in. bearing plates). Each bearing plate had four 1/2 in. diameter bolt holes located in the corners of the plate 1 in. from each edge. The measured weight of the column assembly was 120 lbs. For the specimen tested the

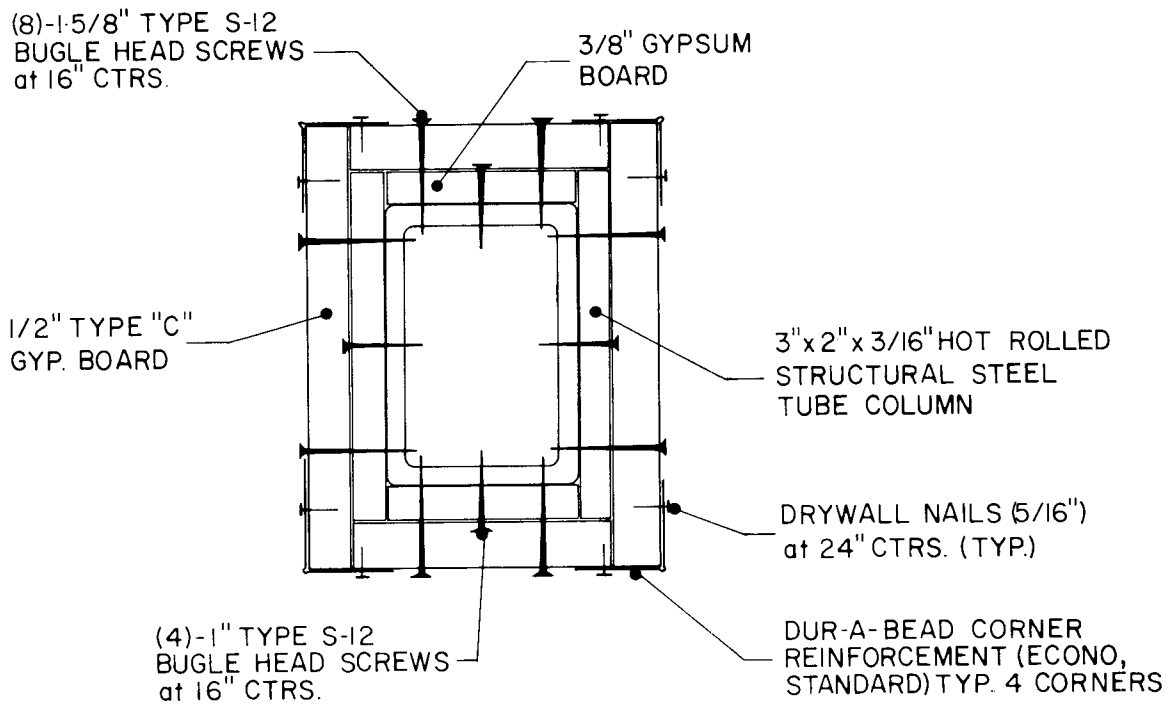
Figure 2. Section detail of the column with specified fastening (not tested).

The under layer of 3/8 in. regular gypsum board was to be attached with 1 in. long type S-12 bugle head screws along the center of each side at 16 in. centers. The face layer of 1/2 in. type C gypsum board was to be attached with two 1-5/8 in. long S-12 bugle head screws at each corner and at 16 in. centers vertically. The four corners were secured with corner reinforcement (ECONO standard dur-a-bead) which was to be attached with 5/16 in. drywall nails at 24 in. centers. The construction detail of the specimen with specified fastener schedule is shown in Figure 2.

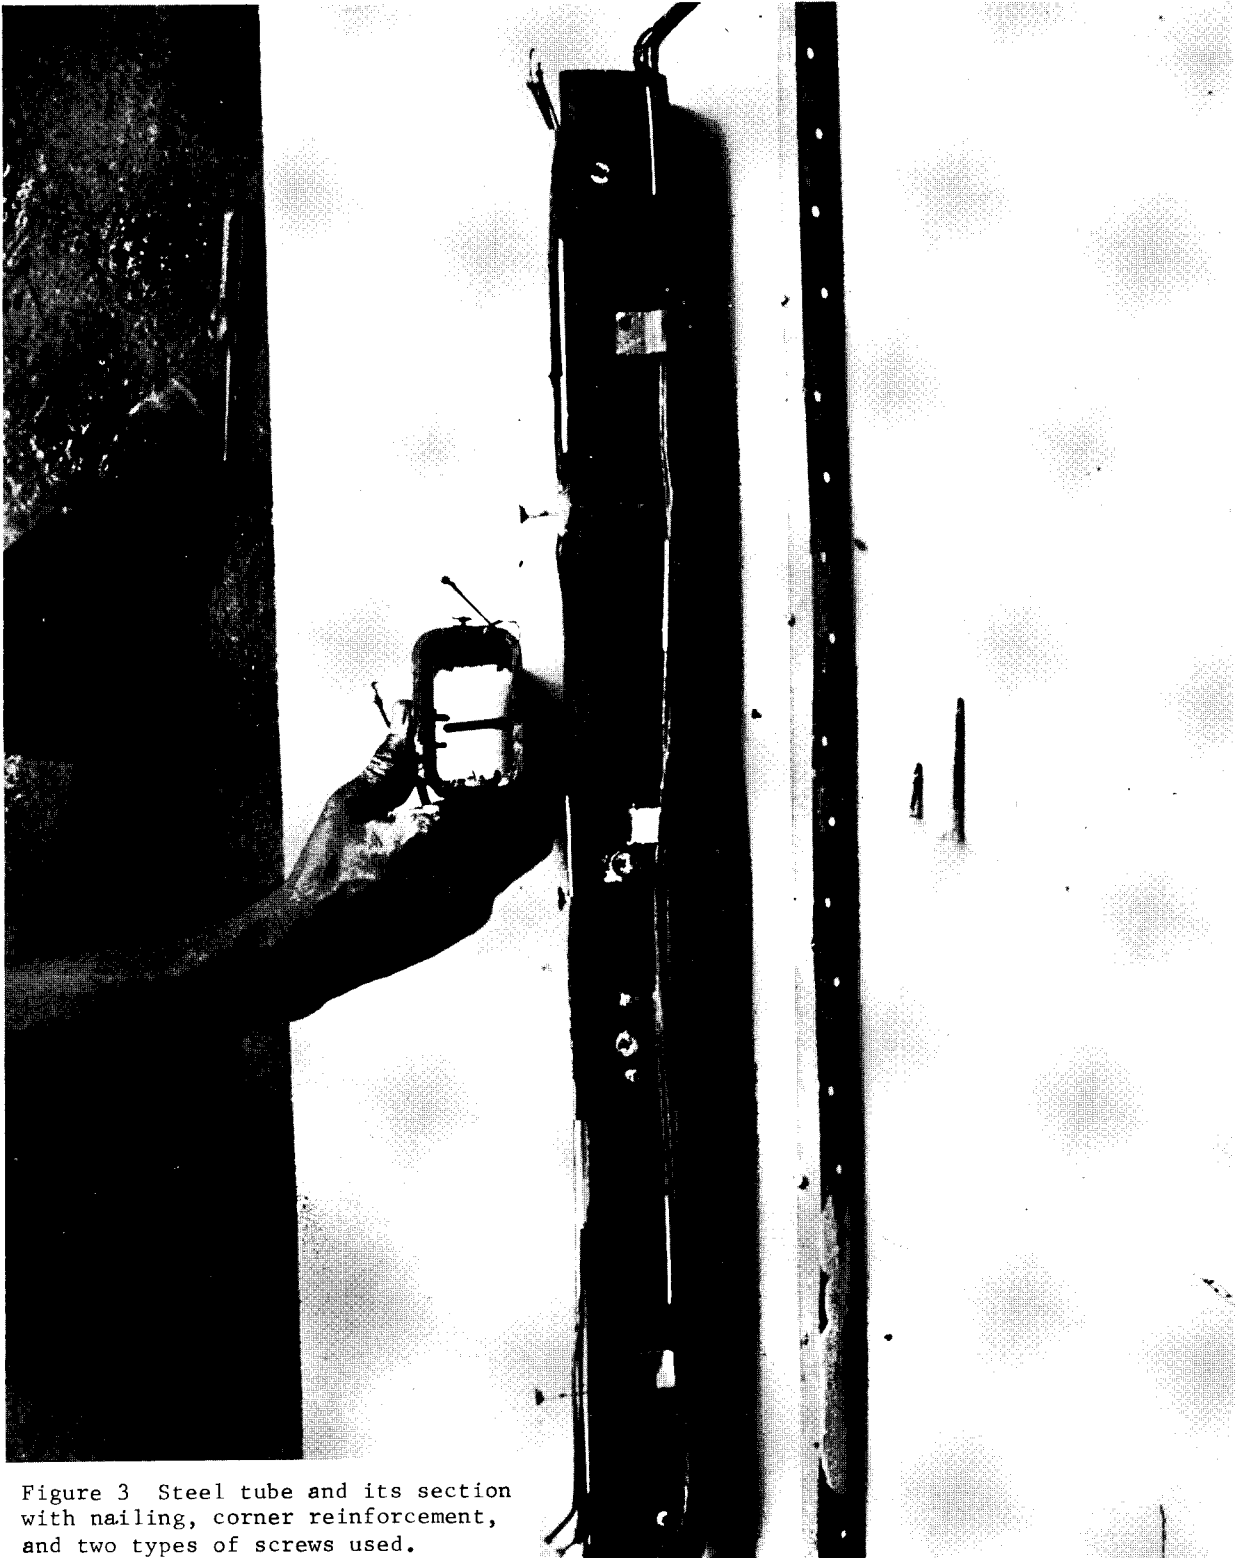
Figure 3 Steel tube and its section with nailing, corner reinforcement, and two types of screws used.

The fasteners used in the test consisted of 1 in. self drilling bugle head metal screws on the underlayer of gypsum board and 2-1/4 in. self-drilling Phillips recessed flat head metal screws. Both were spaced approximately at 16 in. centers along the center line of each side on the face layer. The corner reinforcement was crimped for holding into the gypsum boards. The photograph in Figure 3 shows the fastening on the actual column and corner reinforcement.

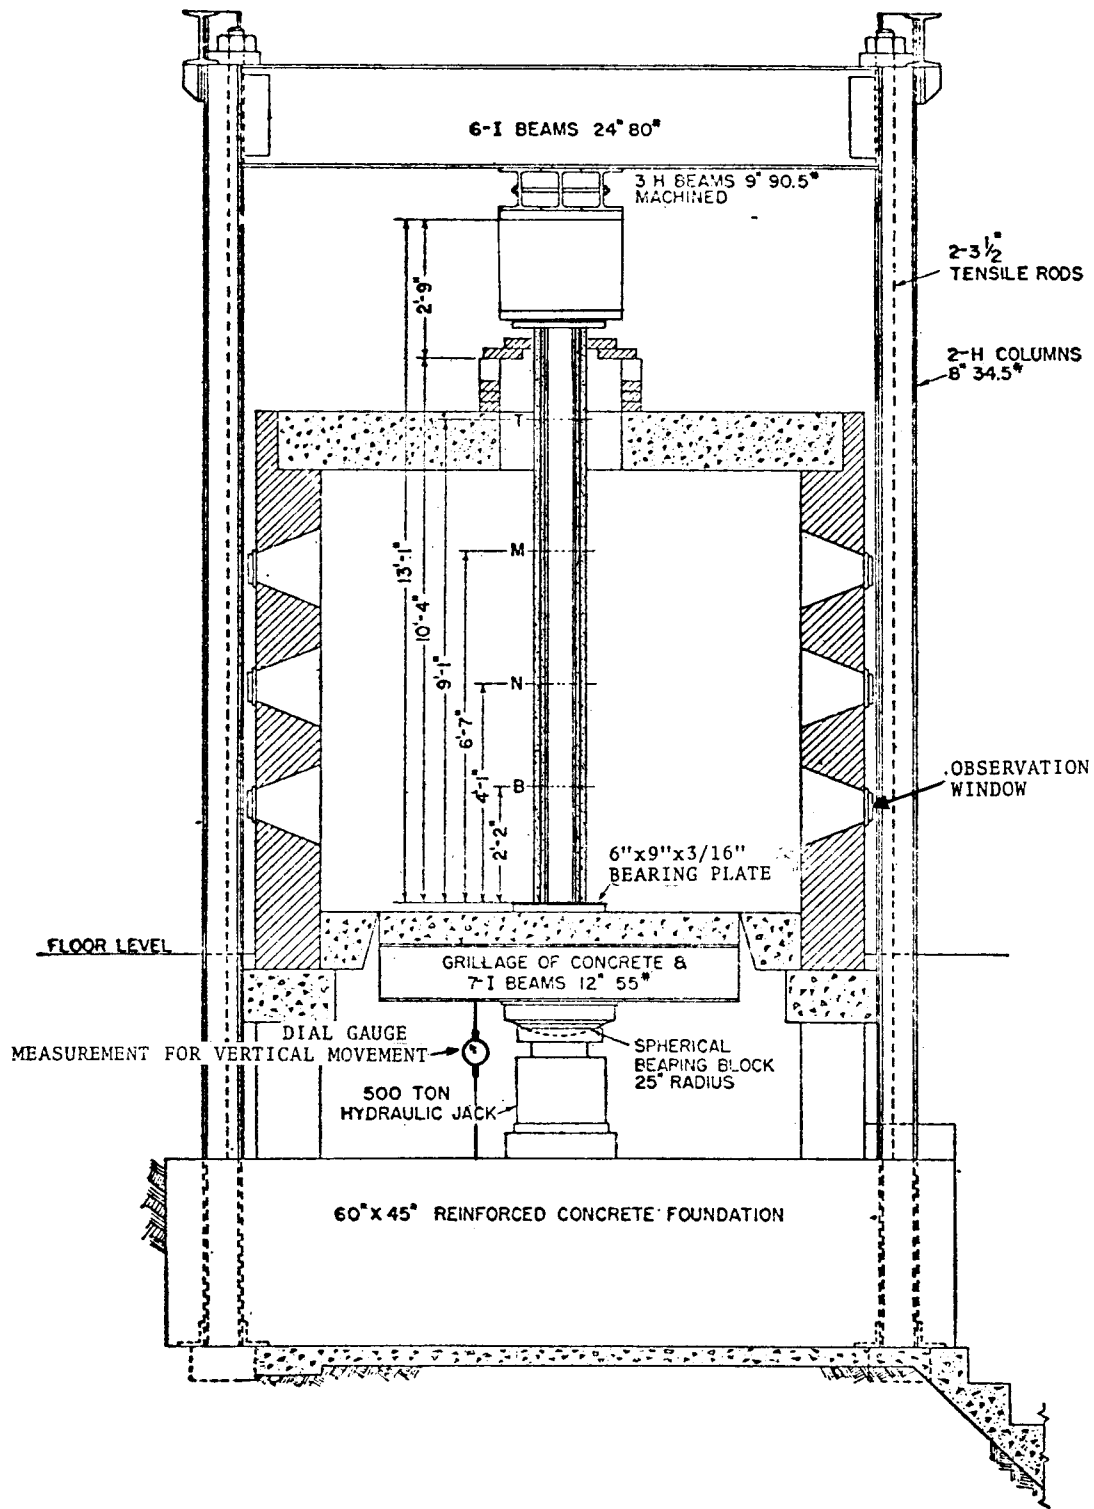
Figure 4. Furnace and loading equipment with typical column in place.

was installed on the steel column face at four levels as indicated by the position B, N, M, and T in Figure 4. Three thermocouples were located at level T and four thermocouples at levels B, N, and M. The thermocouples were attached with sheet metal screws to the column prior to attaching the two layers of gypsum boards. The thermocouple wire was wound twice around each screw with the beaded junction under the head of screw. The lead wires were run underneath the bottom layer of gypsum board, up to the underside of the top bearing plate. Care was taken to avoid damaging the thermocouple wires with the screws used for attaching the gypsum boards.

The vertical deflection of the column assembly during the test was measured by a dial indicator gage, which was placed under the bottom of the loading frame. Figure 4 shows the furnace and loading equipment with the column specimen in place.

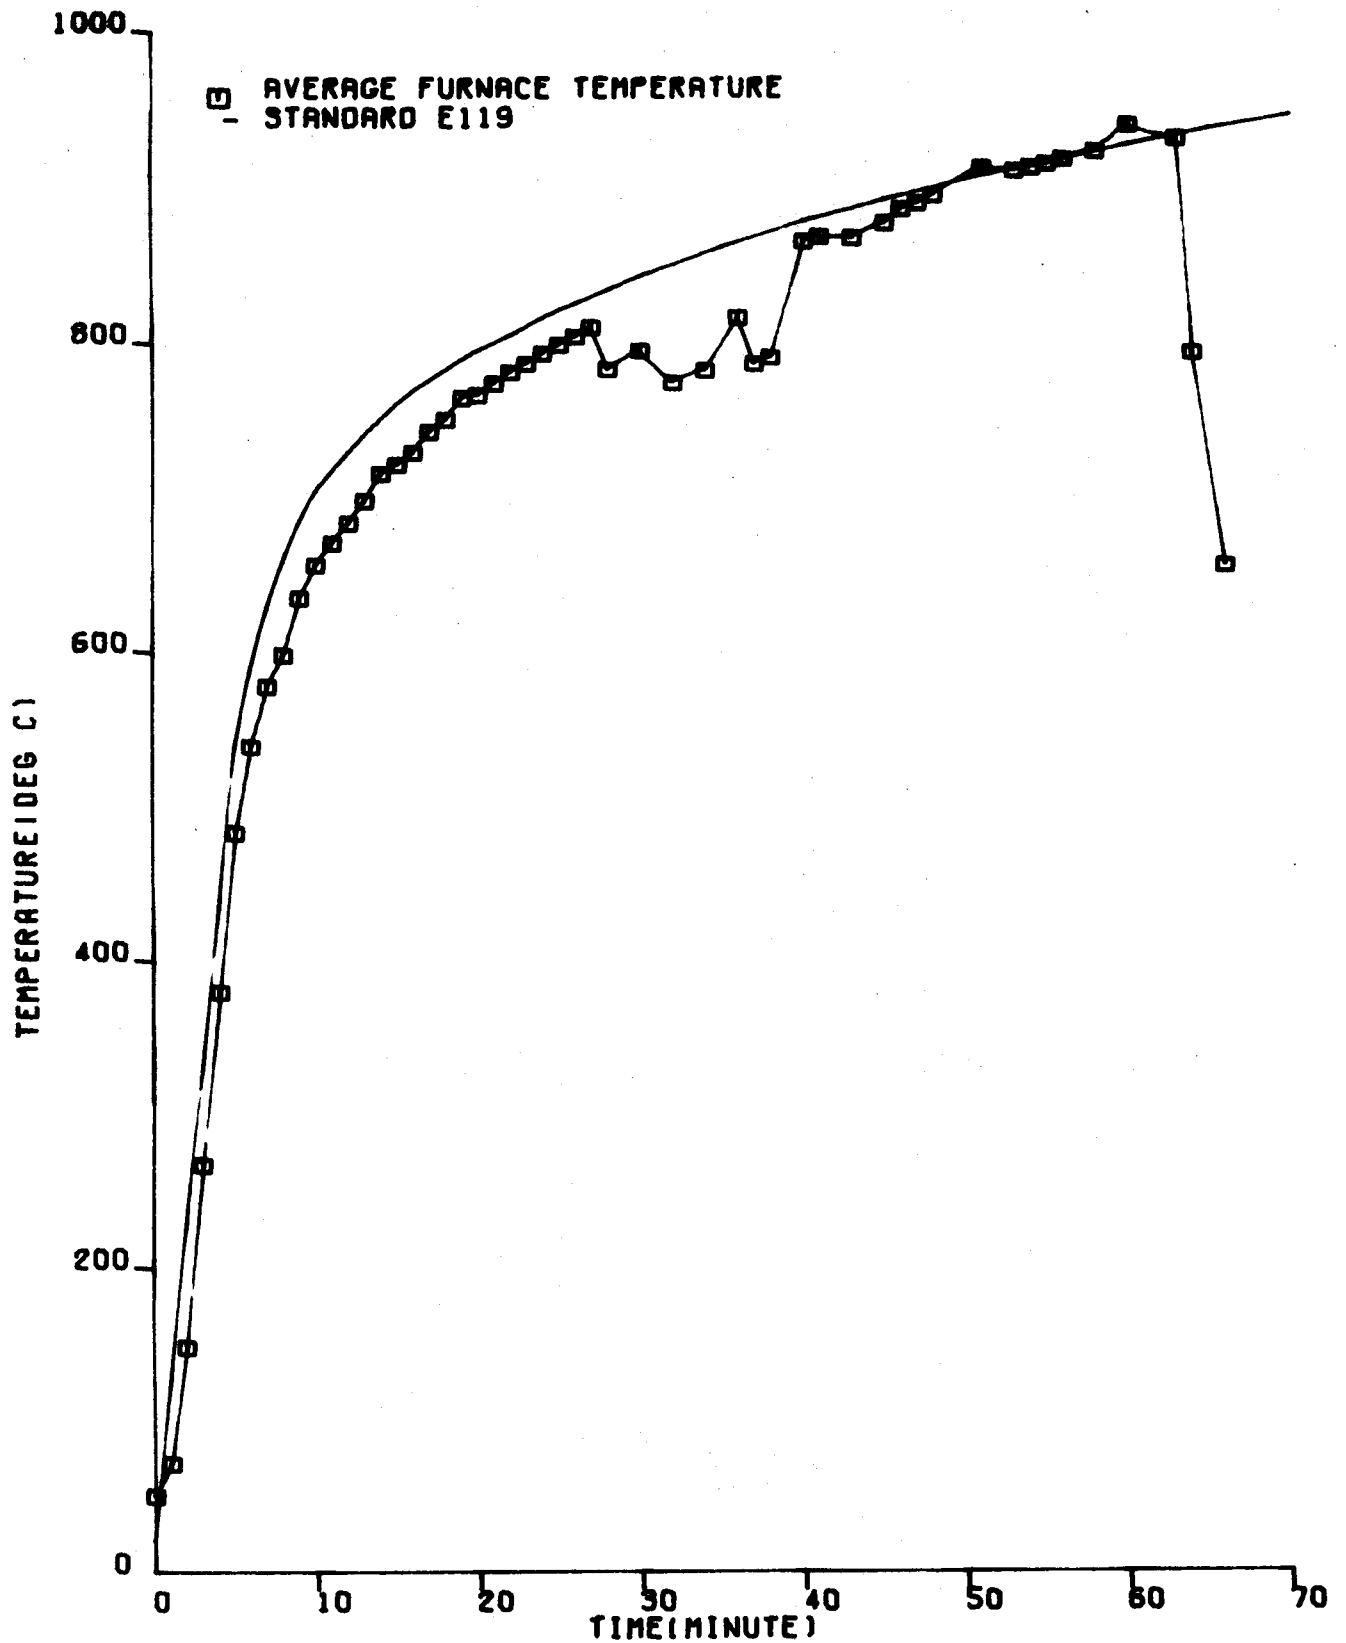
Figure 5
 Average Furnace Temperature Compared With Standard ASTM E 119 Curve (Test-495)

The temperature inside the furnace was measured by 12 standard Chromel-Alumel thermocouples enclosed in 1/2 in. wrought iron pipes with closed ends placed at various heights around the column. The furnace temperature was constrained to follow the standard ASTM E 119 time-temperature curve by manual control of gas flow to the burners. The actual furnace time-temperature curve is shown in Figure 5.

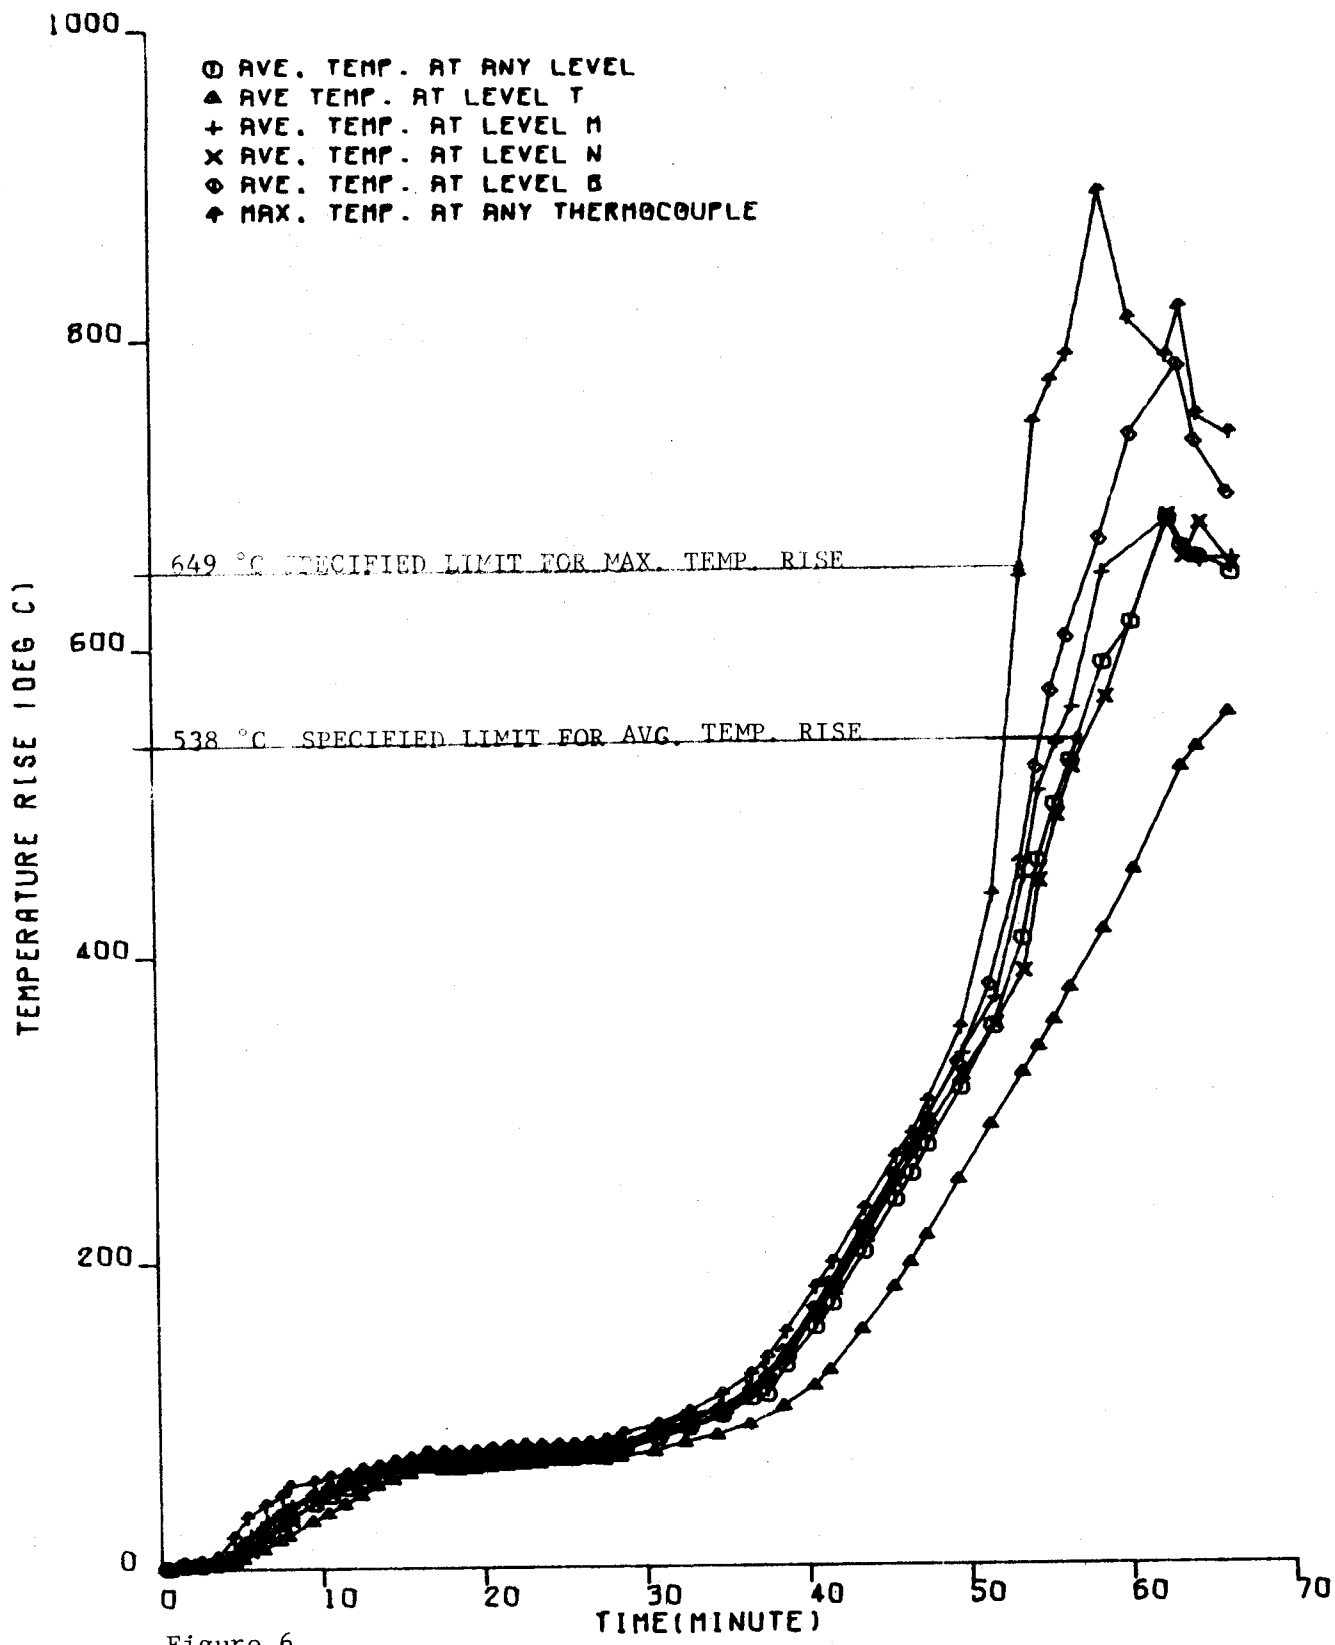
Figure 6
 Average Temperature Rise On The Steel Surface At Any Level. At Level T. M. N.
 And B And Maximum Temperature Rise At Any Thermocouple (Test-495)

The average and the maximum temperature rise of the column thermocouples during the test are shown in Figure 6. At one hour, the column

temperatures ranged approximately from 450°C to 850°C, with an average of 610°C, and a maximum single-point of 830°C. The vertical deflection was measured at the bottom of the loading rig and is shown in Figure 7. Structural failure of the column occurred at 61 min:50 sec. when the column could not sustain the applied load, as shown in Figure 7. The corrected time of the structural failure, according to the standard correction formula in ASTM E 119 which is based on the comparison of the areas under the actual time-temperature curve and the standard curve, was 59 minutes. In spite of the applied load, the length of the column expanded due to the furnace heat. Just prior to the failure, the length of the column had expanded approximately 0.8 inches.

Since the test was performed under the design load, the E 119 criterion for fire endurance was only based on sustaining the applied load. Therefore, the temperature readings of the steel are provided for information only for evaluating the column protection during the test. As shown in Figure 6, the time to an average temperature rise of 538°C and a maximum temperature rise of 649°C were 57.5 minutes and 53.5 minutes, respectively.

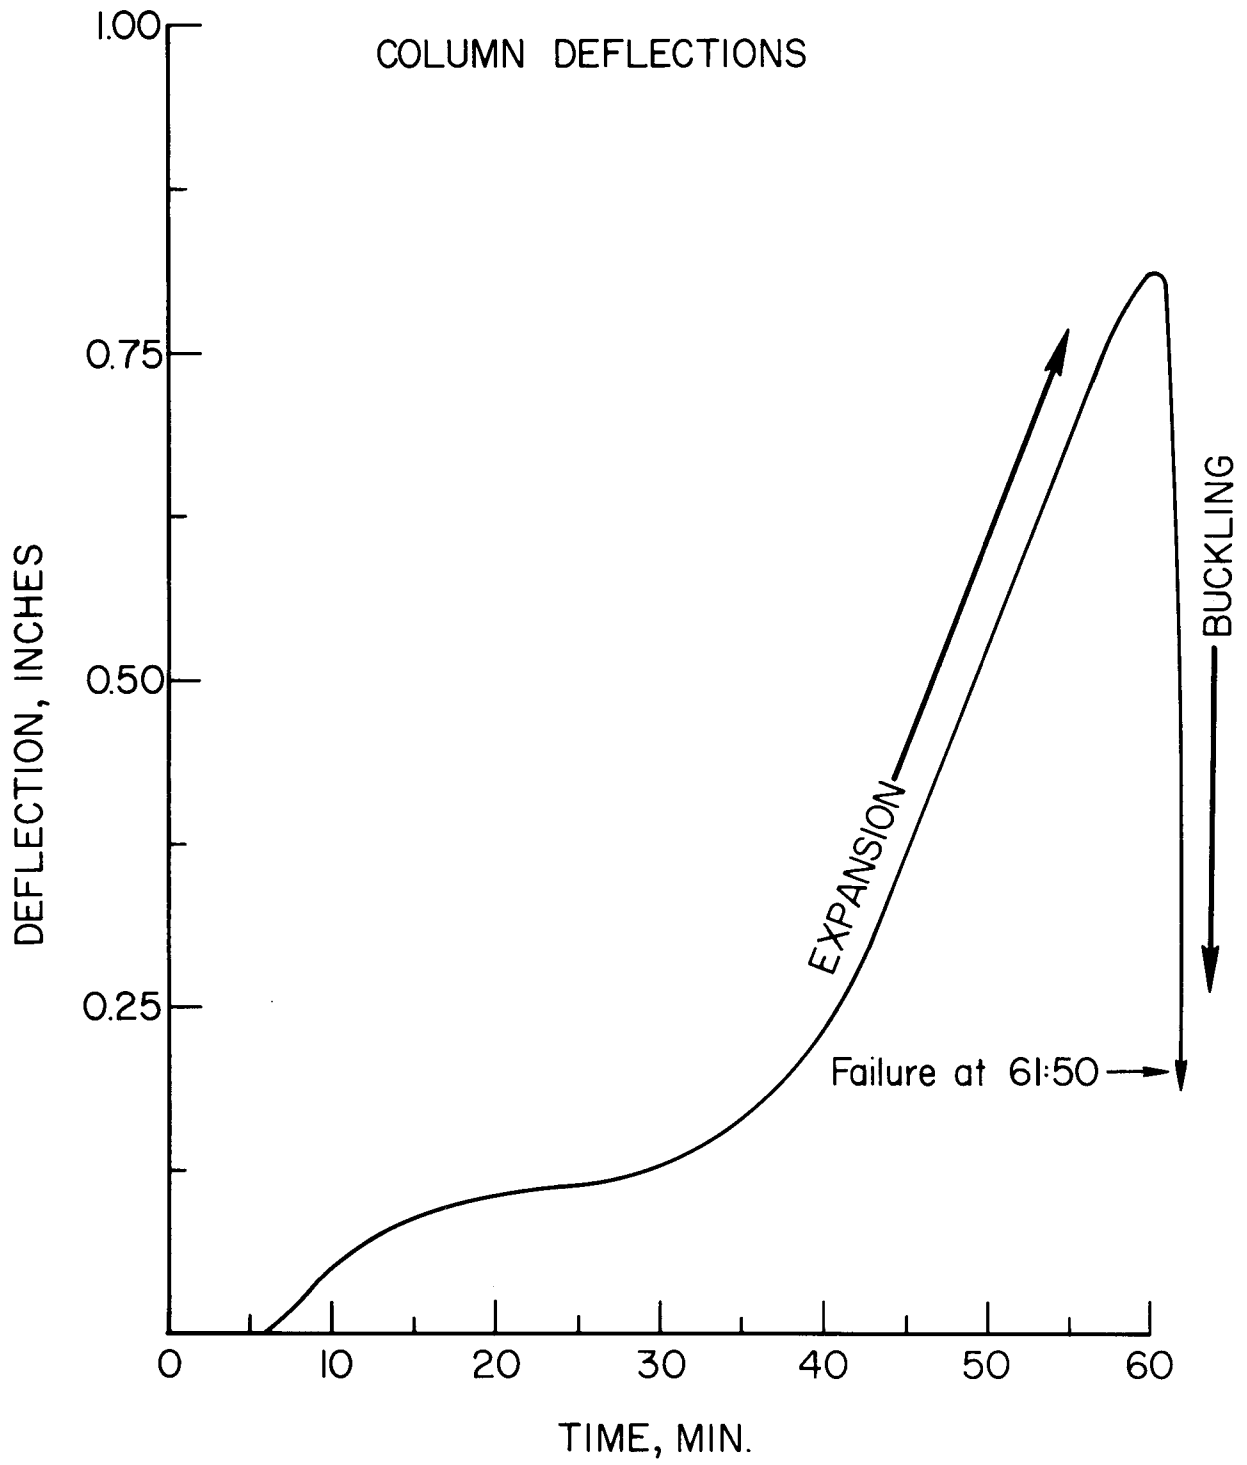
Figure 7. Vertical deflection of the column during the test.

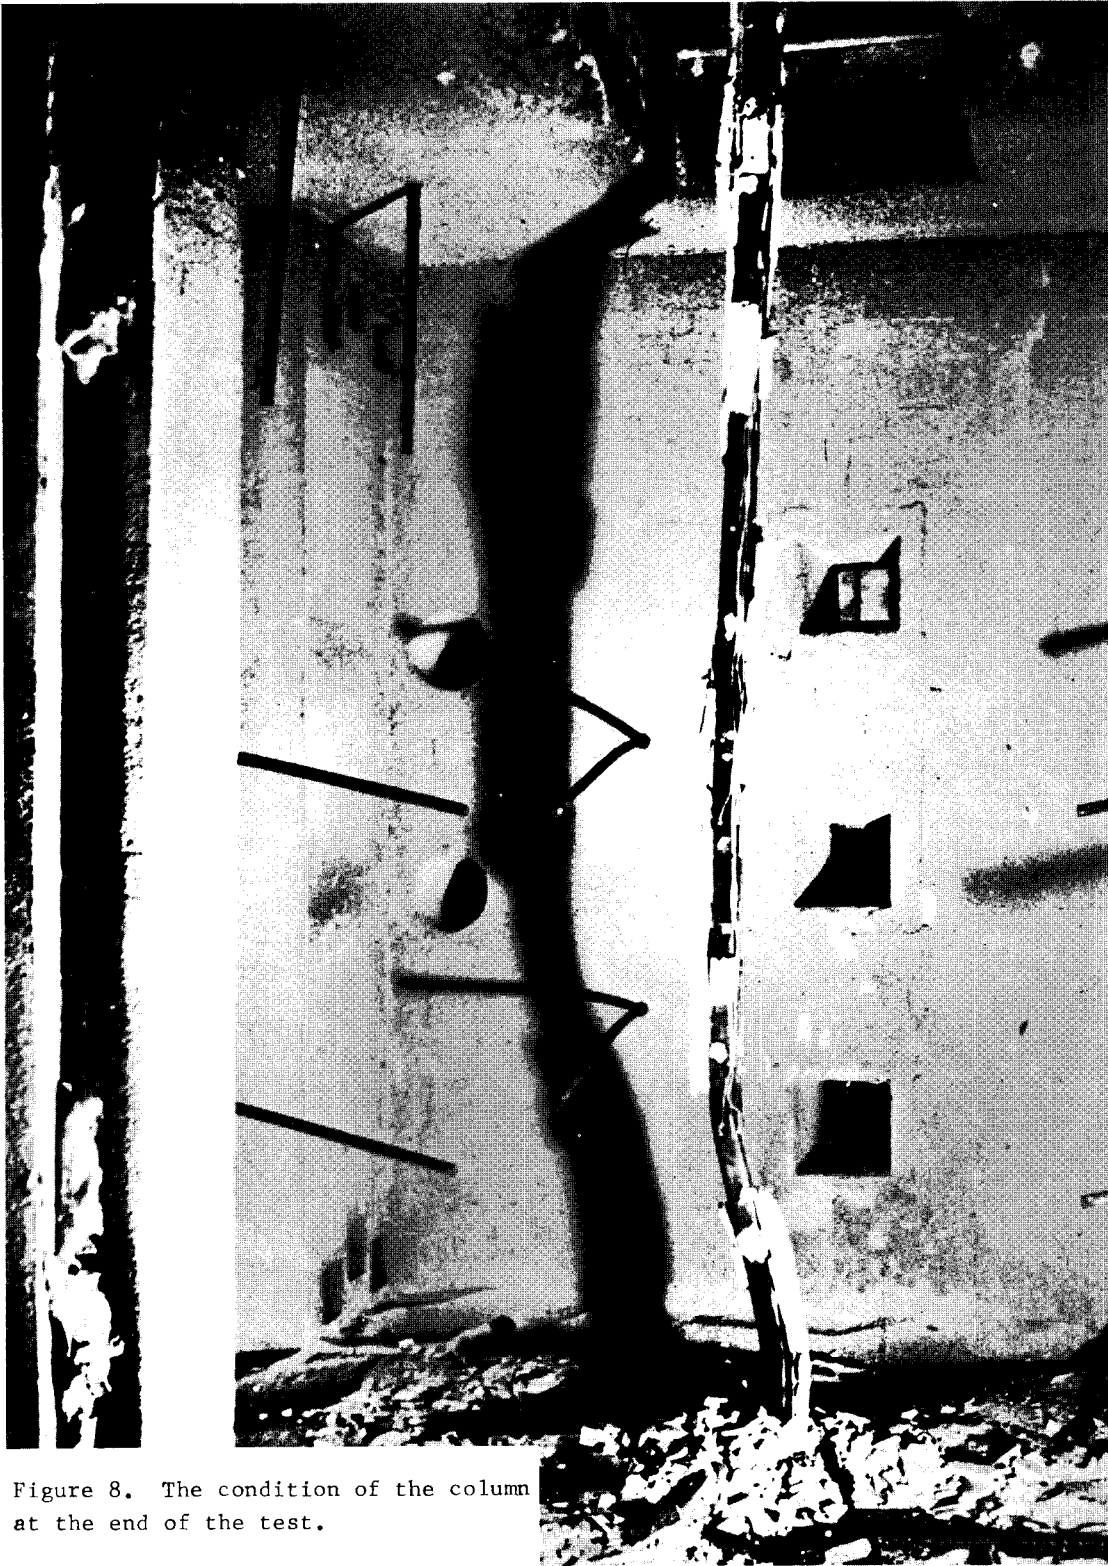
Figure 8. The condition of the column at the end of the test.

Figure 8 shows the conditions of the column at the end of the test and the bowing of the column near the bottom.

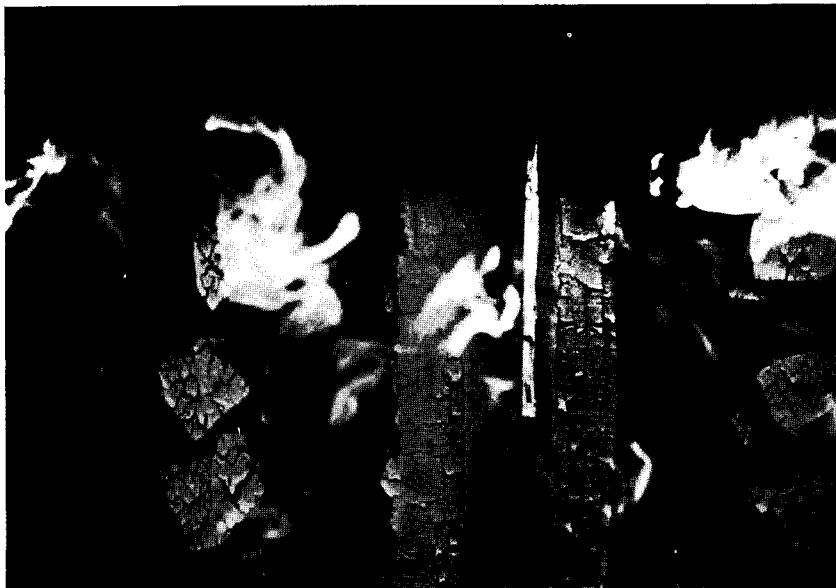
Figure 9. Note the corner reinforcement separating from the column.
Test time of 12 minutes.

12:00	The corner angle reinforcement has been separated and is hanging down. (Figure 9).
28:00	The corner joints on the south and east side of the gypsum boards have opened up about 3/8 inch. The south gypsum boards are buckling a little and this is slowly increasing.

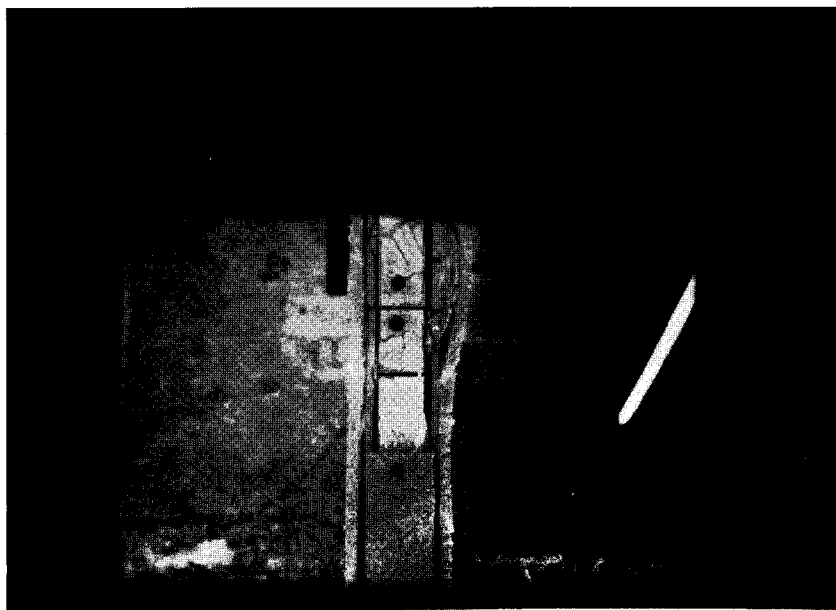
Figure 10. Gypsum covers on the column are falling down.
Test time of 45 minutes.

45:00	The gypsum board on the south face has separated about one foot. Horizontal cracks are observed on the under layer of gypsum board on south side. On the north side the separation of the face gypsum board has increased to about 6 inches. (Figure 10)
