# ***Steel vs. Wood***

## ***Long-Term Thermal Performance***

***Valparaiso Demonstration Homes***

January 2002

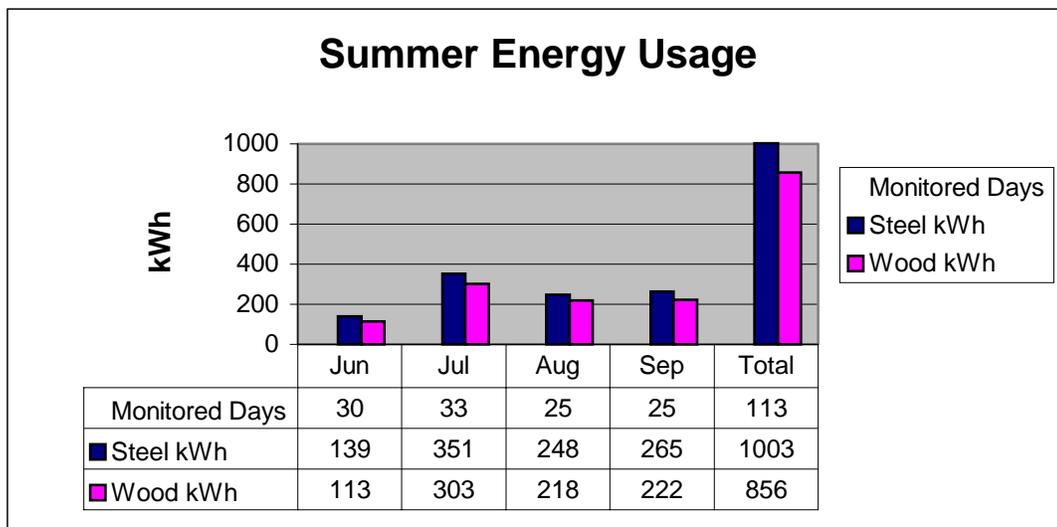
Figure 7.1

As seen in the energy consumption chart, directly monitored HVAC energy is relatively consistent between months, showing an average of 17.1 percent greater use in the steel-framed house than in the wood-framed house.

June represented the biggest percent difference between the steel and wood-framed houses (23.0 percent). August, the hottest month of the year, had the smallest percentage difference in use between the houses (13.8 percent).

The different internal house temperatures and slightly different air infiltration rates and duct tightness were plugged into a computer simulation model (Energy 10 v1.3). The normalized results tend to reduce the energy needed by the steel-framed house relative to the wood framed house. The net results reflect a reduction of 4.1 percentage points down to 13 percent more energy required to condition the steel-framed house than the wood framed house for the four peak summer months. The primary driver for the change was the 0.5°F lower temperature in the steel-framed house.

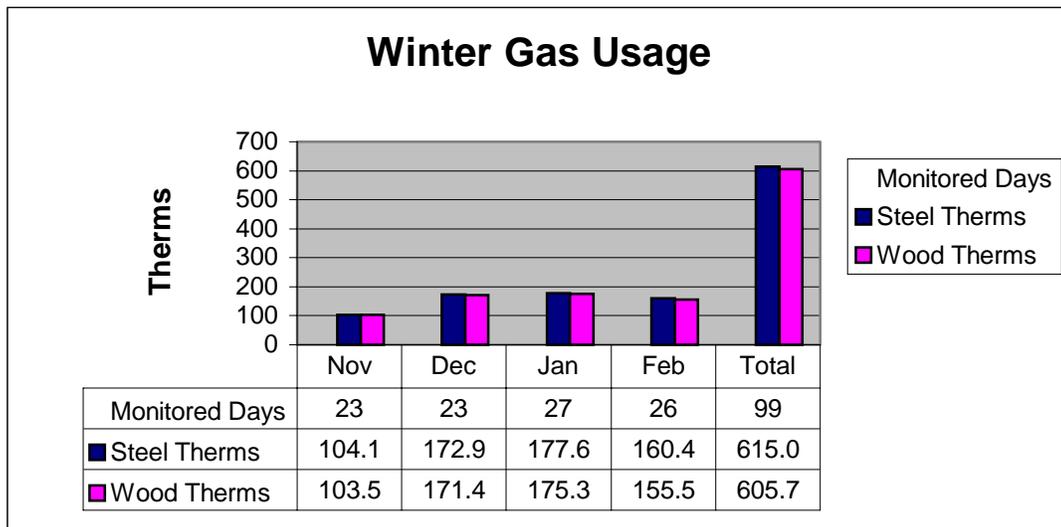
**Figure 7.2**

Directly monitored natural gas consumption indicated that the steel-framed house required 1.5 percent more energy than the wood framed house. The consumption difference was reasonably

consistent over the winter months varying from 0.5 percent in November to 3.1 percent in February.

The computer-modeled normalization increased the winter difference between the two houses from 1.5 percent to 4.4 percent. The average winter temperature in the steel-framed house was 0.4°F lower than the wood framed house requiring less energy to maintain temperature. Another significant contributor to the increased difference was the duct leakage to outside that was about 50 percent higher in the wood framed house (Appendix F). This required the wood framed house to use more energy to deliver conditioned air to the living space.

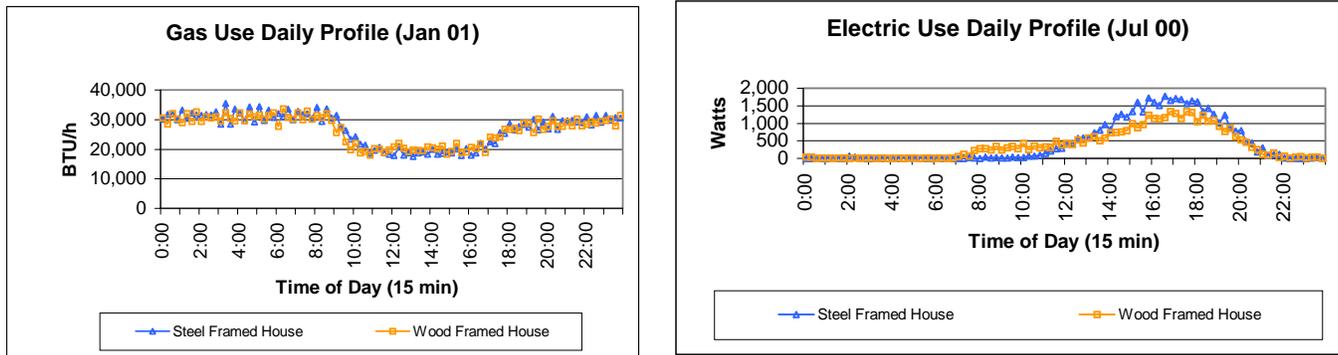
Figure 8.1

One of the architectural differences between the houses is the front porch. The steel-framed house has a full covered front porch shading both the front door and the family room window. The wood framed house has a smaller covered front stoop that provides shading only to the door. Consequently, there were noticeable differences in the morning energy usage despite shading on all family room windows. Summer mornings reflected an earlier cooling load in the wood framed house due to the solar gains in the family room triggering the A/C to run. Winter

mornings had the opposite effect, with the solar gain causing a decreased heating load in the wood-framed house from about 8:00AM to 10:30AM (see graphs below).

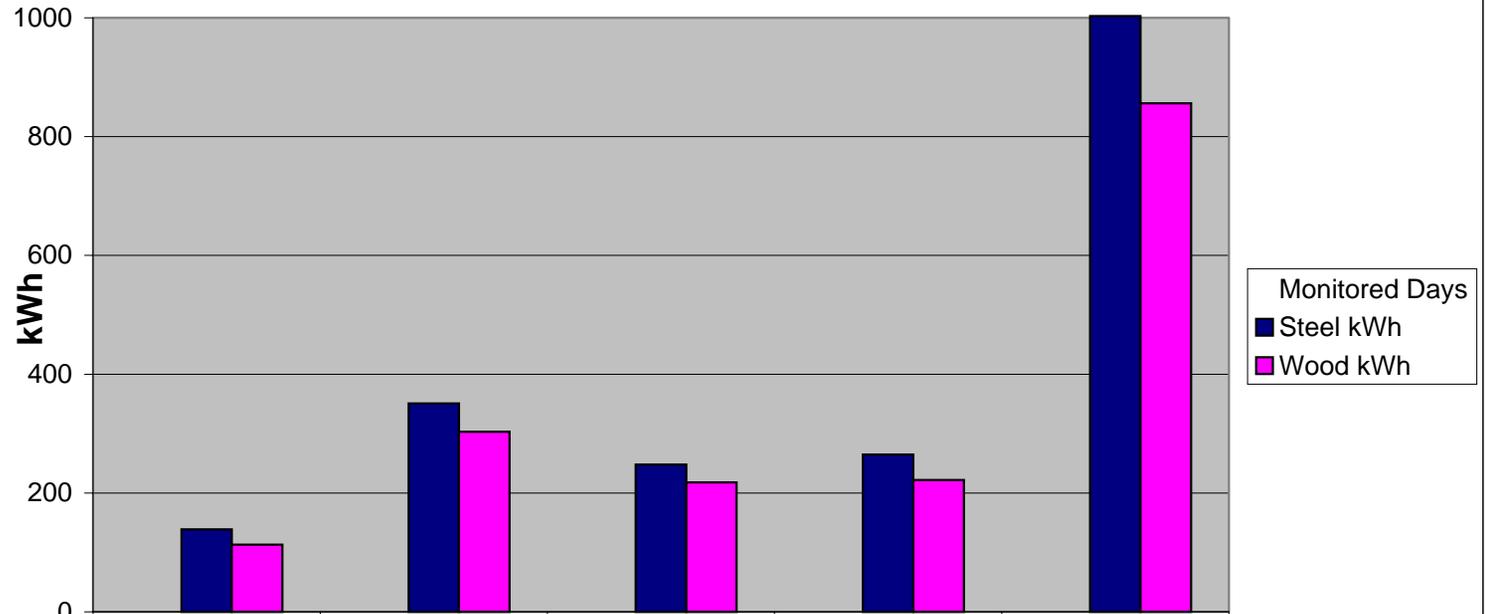
## Actual Summer Electric Usage

Jun	Jul	Aug	Sep	Total
Monitored Days	30	33	25	25	113
■ Steel kWh	139	351	248	265	1003
■ Wood kWh	113	303	218	222	856

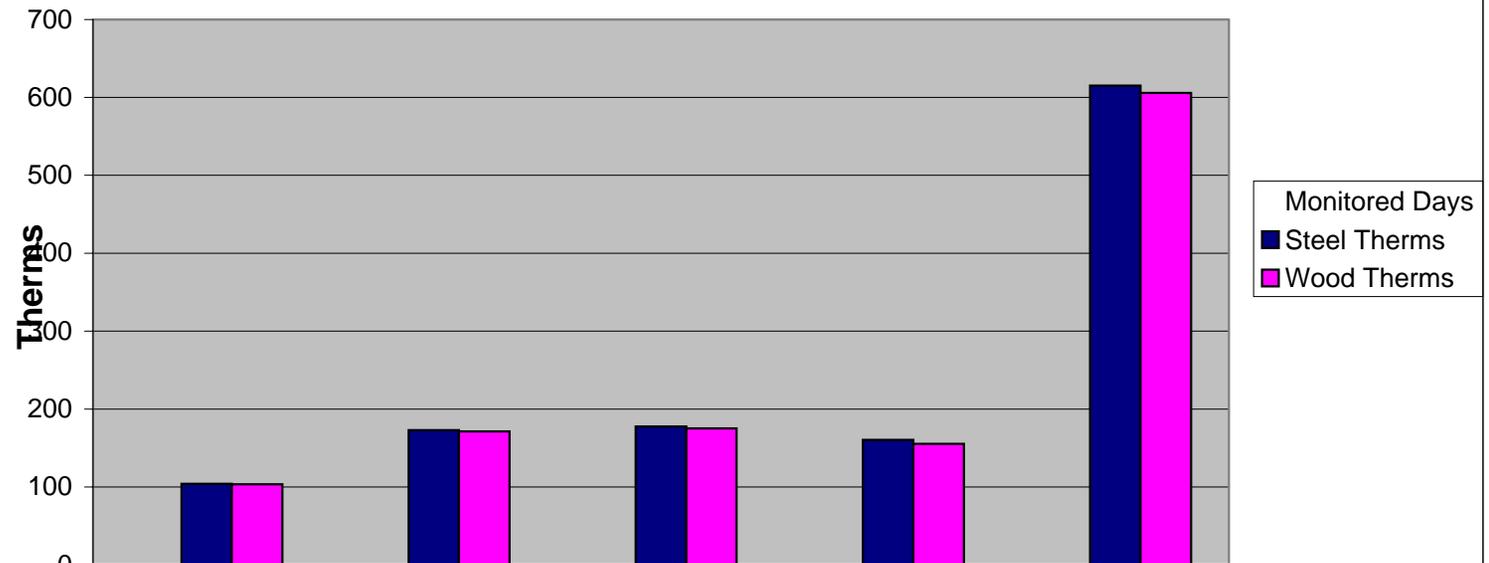
## Actual Winter Gas Usage

Nov	Dec	Jan	Feb	Total
Monitored Days	23	23	27	26	99
■ Steel Therms	104.08641	172.87356	177.64899	160.40355	615.01251
■ Wood Therms	103.54749	171.36159	175.25379	155.50836	605.67123

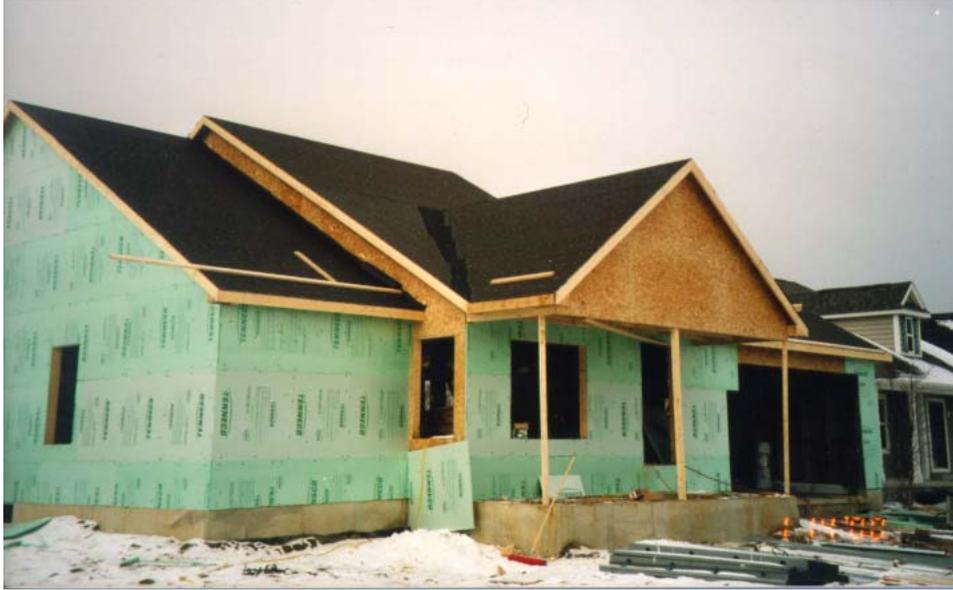
**Steel House Sheathed with Rigid Foam Insulation**
