# **Innovative Rehabilitation Provisions**

**A Demonstration of the  
Nationally Applicable Recommended  
Rehabilitation Provisions**

U.S. Department of Housing and  
Urban Development  
Office of Policy Development  
and Research

NAHB Research Center, Inc.  
Upper Marlboro, MD

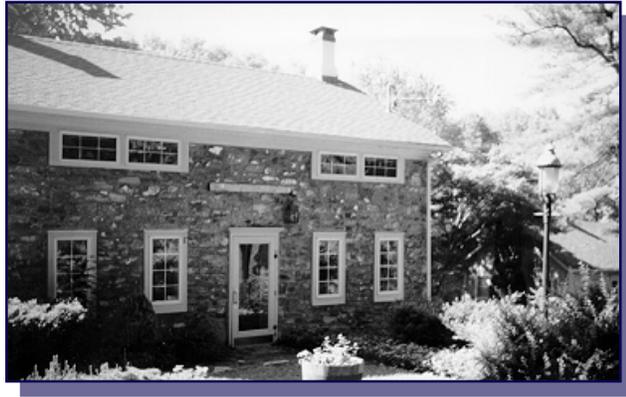
*Figure 5. The Stone Lodge circa 1747.*

The NARRP project called for rehabilitation of a structure known as the Stone Lodge (see Figure 5). The original stone structure was built in 1747, and has a long history of additions and alterations.

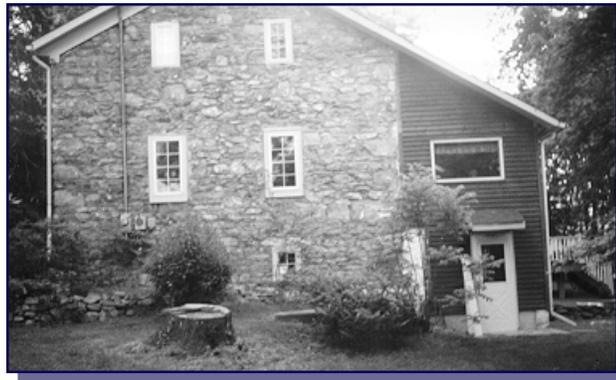
Figure 6. Carriage House and Porch.

A carriage house and porch were added to the structure in the 1800s (see Figure 6). In 1985, the structure's electrical and plumbing systems underwent extensive repair. At the same time, the windows were replaced and the rear porch was enclosed. In 1990, a master bedroom and den were added to the east side of the structure (see Figure 7). The Stone Lodge and its long history of alterations is a perfect example of how rehabilitation is necessary to allow a structure to maintain its functionality over time.

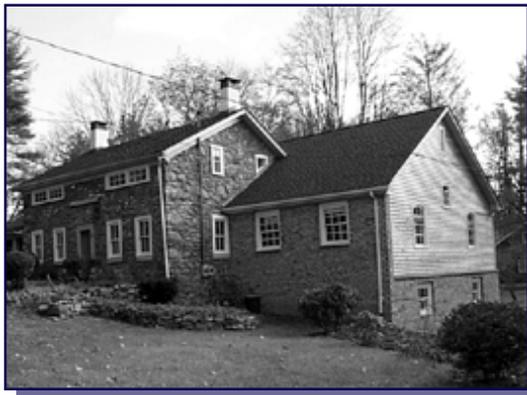
*Figure 8. Front Elevation of Completed Project.*

The current project included a 28- x 28-foot two-story addition and reconstruction of the existing kitchen. The addition accounted for approximately 1,250 square feet of living area and included two bedrooms, a bathroom, dining room, home office, and work/utility room. Figure 8 is a view of the front elevation of the Stone Lodge with the completed addition; Figure 9 is a view of the rear elevation.

The shaded portions of Figures 10, 11, and 12 illustrate the areas affected by the rehabilitation and addition. The addition is incorporated in such a way as to provide a smooth and open transition between the existing and new spaces (see Figures 10, 11, and 12). The addition also blends well into the exterior facade of the existing structure (see Figures 8 and 9).

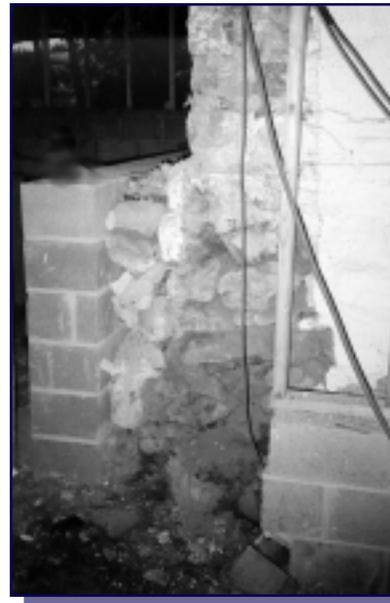
Figure 13. Rubble Stone Foundation.

Officials with the New Jersey State Department of Community Affairs indicated that a structural analysis would likely have to be performed to determine the load-bearing capacity of the existing rubble stone foundation (see Figure 13). Both the NARRP and the New Jersey Subcode contain provisions that allow the existing structural systems in single-family residential dwellings to remain in place if no additional loads are applied and no visible signs of structural failure are apparent. Table 2 provides an estimate of the costs for such a structural analysis. It should be noted that the costs include those for excavation of the exterior of the foundation for a visual inspection. Such costs would not be incurred in all cases.

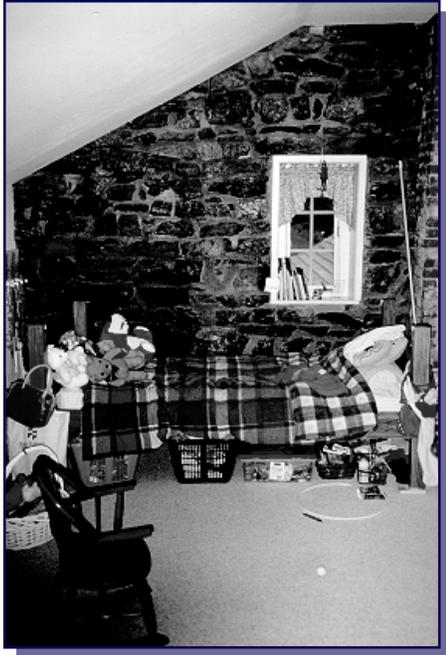
*Figure 14. Existing 19- x 30- Inch Casement Window.*

The home's existing second story is currently used as a bedroom area. None of the five existing windows in the bedroom area meets the requirements for egress windows in new structures. Three of the windows are 19- x 30-inch casements (see Figure 14); the other two are 14- x 36-inch sliders (see Figure 15). Compliance with the old rehabilitation provisions would have likely required widening one of the windows in this area to comply with the egress requirements for new structures. (Widening is not required under the NARRP or the New Jersey Subcode.)

Widening even one window opening would be extremely difficult because of the 14-inch-thick stone exterior walls. Sufficient temporary support would have to be provided with needle beams. Further, given that the existing openings do not have structural headers, a header or lintel would have to be designed and installed to support the wider opening.

Table 3 provides an estimate of the cost of widening a window to meet current egress requirements. The estimate assumes that only one of the casement windows would be widened because any modification to the sliders in the front of the house would have been aesthetically unacceptable. Table 4 provides a similar estimate for a structure with wood-framed exterior walls and wood siding.

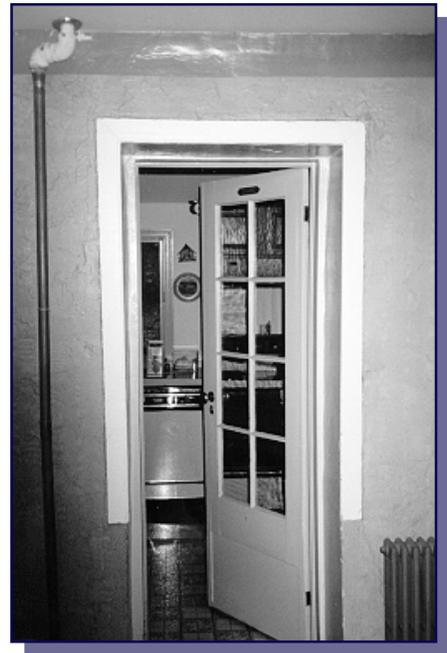
Figure 16. Low Ceiling Height.

The bathroom located in the existing lower level has ceiling heights of approximately 6'8" (see Figure 16). The minimum ceiling height required for new buildings is 7-feet in living areas. Accordingly, the concrete slab would have to be demolished and excavated to accommodate the required ceiling height, thereby requiring alteration of the existing plumbing in the bathroom to accommodate the lower floor level. Table 5 presents estimated costs for performing this work. The remainder of the lower level is used as storage and would not require alteration.

Although most code officials would not require the ceiling height to be modified, officials with the New Jersey State Department of Community Affairs indicated that they would require the minimum height under a strict interpretation of the code and would be well within their rights to do so.

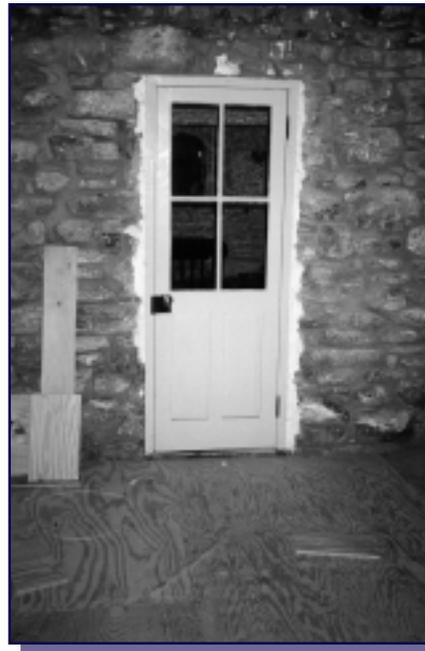
Figure 17. Existing Corridor.

The doorway connecting the existing kitchen area to the living area of the existing structure is 24-inches wide (see Figure 17). During the revitalization, the door was removed, leaving the opening to remain as a corridor. Building officials with the New Jersey State Department of Codes indicated that the old rehabilitation provisions would likely have required the widening of one of the two corridors leading from the family room to the new additions. The procedure would have been extremely difficult because the corridor openings are located in load bearing stone walls that are approximately 14-inches thick. The current openings do not have a header or lintel to carry the load. In addition, a structural analysis would be required to determine the appropriate size for a concrete beam or steel lintel to reinforce the larger opening. Table 6 provides an estimate of the cost to widen a corridor to meet current requirements; Table 7 provides a similar estimate for a structure with wood framed exterior walls and wood siding.

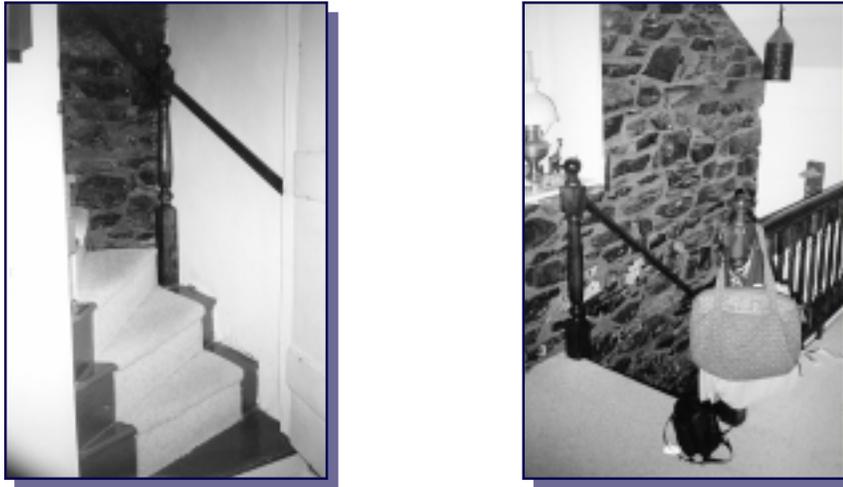
Figure 18. Existing Pocket Stairway.

The existing structure has two original pocket or closet-type stairways located in the central part of the original structure (see Figure 18). While structurally sound, the stairways fall significantly short of the requirements for new structures. They are only 32 inches wide with treads only 8 inches wide. The winders in the “L” portion of the stairways are 10 inches at the widest point. The stairway leading to the basement is equipped with the original rope handrail, which is functional but does not meet code requirements.

The 1993 BOCA code contains a provision that allows existing stairways to remain; the 25/50 rule, however, required structures to comply fully with the requirements for new structures. Building officials with the New Jersey State Department of Codes stated that under the old code, stairways would have to be brought into compliance with requirements for new structures. Under the 1993 BOCA code, stairways must be 36 inches wide with a minimum tread width of 10 ¾ inches. Winders in an “L” stairway must be a minimum of 6 inches wide at the narrowest point. They must also be a minimum of 9 inches wide at a distance of 12 inches from the narrowest point.

It would be impossible to alter the existing stairways to bring them into compliance with the requirements for new structures. Instead, the stairways would have to be demolished and replaced with new stairways, thus necessitating extensive design work and the alteration of existing space. Mr. Asdal indicated that demolition and reconstruction of the stairways would have rendered the project infeasible not only because of the associated high costs (see Table 8), but also because of the negative impact on the architectural appeal of the existing structure. Neither NARRP nor the New Jersey Subcode requires work in areas outside the work area.
