REVIEW OF STRUCTURAL MATERIALS AND METHODS FOR HOME BUILDING IN THE UNITED STATES: 1900 to 2000

U.S. Department of Housing and Urban Development
Washington, DC

NAHB Research Center, Inc.
Upper Marlboro, MD

January 25, 2001

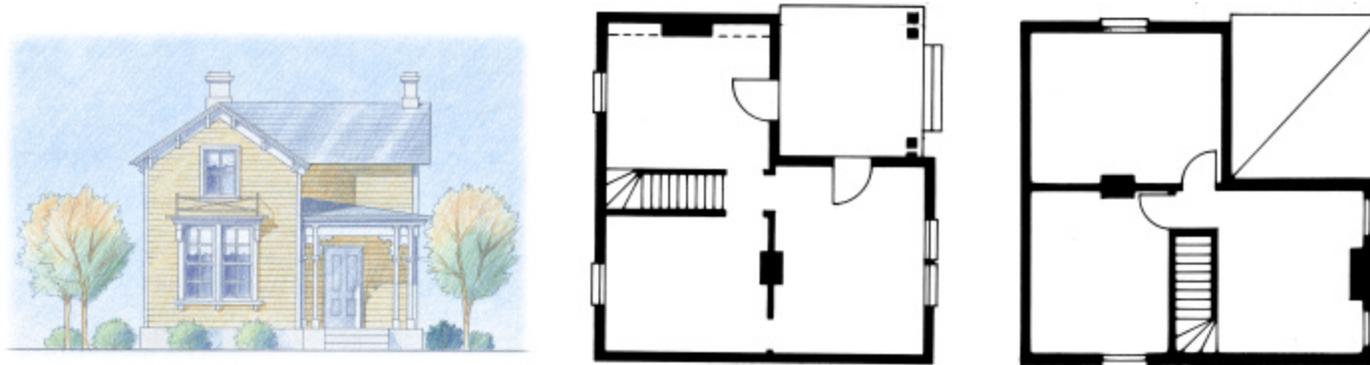
Figure 1. Profile home in 1900 (2 story).²

The front elevation and floor plan of a typical home produced in 1900 is shown in Figure 1. Good examples of traditional housing styles and architectural plans in the early 1900s are found in catalogues produced by Sears, Roebuck and Co., a major producer of traditional American kit homes from about 1910 into the early 1930s (see Bibliography). Likewise, it should be recognized that a large portion of the public lived in rural areas that were not subject to municipal building codes, and housing needs were likely fulfilled in a variety of ways that may not be well documented in the popular literature on housing construction. For example, in *Cotton Field's No More* it is stated that "more than half of the farmers lived in one- and two-room shacks that had not been whitewashed or painted for many years, if ever. Many of these houses had holes in the roof, wall, and floor." Further, U.S. Census data for 1900 reports that the value of land and buildings per farm in eleven Southern states ranged from \$600 to \$2,000. By contrast, the values for Indiana and Kansas were \$6,550 and \$3,718, respectively. Thus, living conditions and housing varied widely in the early 1900s.

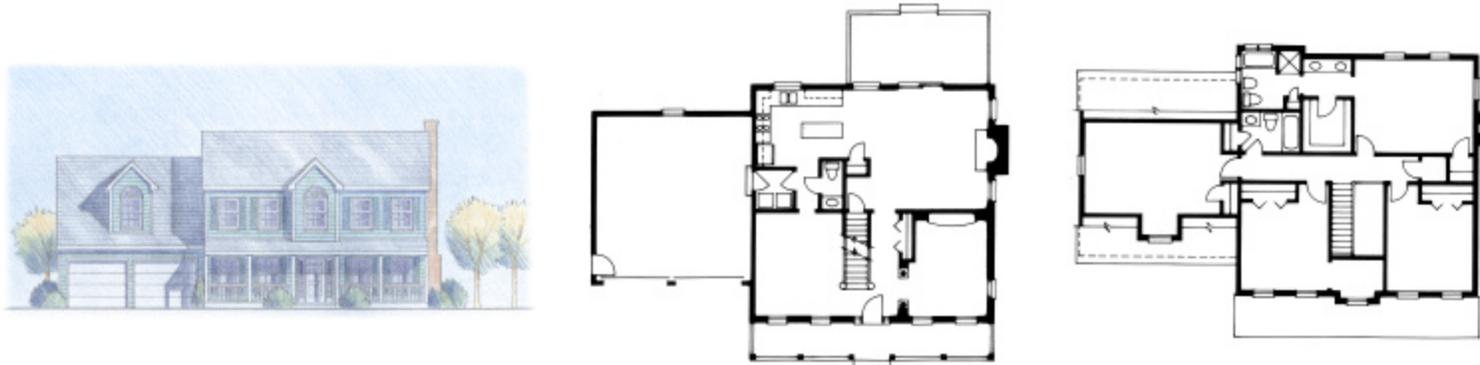
Figure 3. Profile home in 2000 (2 story).

The front elevation and floor plan of a typical home produced in 2000 is shown in Figure 3.
