NBSIR 75-688

Performance of Mobile Homes - A Field Inspection Study

June 1975

Interim Report

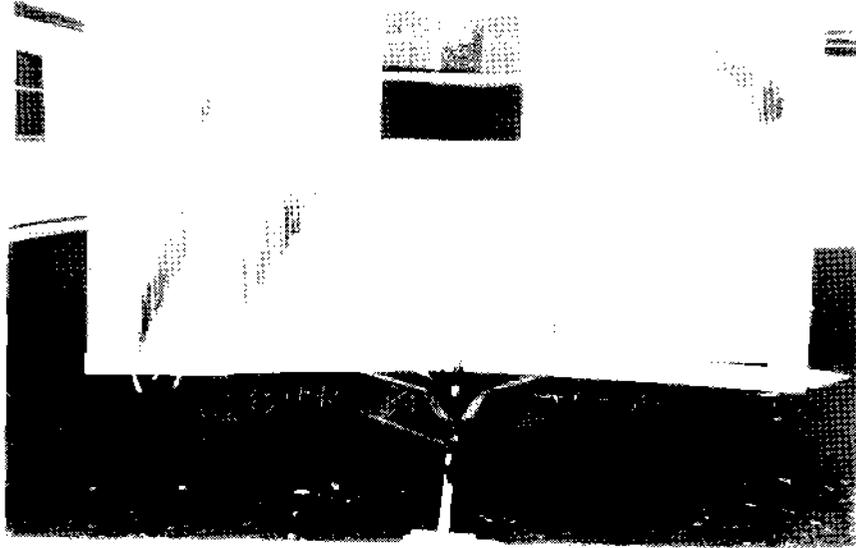
Figure C-34 A-Frame Assembly and Outrigger Failure
Resulting in Damage to Mobile Home - Exterior View.

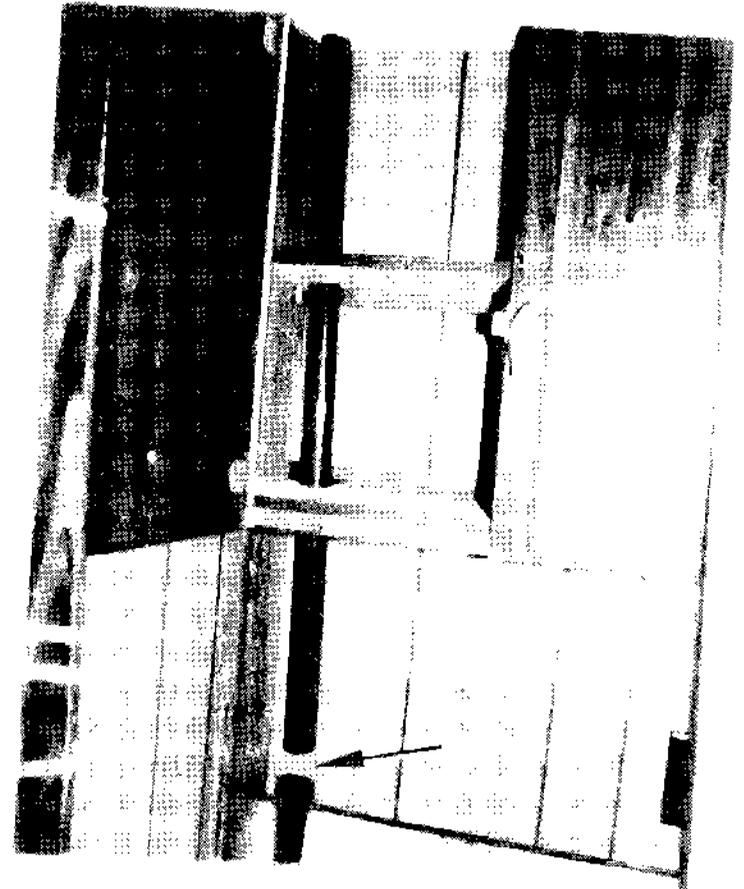
Figure C-71 Plastic Drain Pipe Fitting Has Not Been Properly Adhered with Adhesive.

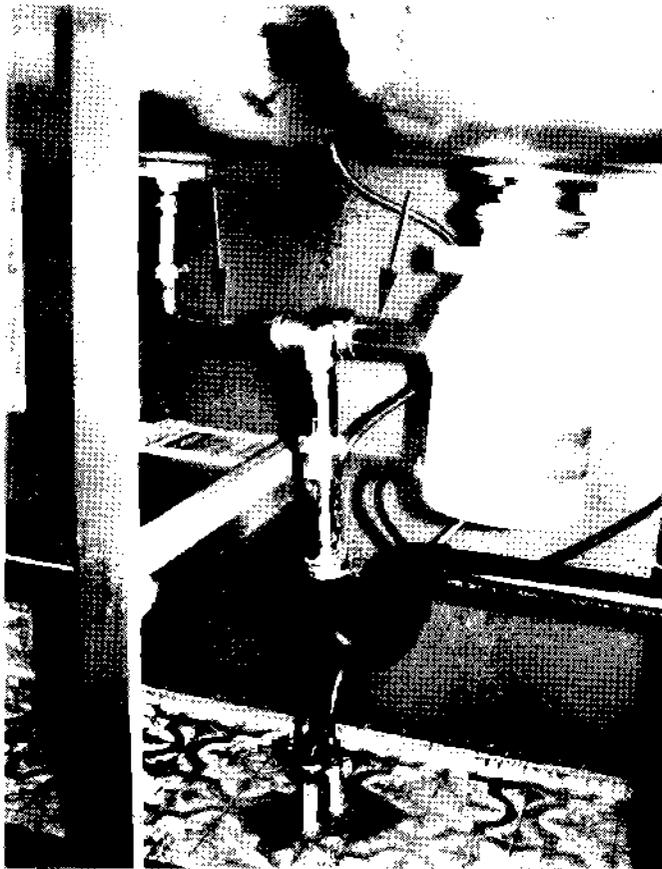
Figure C-73 Negative Slope of Drain Pipe Under Kitchen Sink

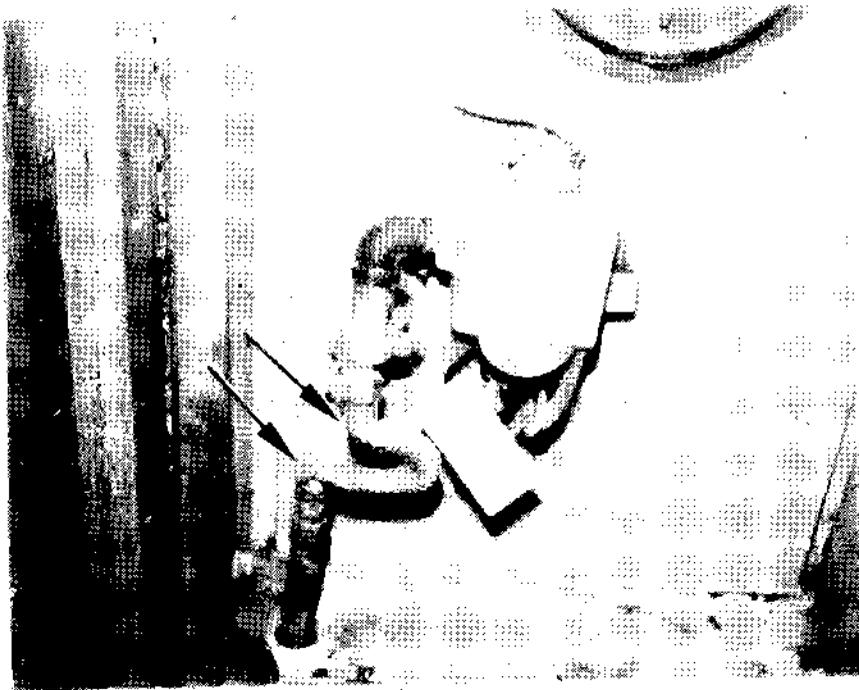
Figure C-84 Flexible Gas Connector on Furnace
with Sharp Radius Bend
