PHYSICAL NEEDS ASSESSMENT AND ENERGY AUDIT

WOODHILL HOMES

2488 Morris Black Place
Cleveland, Ohio 44104

EMG Project #: 109304.14R-025.308
Date of Report: April 22, 2015
On site Date: March 16 - 19, 2015

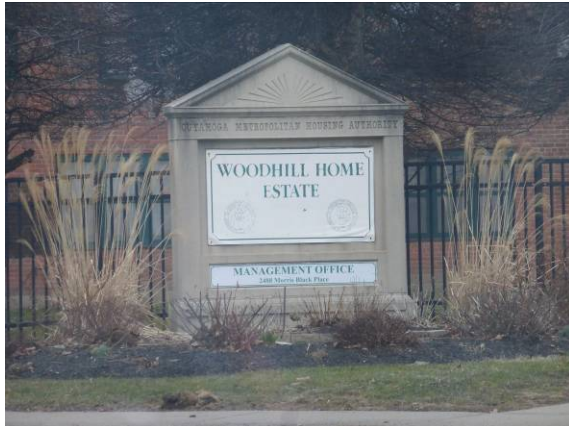
Photo #1: Site signage

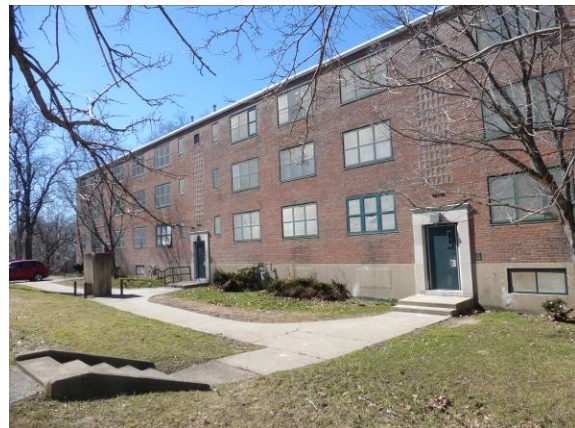
Photo #4: 3 story walk up - front elevation

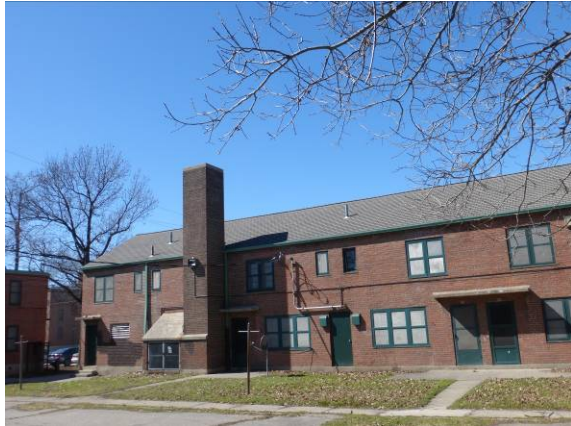
Photo #7:	Pitched roof row homes – rear elevation
-----------	---

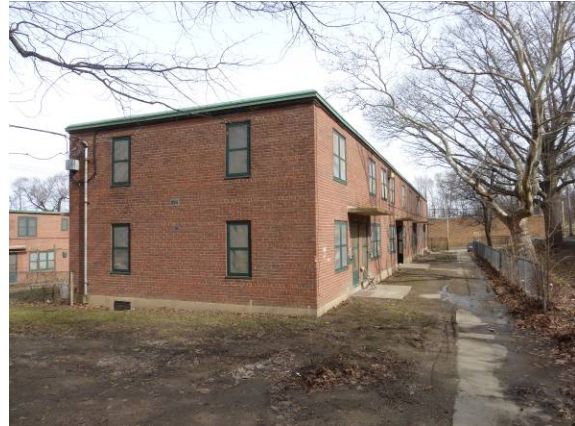
Photo #8:	Flat roof row homes
-----------	---------------------

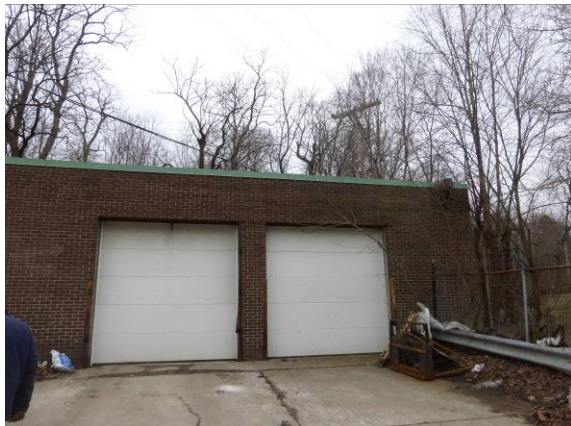
Photo #9:	Maintenance garage
-----------	--------------------

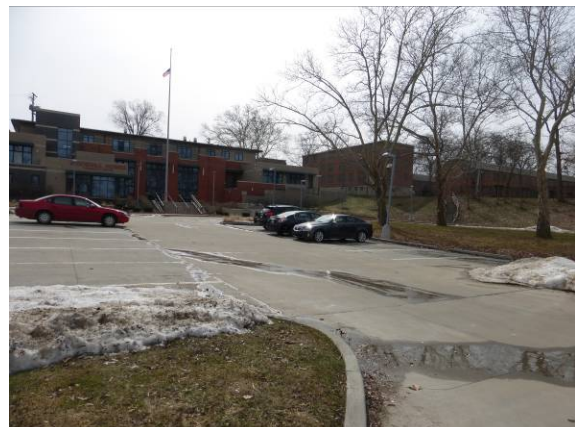
Photo #12:	Community center parking
------------	--------------------------

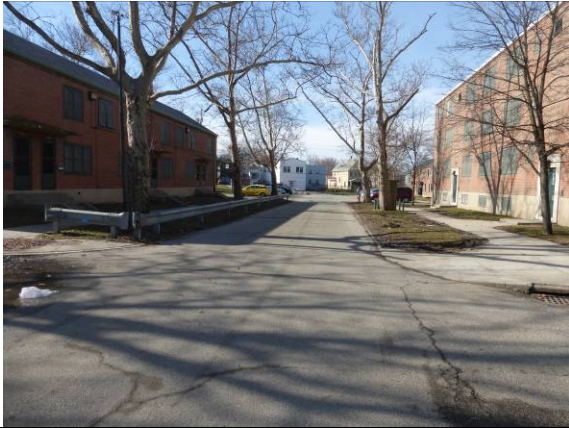
Photo #13:	Site drive aisle
------------	------------------

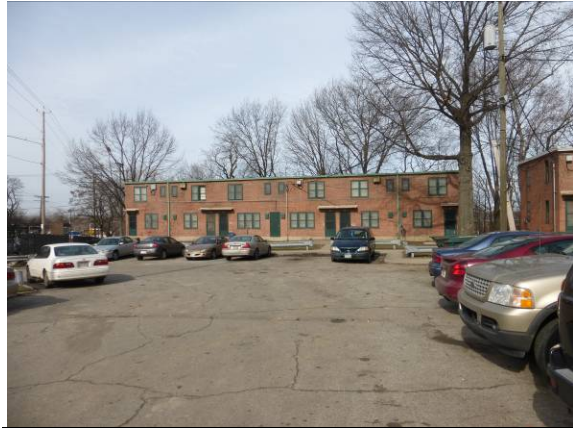
Photo #14:	Tenant parking
------------	----------------

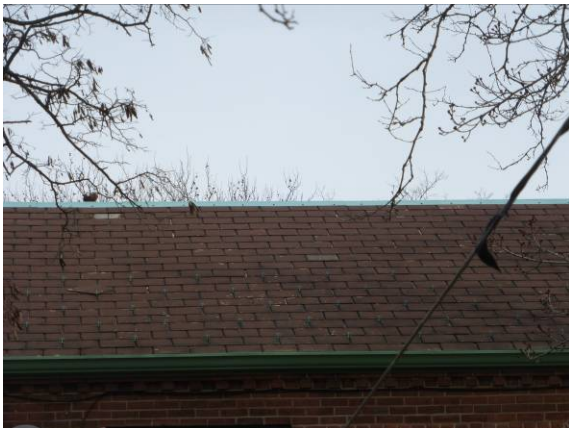
Photo #15:	Tenant row-home roof
------------	----------------------

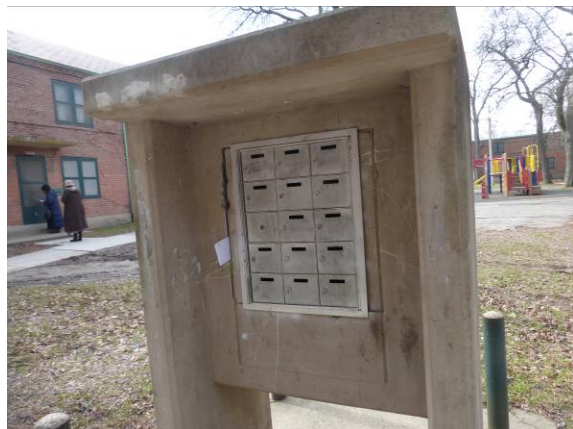
Photo #18:	Tenant mail box
------------	-----------------

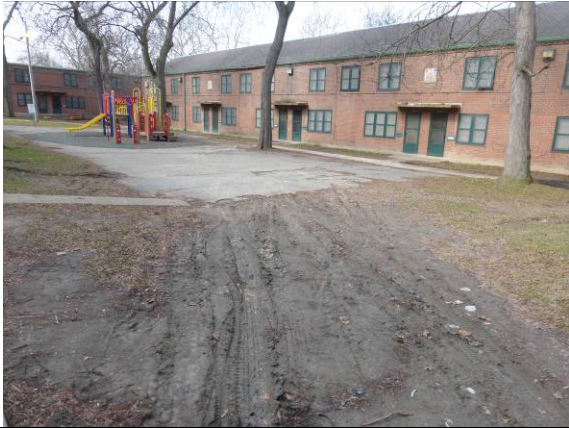
Photo #19: Courtyard and landscaping

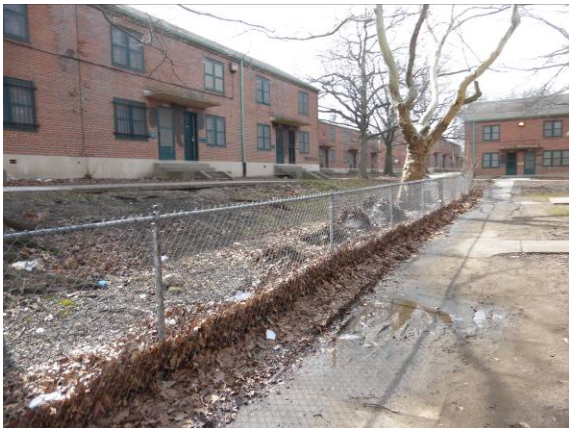
Photo #21: Chain link fence

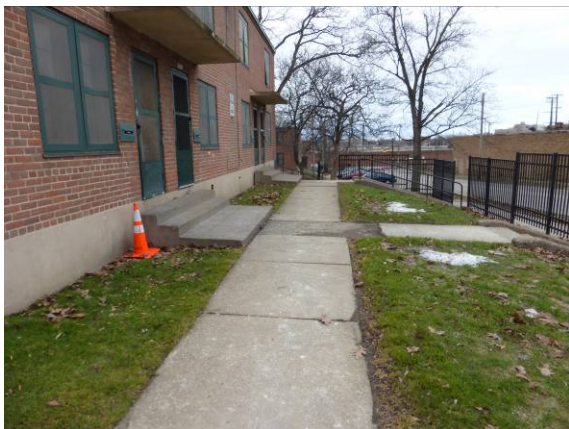
Photo #23: Site sidewalk

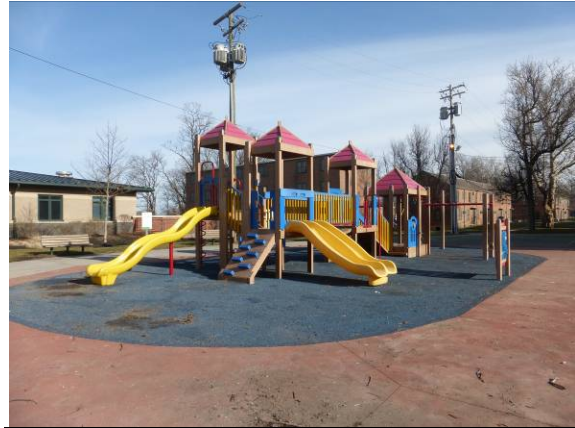
Photo #26: Playground

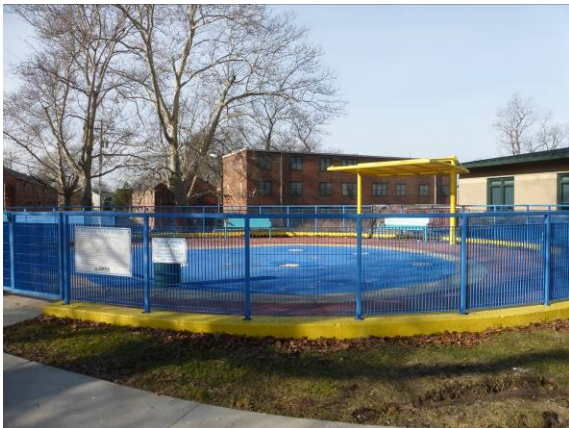
Photo #27: Splash park

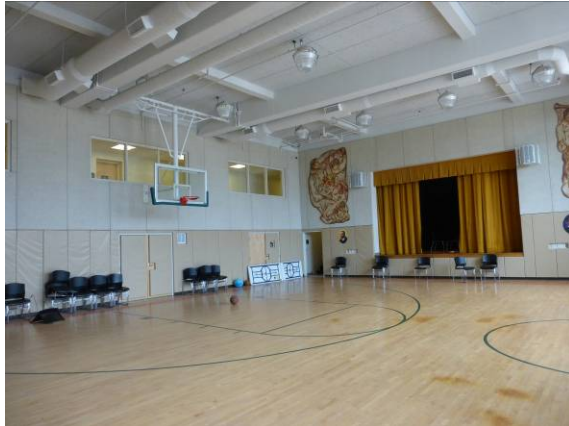
Photo #31: Community center - gym

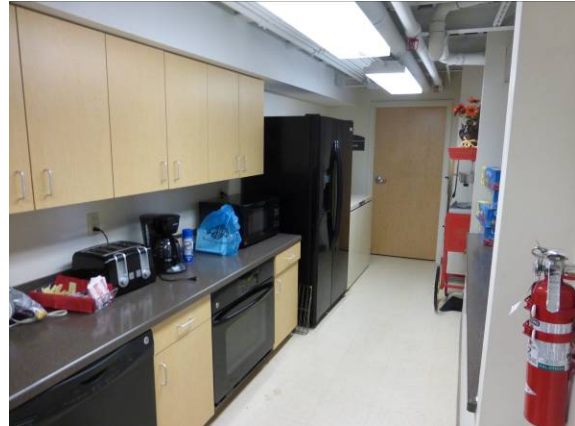
Photo #32: Community center - kitchen

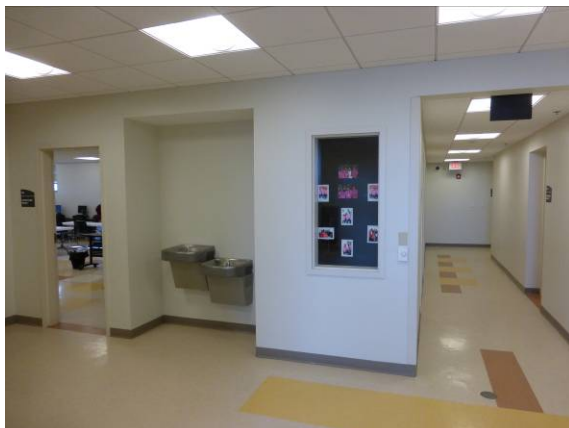
Photo #33: Community center - corridor

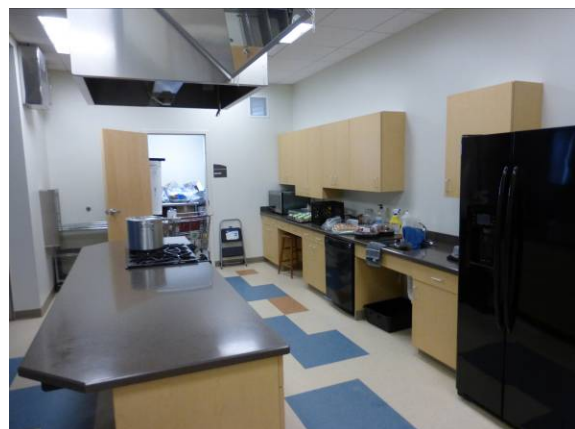
Photo #36: Community center - kitchen classroom

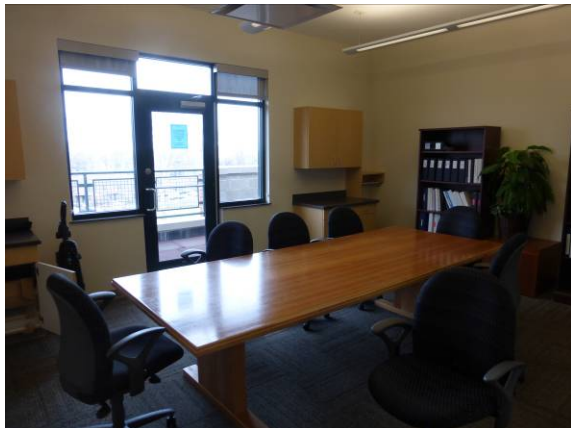
Photo #39: Community center - conference room

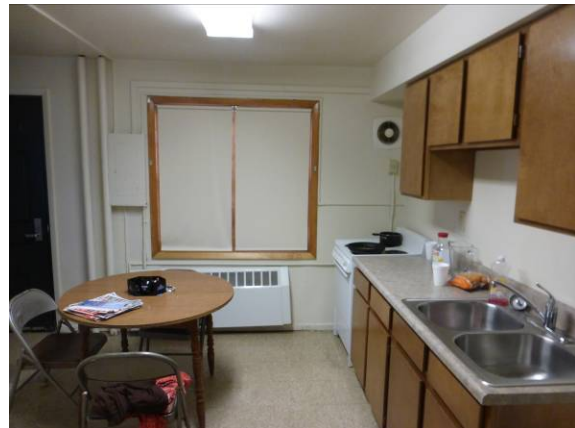
Photo #46: Row house kitchen

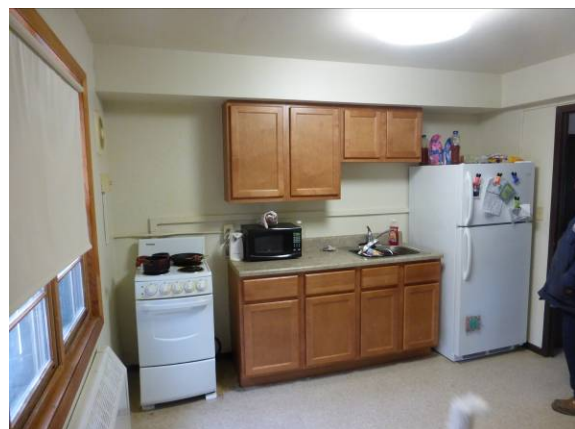
Photo #48: Row house kitchen

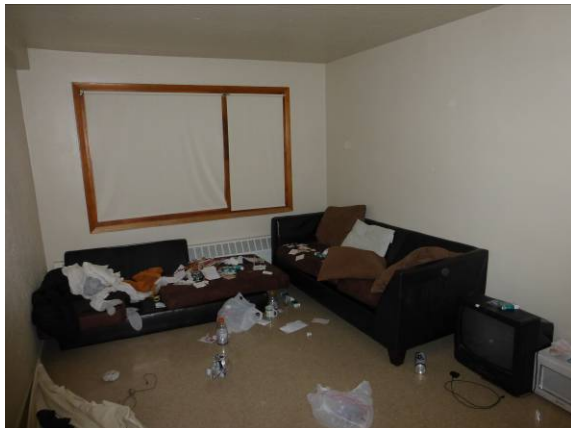
Photo #51: 3 story walk up - living room

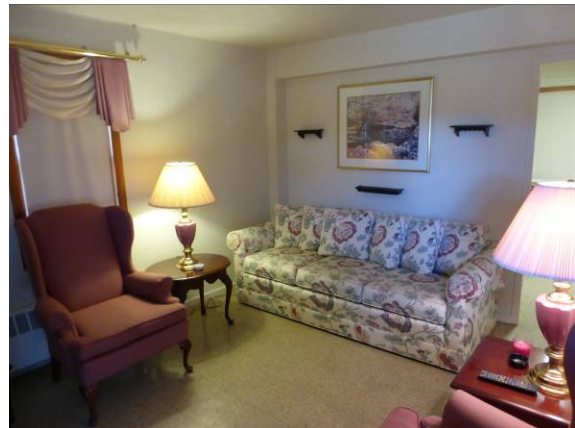
Photo #52: Row house - living room

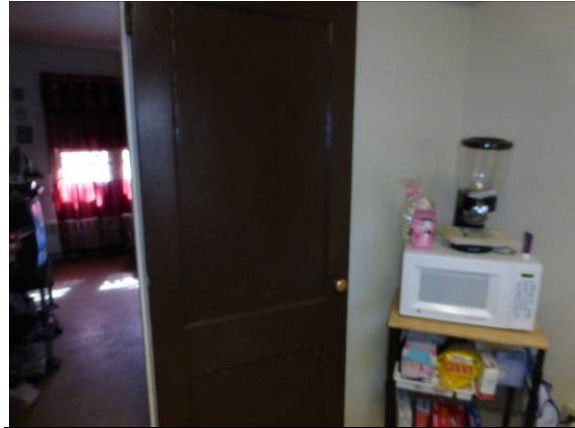
Photo #56:	Tenant unit interior door
------------	---------------------------

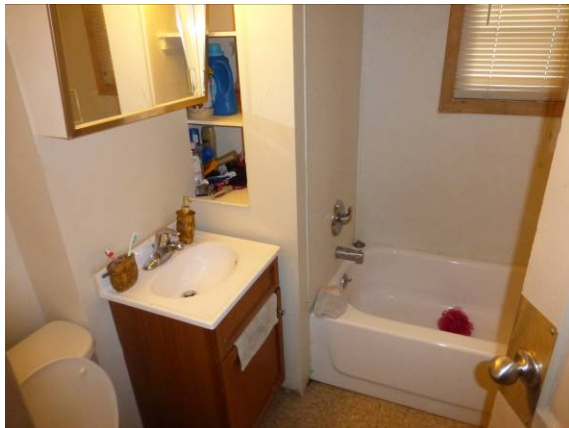
Photo #57:	Bathroom
------------	----------

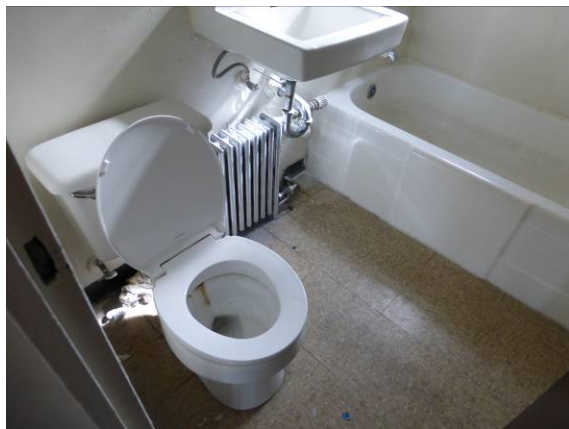
Photo #59:	Toilet
------------	--------

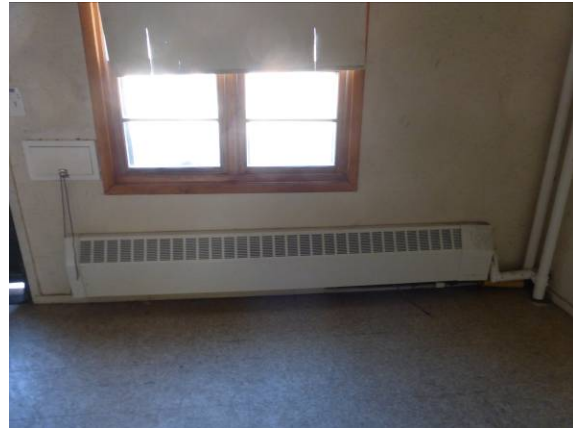
Photo #62: Radiator

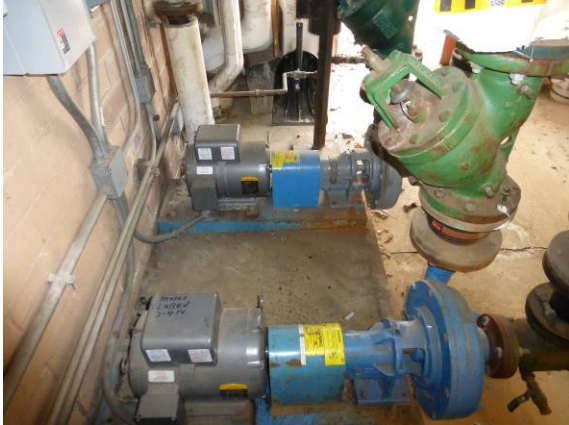
Photo #67:	Pump
------------	------

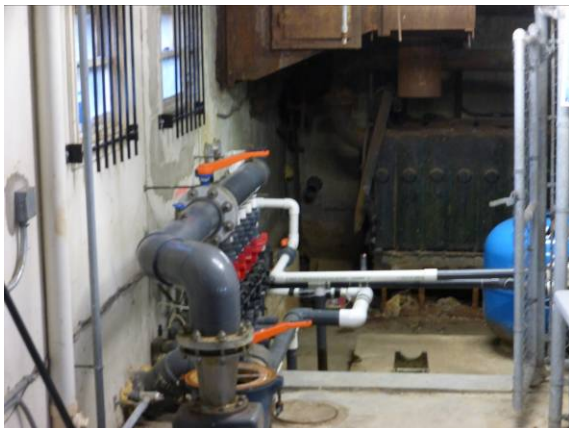
Photo #69:	Splash park equipment
------------	-----------------------

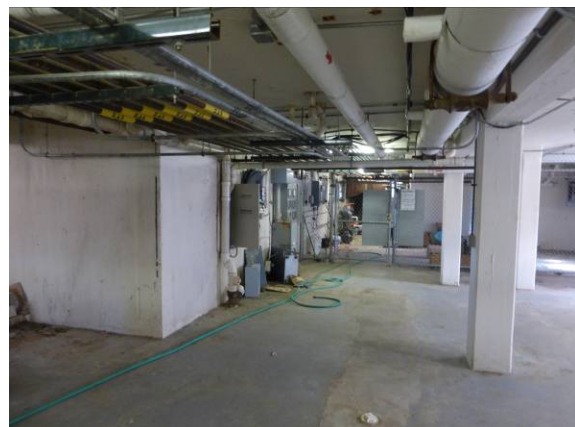
Photo #78: 3 Story walk up building basement
